Expertise

Protocol number: 48497817
Order No. / Reference: 27216483
Inspection date: 3 Nov 2026

Manufacturer: Mercedes-Benz	Model: GLB 200 7G-DCT EDITION 2022
VIN: W1N4M8HB0PW285177

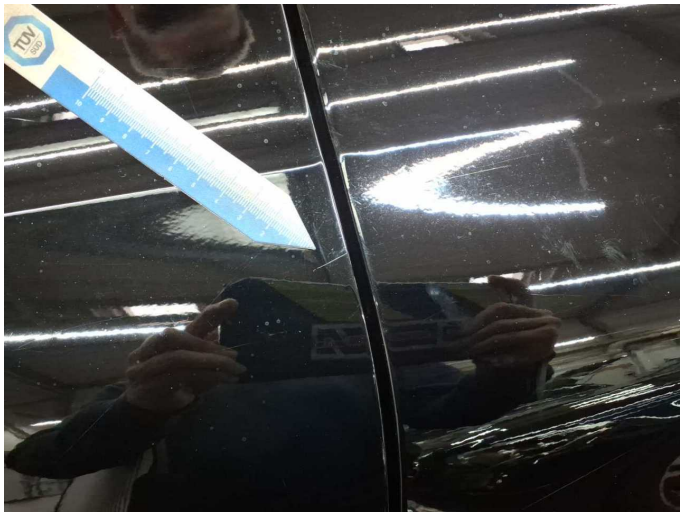
No.	Component group	Description
1	Door - rear left side	Door (Polieren) - Scratch(es) - Smart repair
2	Side panel - rear left side	Side panel (Pointen) - Scratch(es) - Smart repair

Damage 1: Door - rear left side: Door (Polieren) - Scratch(es) - Smart repair

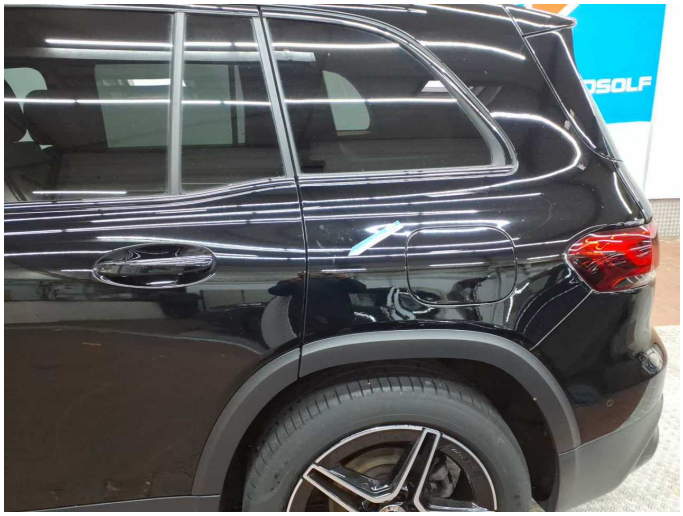
Damage 2: Side panel - rear left side: Side panel (Pointen) - Scratch(es) - Smart repair
