Expertise

Protocol number: 48573053
Order No. / Reference: 27296104
Inspection date: 9 Nov 2026

Manufacturer: Skoda	Model: Octavia Combi 2.0 TDI DSG 4x4 Ambition
VIN: TMBLJ8NX9RY019109

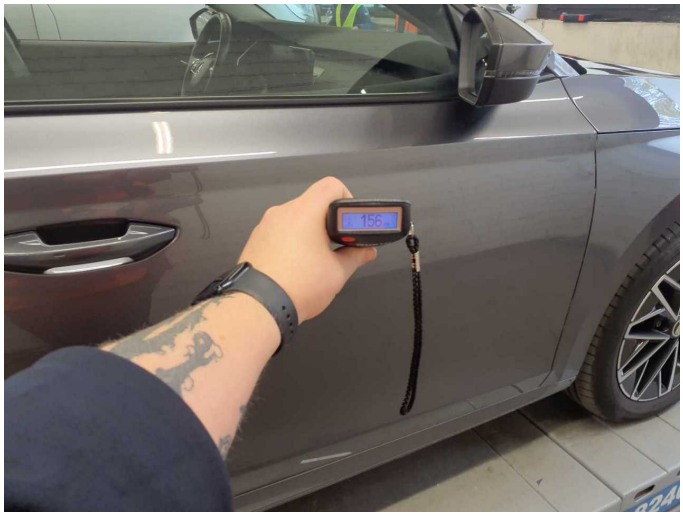
Mudguard - left side	155 µm	Mudguard - right side	150 µm
Bonnet	544 µm	Side panel - rear right side	168 µm
Door - rear left side	161 µm	Door - rear right side	187 µm
Door - front left side	156 µm	Door - front right side	156 µm

Repainting 1: Mudguard - left side, Mudguard - right side, Bonnet, Side panel - rear right side, Door - rear left side, Door - rear right side, Door - front left side, Door - front right side
