TÜV SÜD Auto Partner GmbH
Wiesenring 2
04159 Leipzig

# Expertise

Protocol number: 48075498
Order No. / Reference: 26826485
Inspection date: 12 Oct 2026

| Manufacturer: Audi | Model: A4 Avant 35 TDI S tronic |

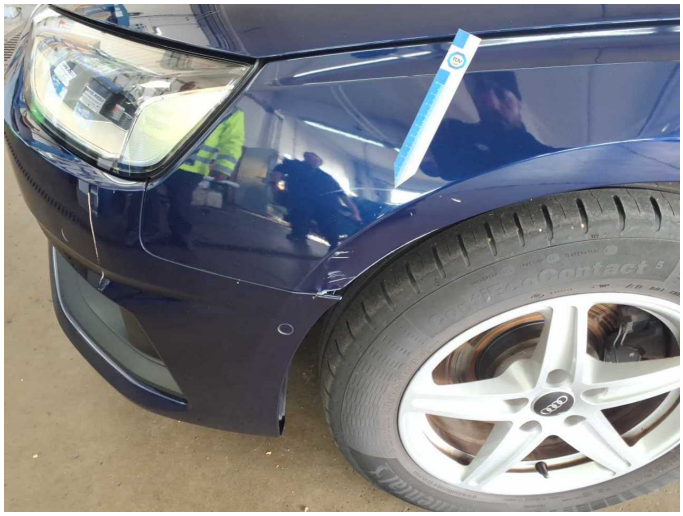
| No. | Accident |
|---|---|
| 1 | Front, Side - left |

**Accident 1:** Front, Side - left

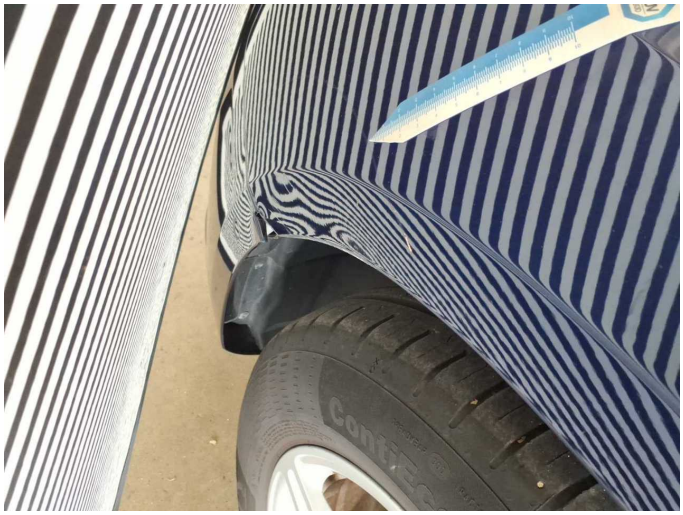
**Accident 1:** Front, Side - left

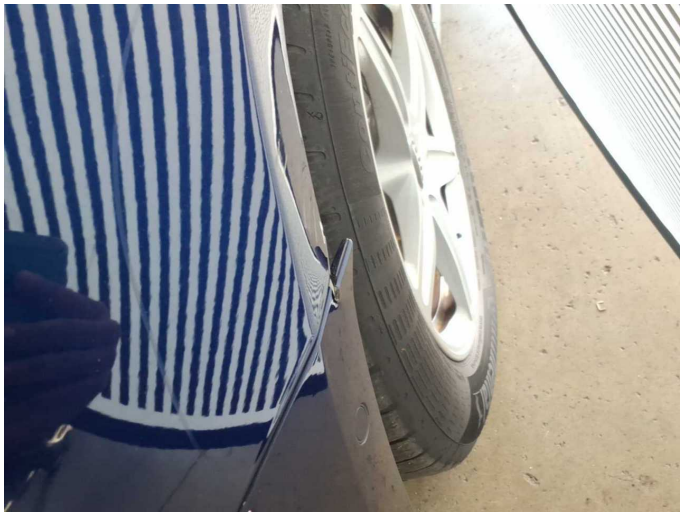
**Accident 1:** Front, Side - left

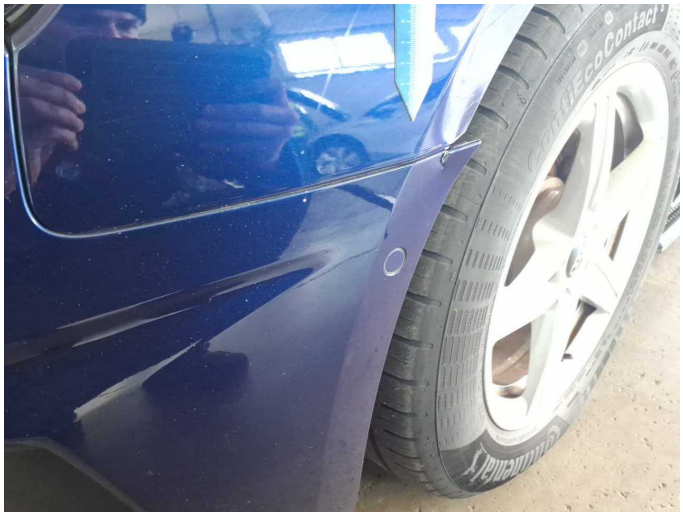
**Accident 1:** Front, Side - left

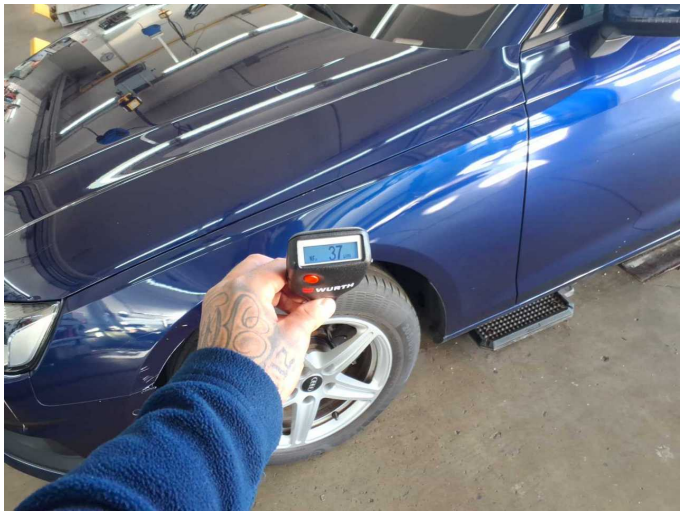
| No. | Previous damage | Extent of damage (Net) |
|---|---|---|
| 2 | Side - left, Provided by user / customer, from 20 Oct 2024 | 2.368,91 € |

**Previous damage 2:** Side - left
