TÜV SÜD Auto Partner GmbH
Gutenbergstraße 13
70771 Leinfelden-Echterdingen

Expertise

Protocol number: 48560431
Order No. / Reference: 27166657
Inspection date: 6 Nov 2026

Manufacturer: Ford	Model: Focus Turnier 1.0 EcoBoost Hybrid Aut. ST-LINE X
VIN: WF0PXXGCHPSK53519

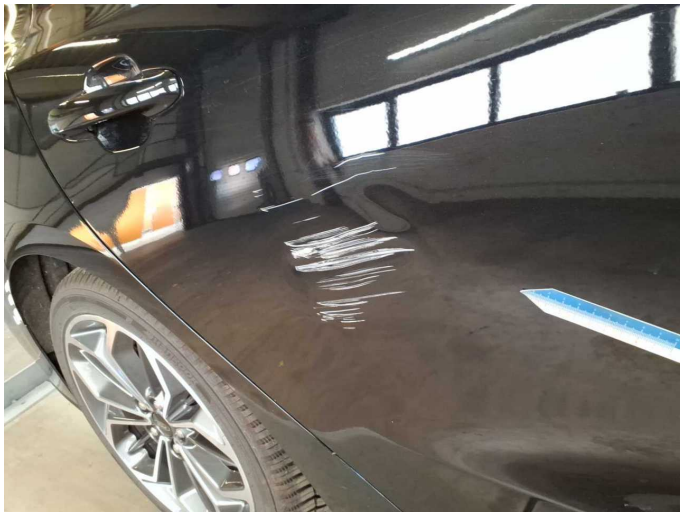
No.	Component group	Description
1	Wheel / tyres	Tyre - rear left side - Damaged - Replace
2	Engine	Engine cover - Damage caused by marten / rodent - Replace
3	Wheel / tyres	Alloy rim - front left side - Scratch(es) - Loss in value
4	Door - rear right side	Door - Dent / paintcoat damage - Repair and paint
5	Rear bumper	Rear bumper - Deformed - Repair and paint

Damage 4: Door - rear right side: Door - Dent / paintcoat damage - Repair and paint

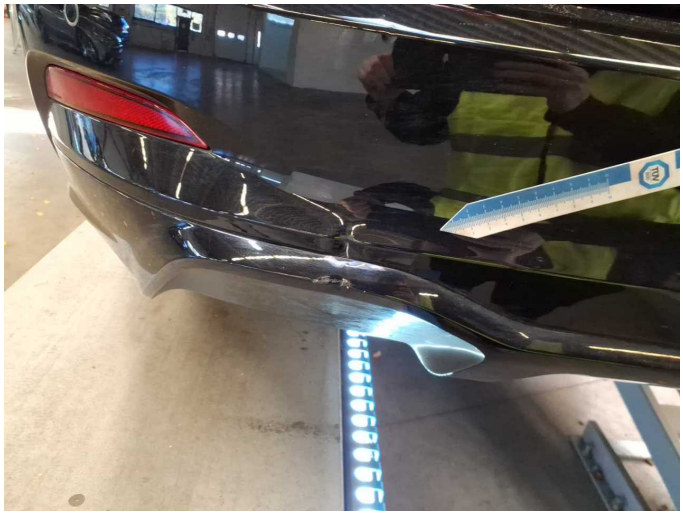
Damage 5: Rear bumper: Rear bumper - Deformed - Repair and paint
