Expertise

Protocol number: 48293485
Order No. / Reference: 27170335
Inspection date: 23 Oct 2026

Manufacturer: Volkswagen	Model: Touran 2.0 TDI SCR DSG Highline
VIN: WVGZZZ1T8RW004717

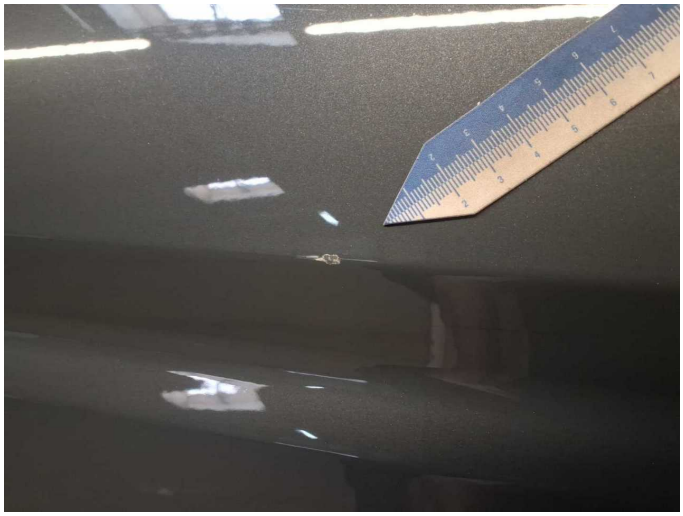
Damage 4: Sill - right side: Sill - Unprofessionally repaired - Repair and paint

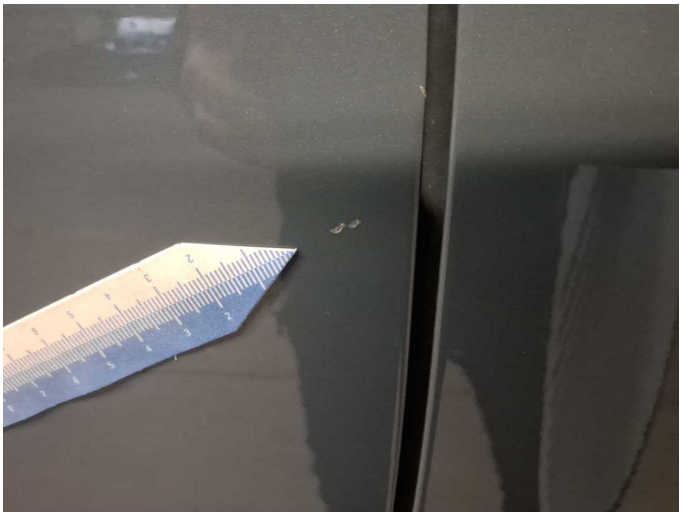
Damage 5: Door - rear right side: Door - Scratch(es) - Paint
