Expertise

Protocol number: 48135038
Order No. / Reference: 26745284
Inspection date: 14 Oct 2026

Manufacturer: Mercedes-Benz	Model: C 200 d T 9G-TRONIC Avantgarde Advanced
VIN: W1KAH0DB0RF141966

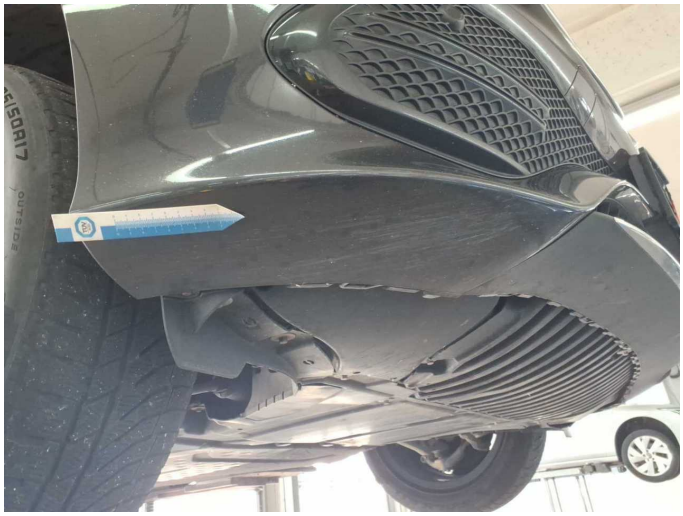
Damage 6: Rear bumper: Rear bumper - Scratch(es) - Paint

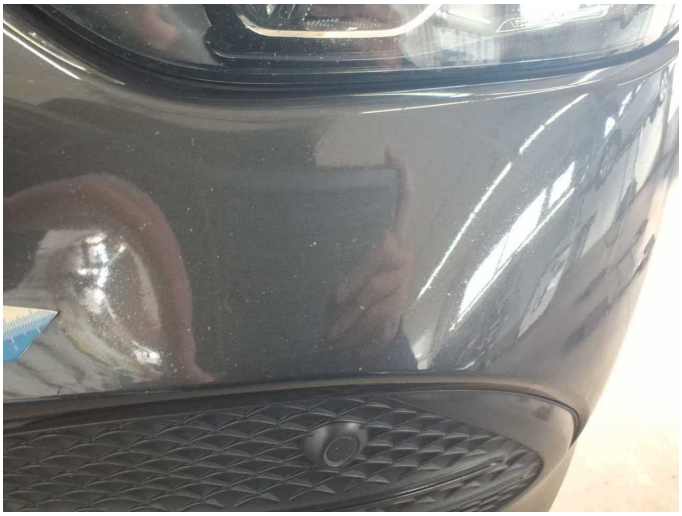
Damage 7: Front bumper: Front bumper (viele kleine Steinschläge) - Scratched - Paint

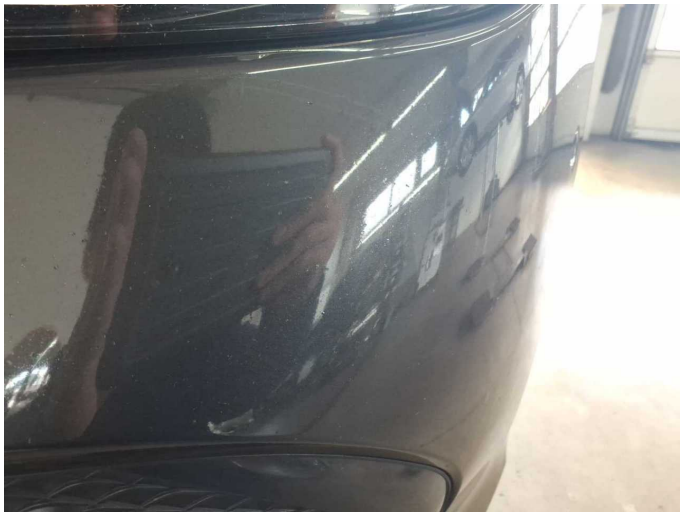
Damage 7: Front bumper: Front bumper (viele kleine Steinschläge) - Scratched - Paint

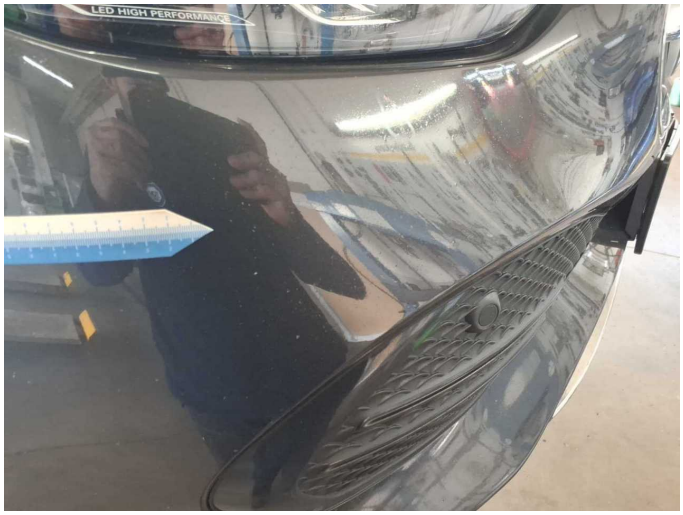
Damage 7: Front bumper: Front bumper (viele kleine Steinschläge) - Scratched - Paint

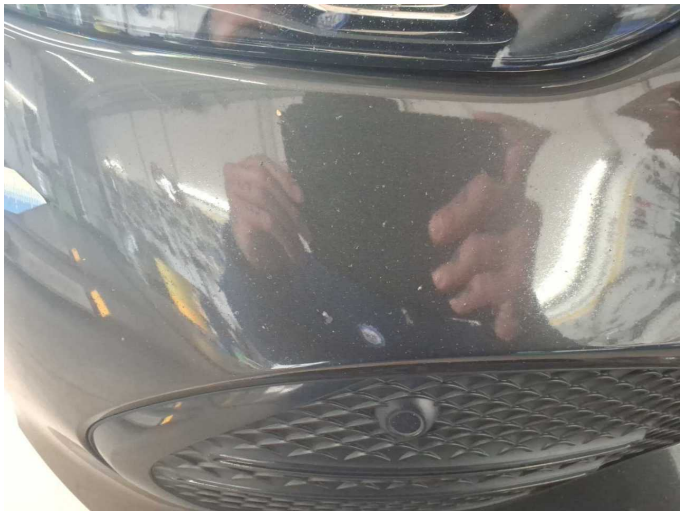
Damage 7: Front bumper: Front bumper (viele kleine Steinschläge) - Scratched - Paint

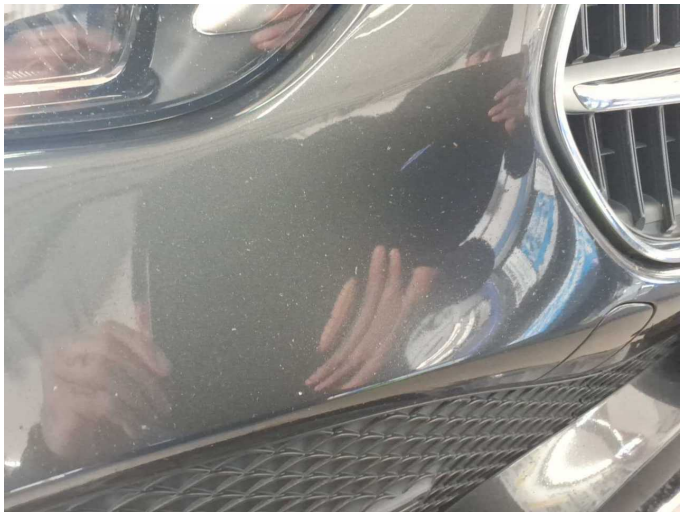
Damage 7: Front bumper: Front bumper (viele kleine Steinschläge) - Scratched - Paint
