Expertise

Protocol number: 48059341
Order No. / Reference: 27081631
Inspection date: 9 Oct 2026

Manufacturer: Opel	Model: Insignia Sports Tourer 2.0 Diesel Aut. Business
VIN: W0VZT8EP1M1015759

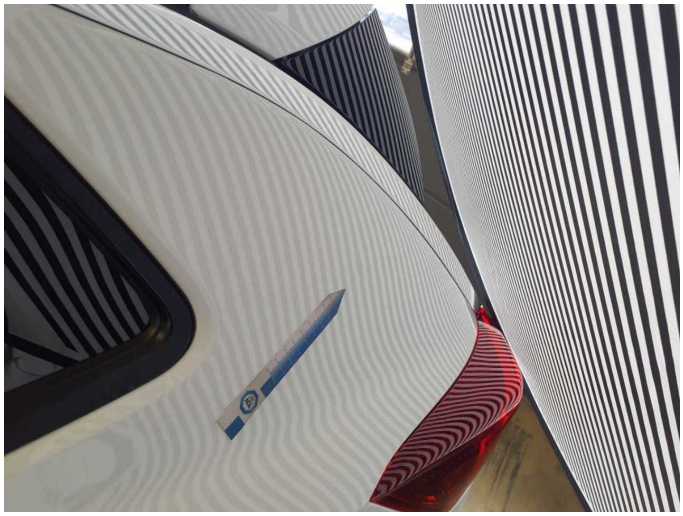
Damage 1: Side panel - rear left side: Side panel - dent(s) - Smooth repair work

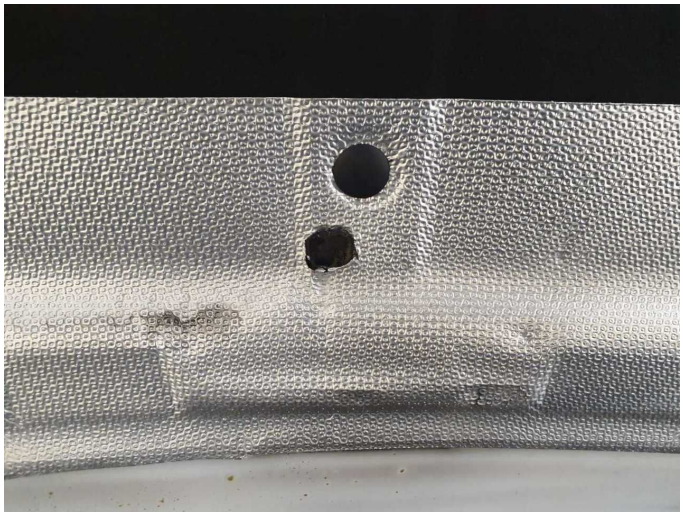
Damage 4: Bonnet: Insulation lining - Broken / torn - Replace

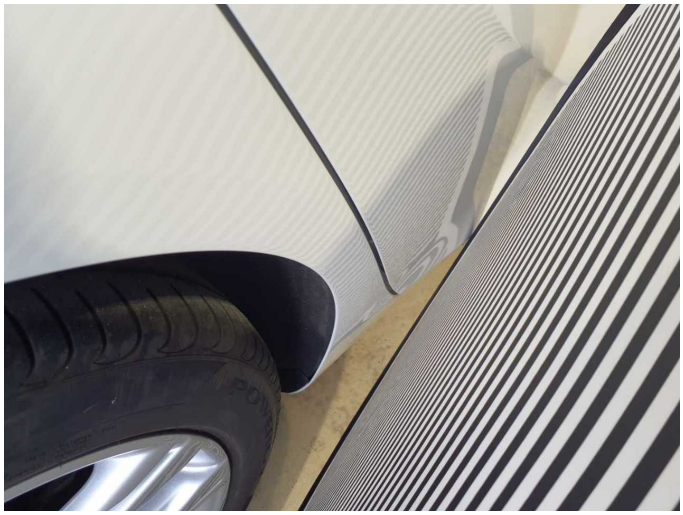
Side panel - rear right side	451 µm	Door - rear left side	190 µm
Door - rear right side	201 µm	Door - front left side	208 µm

Damage 6: Side panel - rear right side: Side panel (Wellig) - Unprofessionally repaired - Repair and paint
