PEUGEOT 3008

Summary of damages

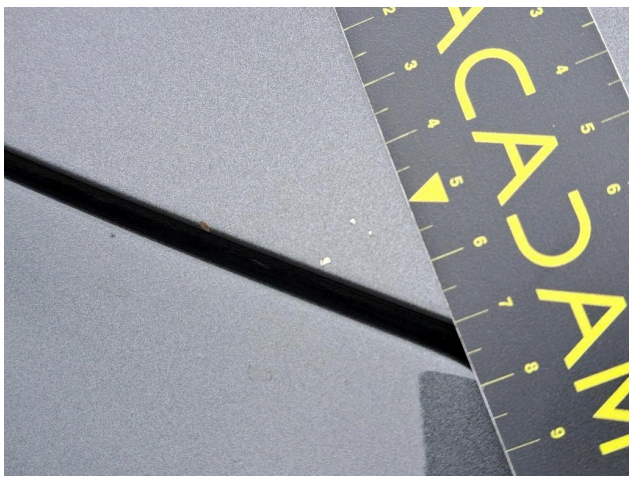
Bodywork
Damaged -
Acceptable.
Roof & other

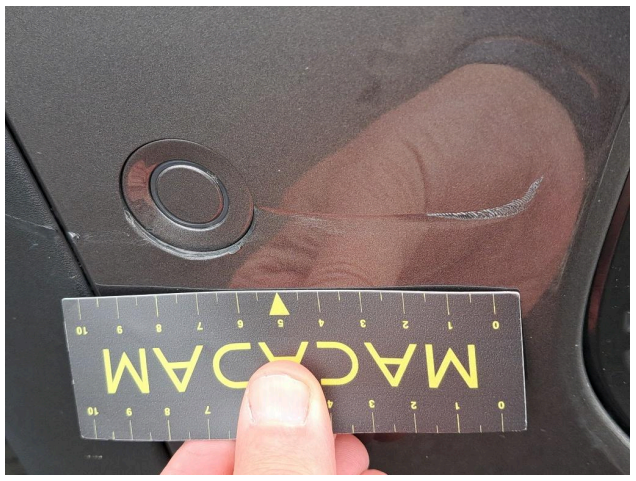
Front right wing molding, Smart repair
claw(s) , right

Front bumper,
scratch(es),
paint
front
