Expertise

Protocol number: 48008742
Order No. / Reference: 27046325
Inspection date: 23 Sept 2026

Manufacturer: Opel	Model: Astra Sports Tourer 1.5 D Business Elegance
VIN: VXKFCYHZLP1056565

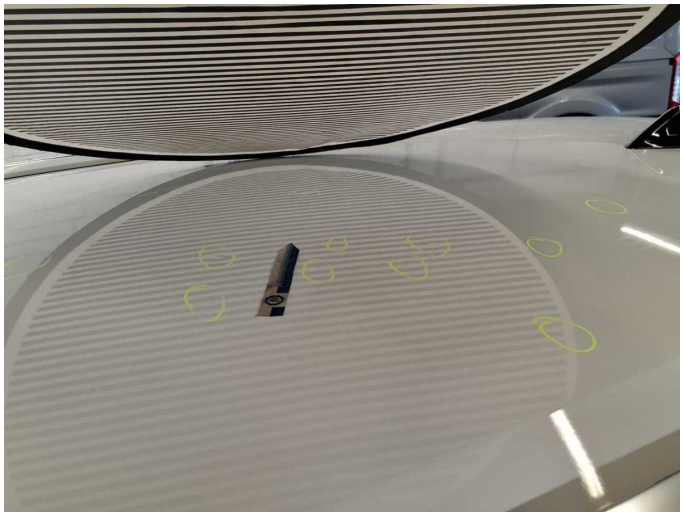
No.	Component group	Description
1	Trim / covers	Floor mats - Holes - Replace
2	Front bumper	Front bumper - Stone chips - Smart repair
3	2nd wheel set	Tyres - complete set - Worn - Replace
4	Roof	Roof - Damage by hail - Smooth repair work

Damage 4: Roof: Roof - Damage by hail - Smooth repair work

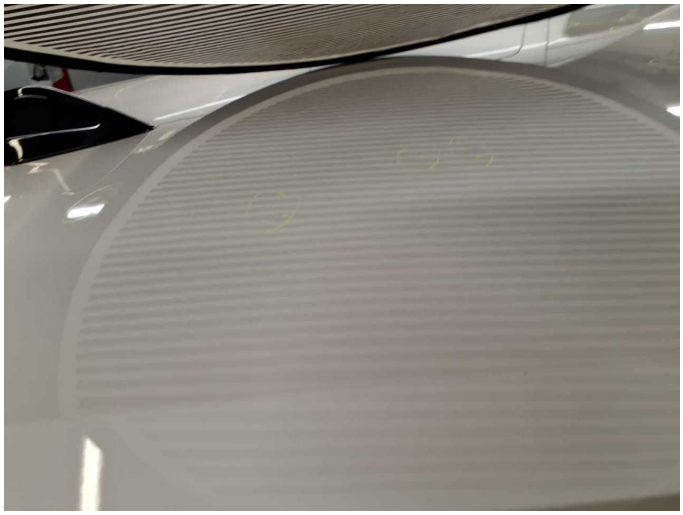
Damage 4: Roof: Roof - Damage by hail - Smooth repair work

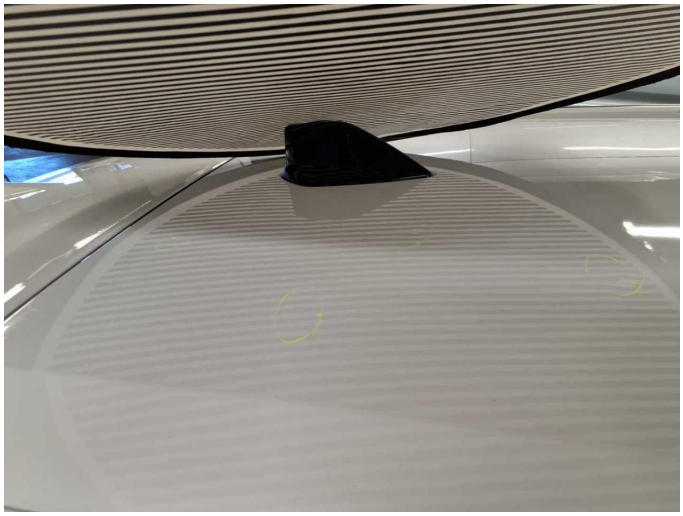
Damage 4: Roof: Roof - Damage by hail - Smooth repair work
