BMW

VIN: WBA11AK0X07L94647

Statement details

Inspection loc PARC HÖDLMAYR TONGEREN	**Statement date** 21/10/2026	**Inspection approval date** 22/10/2026

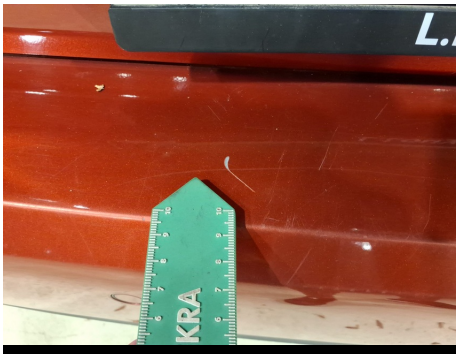
003	Bumper / Back [1] Painted : Yes	Scratched	Acceptable

Bumper / Back / Scratched
