Expertise

Protocol number: 48417598
Order No. / Reference: 27219321
Inspection date: 29 Oct 2026

Manufacturer: Skoda	Model: Octavia Combi 2.0 TDI DSG Style
VIN: TMBJJ0NX7PY045360

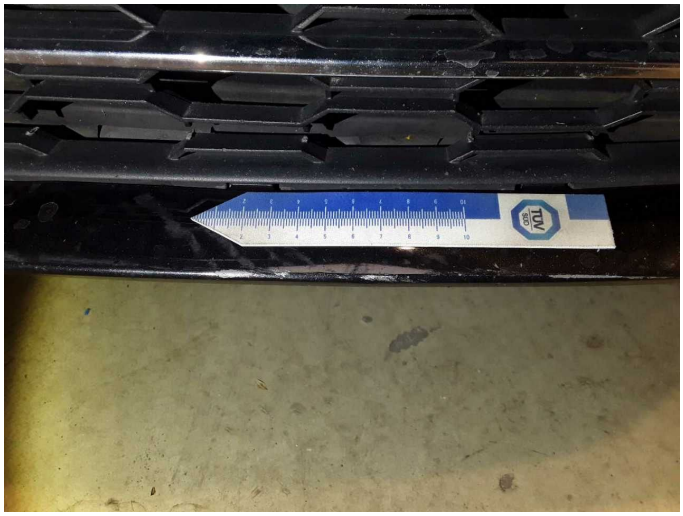
Damage 3: Front bumper: Front bumper - Scratch(es) - Smart repair

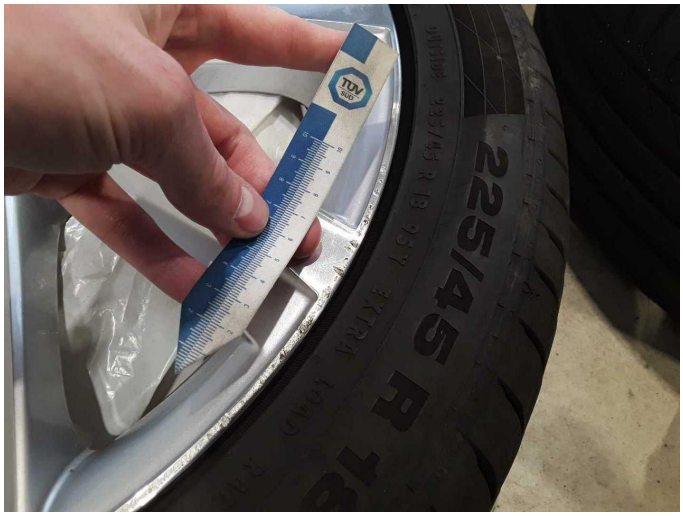
Damage 6: 2nd wheel set: 1 alloy rim (Mit Materialabtrag, Großflächig verkratzt) - Scratched - Replace

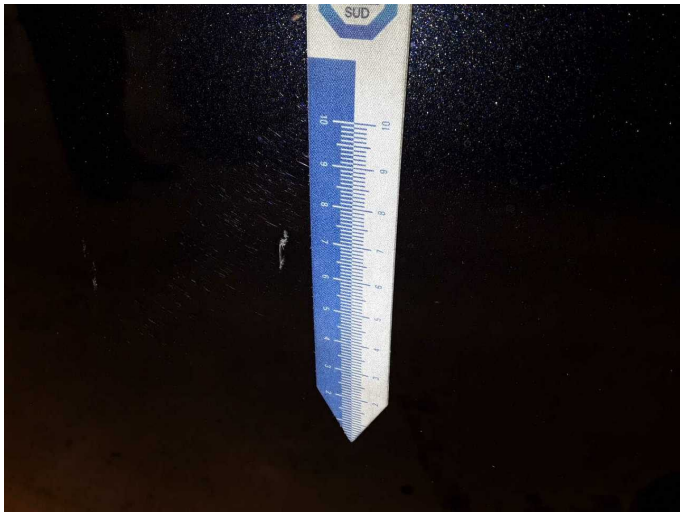
Damage 9: Door - front left side: Door - Scratch(es) - Paint

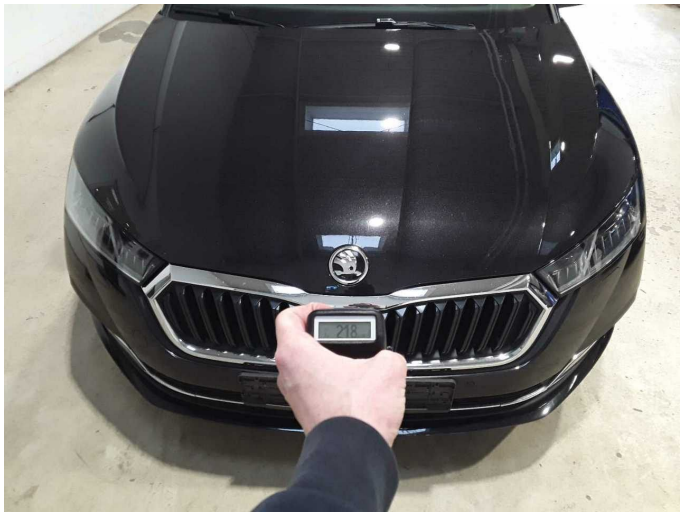
Repainting 1: Bonnet

No.	Repainting
1	Bonnet, Professionally carried out, Invoice of repair done Non-existent

Bonnet	218 µm
