Expertise

Protocol number: 48064616
Order No. / Reference: 27095039
Inspection date: 12 Oct 2026

Manufacturer: Mercedes-Benz	Model: GLA 200 d 4Matic 8G-DCT Style
VIN: W1N4N1DB8PJ528550

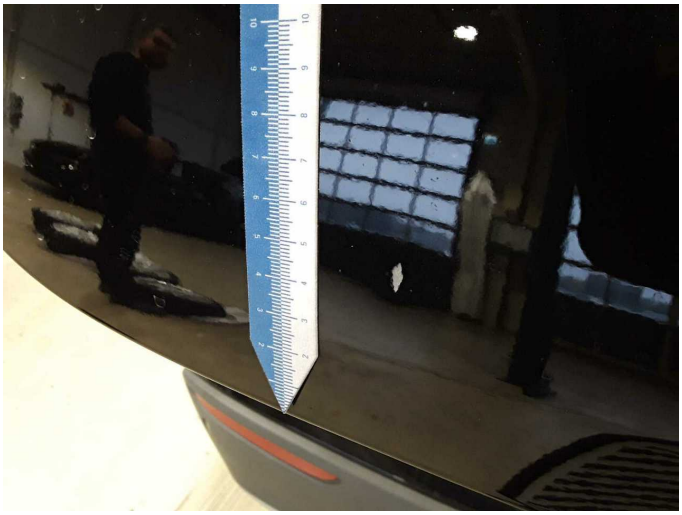
No.	Component group	Description
1	Boot lid / rear door	Boot lid - Dent / paintcoat damage - Smart repair
2	Bonnet	Bonnet (Anätzung) - Paint defect - Repair and paint

Damage 1: Boot lid / rear door: Boot lid - Dent / paintcoat damage - Smart repair

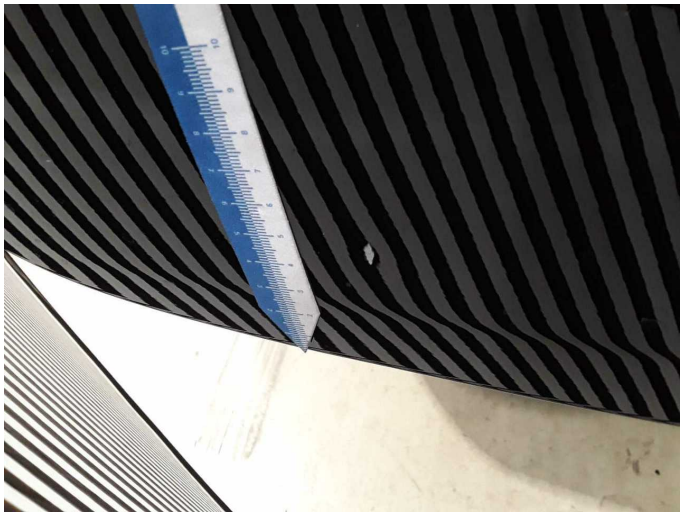
Damage 1: Boot lid / rear door: Boot lid - Dent / paintcoat damage - Smart repair

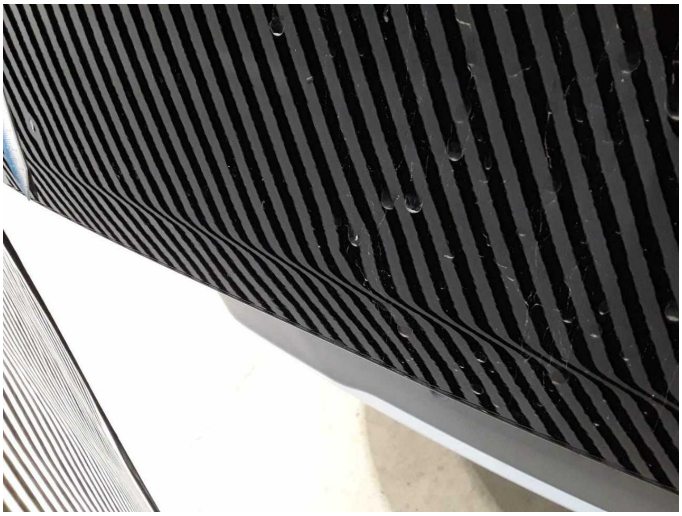
Damage 1: Boot lid / rear door: Boot lid - Dent / paintcoat damage - Smart repair

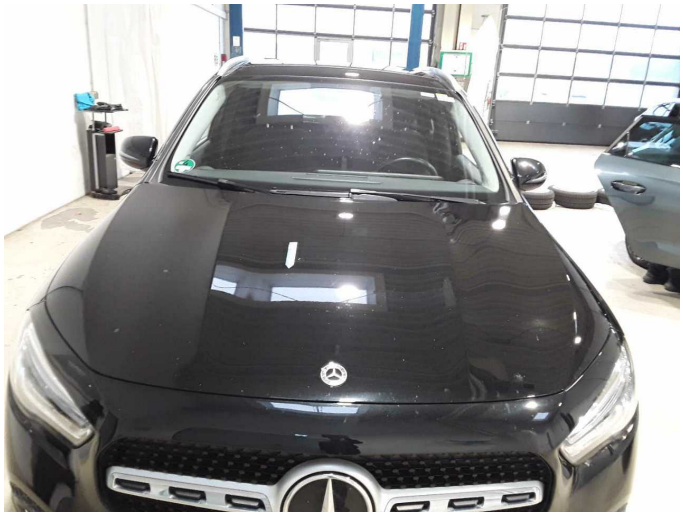
Damage 2: Bonnet: Bonnet (Anätzung) - Paint defect - Repair and paint
