TÜV SÜD Auto Partner GmbH
Wiesenring 2
04159 Leipzig

Expertise

Protocol number: 48546738
Order No. / Reference: 27262161
Inspection date: 4 Nov 2026

Manufacturer: Renault	Model: Trafic Blue dCi 150 Life
VIN: VF1JL000269817632

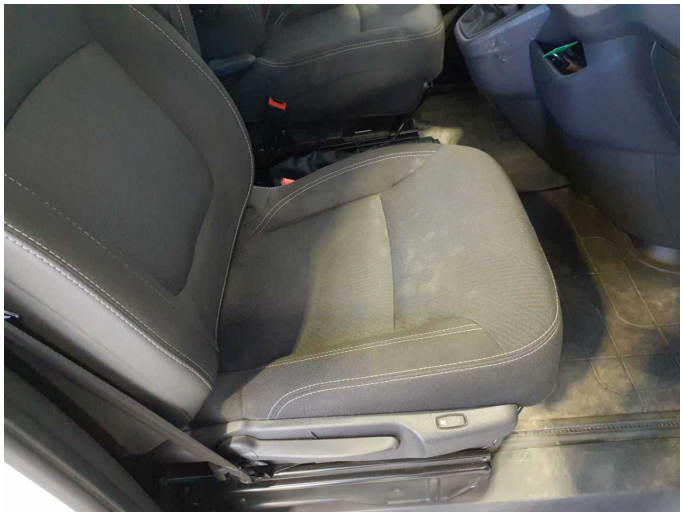
Damage 2: Seat - front: Seat cover - left side - Soiled - Clean

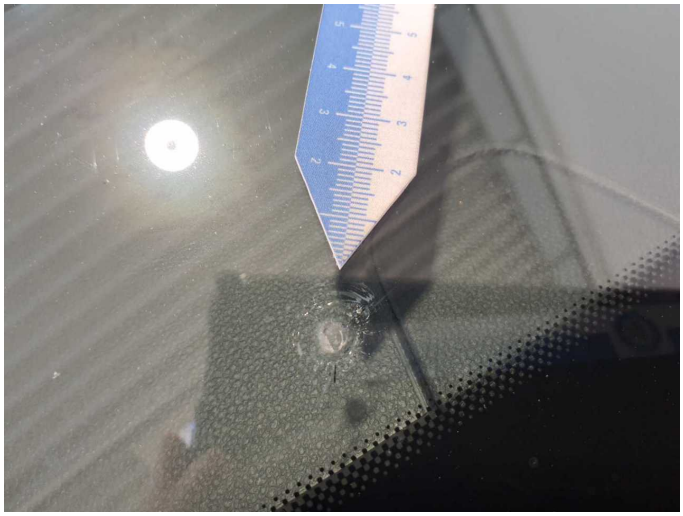
Damage 7: Vehicle glazing: Windscreen (kein Staubschutz) - Stone chips - Replace
