Expertise

Protocol number: 48205797
Order No. / Reference: 27153456
Inspection date: 12 Oct 2026

Manufacturer: CUPRA	Model: Born 170kW/58kWh
VIN: VSSZZZK18RP016991

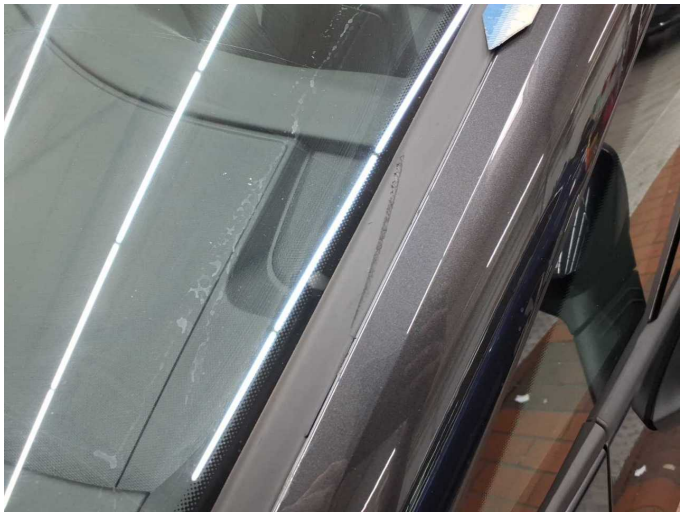
Damage 1: Vehicle glazing: Windscreen seal - Scratch(es) - Replace

Damage 2: Door - front left side: Door - Scratch(es) - Smart repair

Damage 3: Rear bumper: Rear bumper - Scratch(es) - Smart repair

Damage 5: Wheel / tyres: Tyres - complete set - Worn - Replace
