Expertise

Protocol number: 48504342
Order No. / Reference: 27167602
Inspection date: 5 Nov 2026

Manufacturer: Skoda	Model: Superb Combi 2.0 TDI 4x4 DSG Sportline
VIN: TMBLR9NP1P7007537

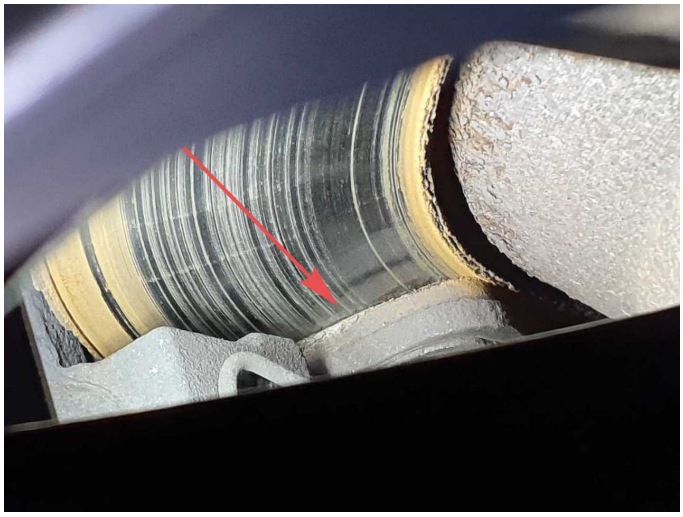
Damage 6: Braking system: Brake discs and pads - rear - Worn - Replace
