Expertise

Protocol number: 47743295
Order No. / Reference: 27003442
Inspection date: 24 Sept 2026

Manufacturer: IVECO	Model: Daily 35 S 14NA8 V Kasten
VIN: ZCFCR35AX05542563

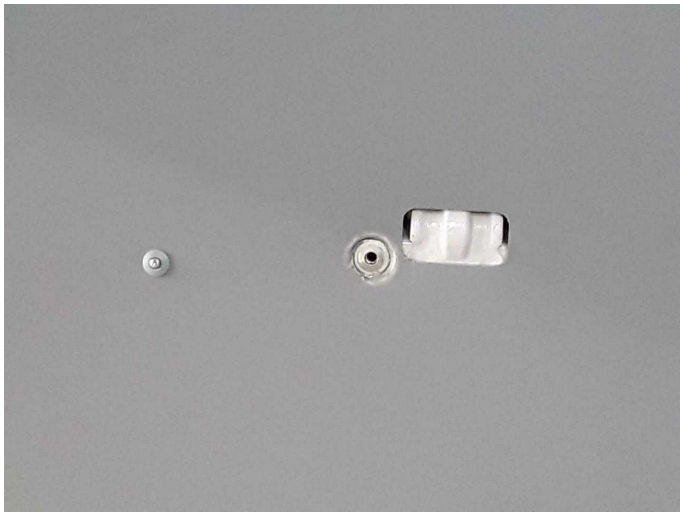
No.	Component group	Description
1	Bonnet	Bonnet - dent(s) - Smart repair
2	Rear axle	Rear axle (Luftfahrwerk) - on - Perform diagnosis
3	Wheel / tyres	Tyre - rear left side - Defective - Replace
4	Interior	Interior (Laderaum) - Holes - Loss in value
5	Body	Body - Glued / labelled - De-glue / neutralise

Damage 4: Interior: Interior (Laderaum) - Holes - Loss in value
