Expertise

Protocol number: 48509343
Order No. / Reference: 27198709
Inspection date: 28 Oct 2026

Manufacturer: Opel	Model: Mokka 1.2 DI Turbo Automatik Elegance
VIN: VXKUSHNSSNW046241

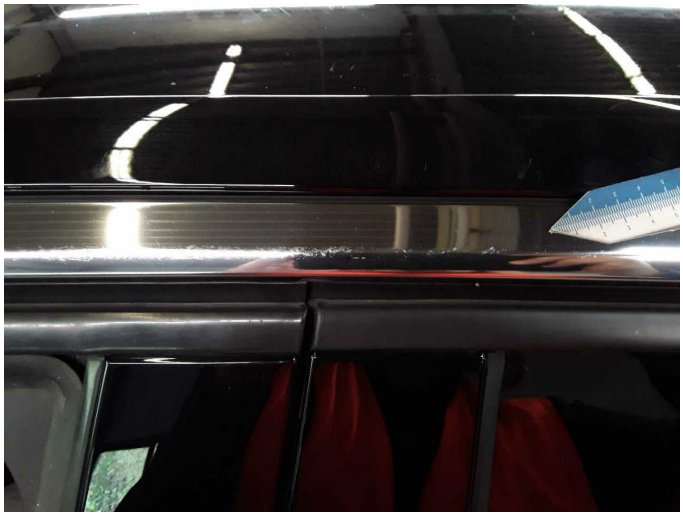
Damage 2: Side panel - rear left side: Brightware (Dachholm links) - Scratched - Loss in value

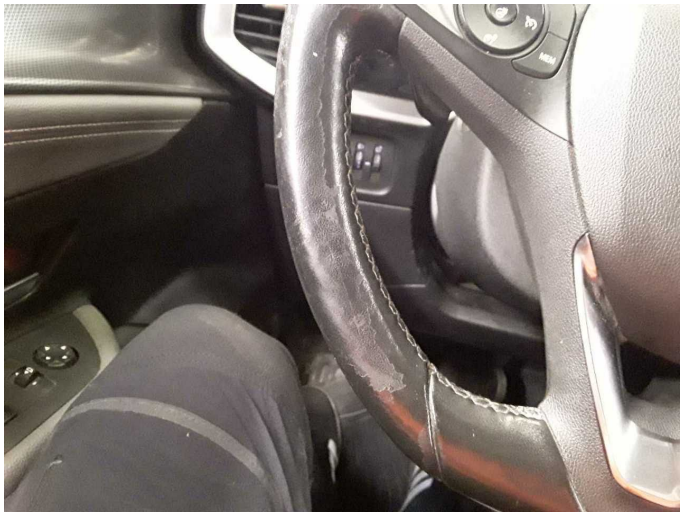
Damage 7: Steering system: Steering wheel sheath - Scratched - Loss in value

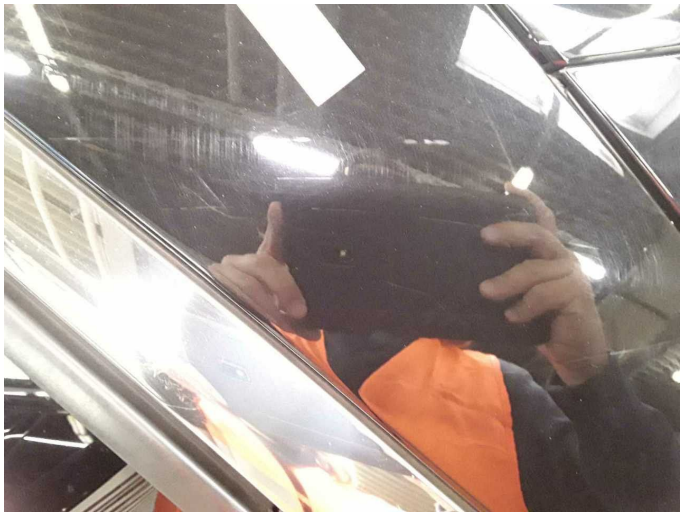
Damage 10: Roof: Roof rail - left side - Scratch(es) - Paint

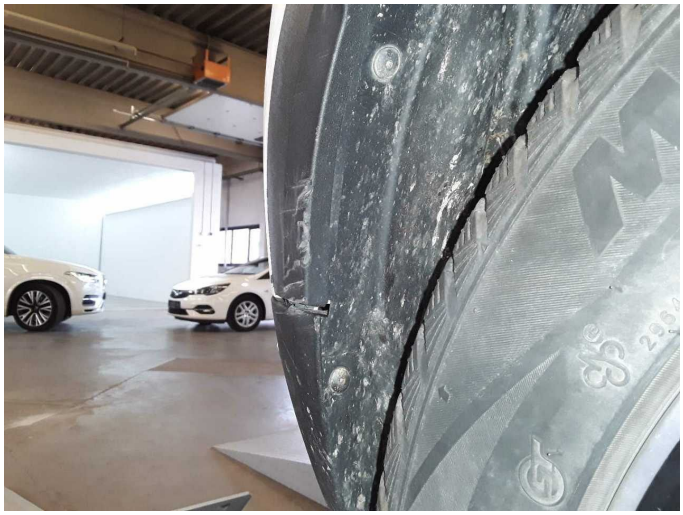
Accident 1: Rear, Side right
