Expertise

Protocol number: 48072933
Order No. / Reference: 26745021
Inspection date: 12 Oct 2026

Manufacturer: Mercedes-Benz	Model: GLB 200 d 8G-DCT Entry
VIN: W1N4M1CB2RW358258

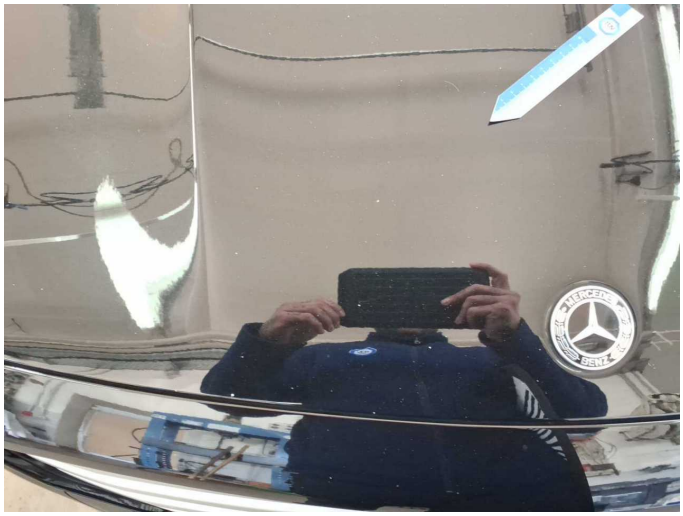
Damage 7: Bonnet: Bonnet - Stone chips - Paint

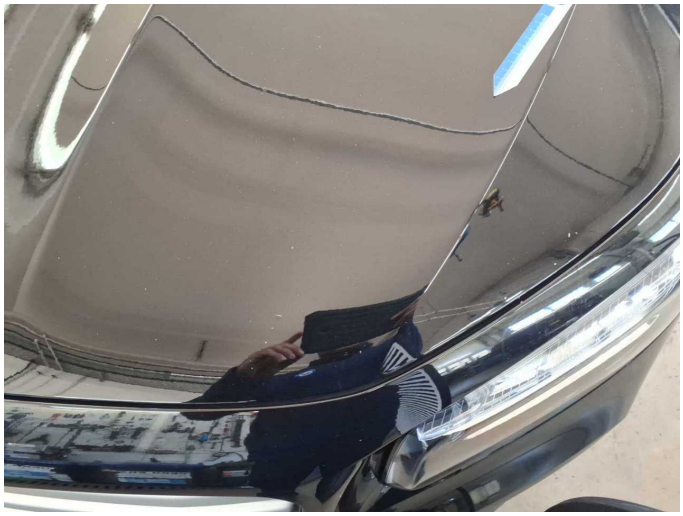
Damage 7: Bonnet: Bonnet - Stone chips - Paint

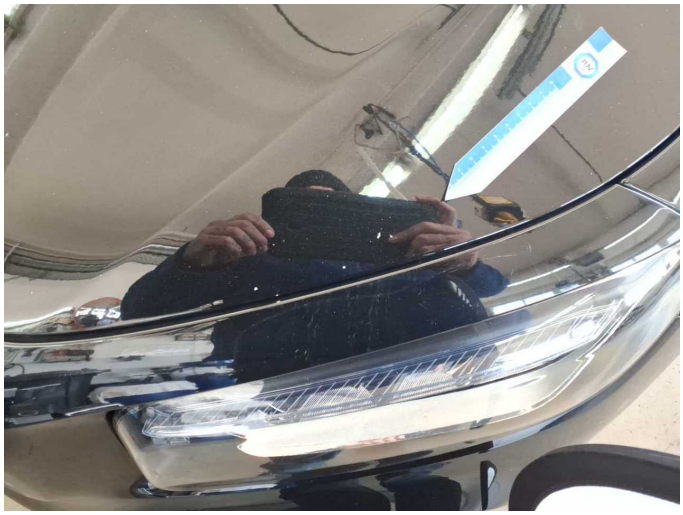
Damage 7: Bonnet: Bonnet - Stone chips - Paint
