Besichtigungsdatum: 23.10.2026
Protokollnummer: 48437115
Erstellt durch: Paula Busch
Besichtigt durch: Furkan Kara

VSSZZZKL1RR090646

Zustandsbericht

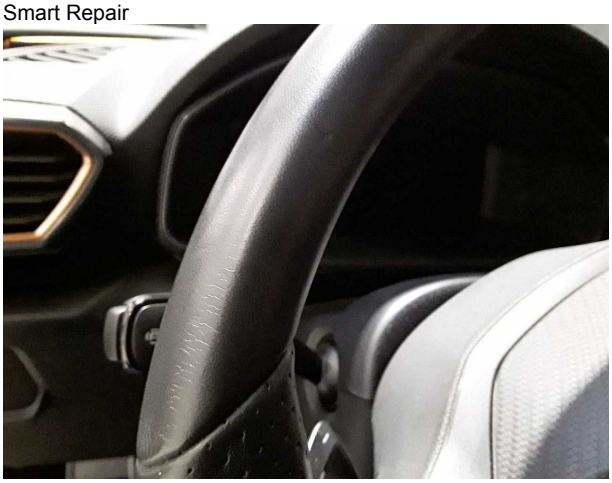
Beschädigung #1: Lenkanlage: Lenkrad - verkratzt / verschürft - Smart Repair

Beschädigung #1: Lenkanlage: Lenkrad - verkratzt / verschü… - Smart Repair

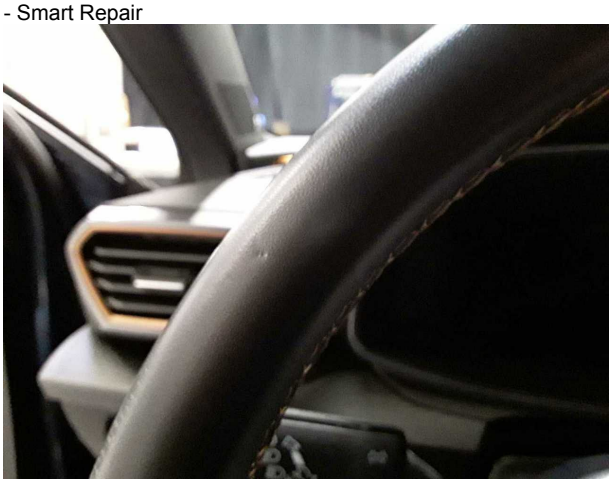
Beschädigung #1: Lenkanlage: Lenkrad - verkratzt / verschürft - Smart Repair

Beschädigung #1: Lenkanlage: Lenkrad - verkratzt / verschü… - Smart Repair
