Expertise

Protocol number: 48195120
Order No. / Reference: 26885404
Inspection date: 15 Oct 2026

Manufacturer: Skoda	Model: Octavia Combi 2.0 TDI DSG RS
VIN: TMBJK8NX5NY099040

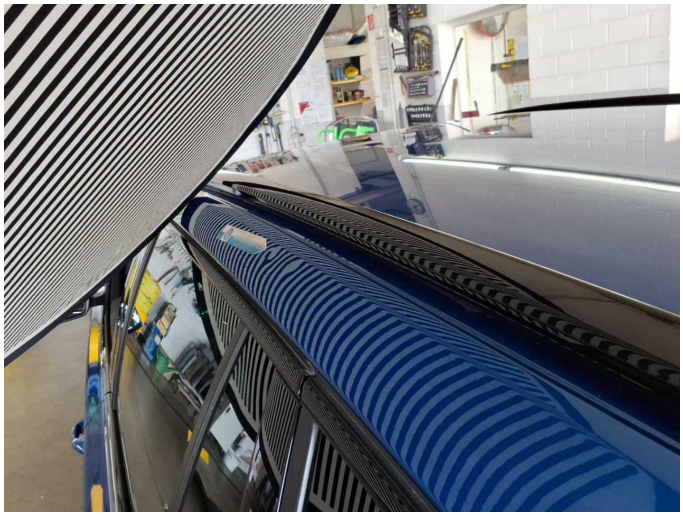
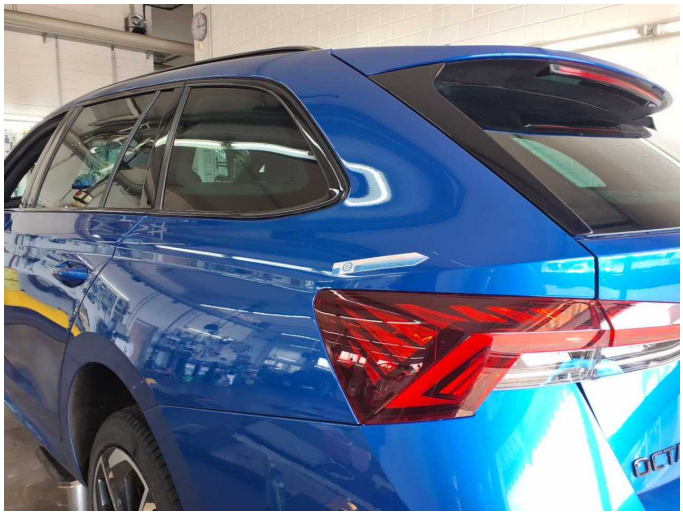
Damage 3: Roof: Roof rail - left side - dent(s) - Smooth repair work

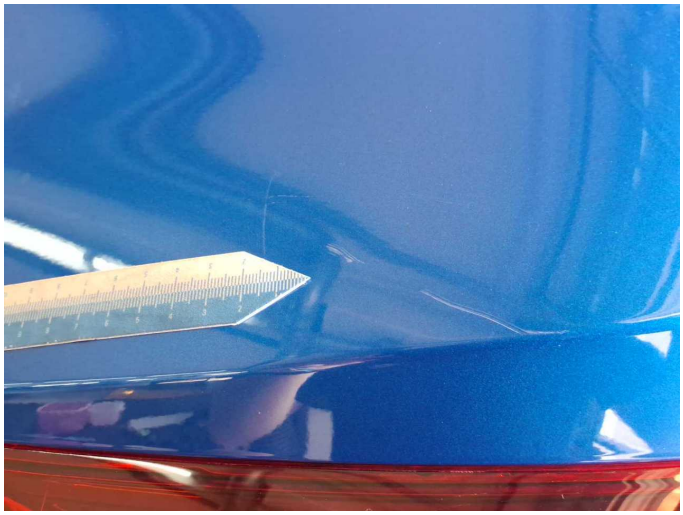
Damage 4: Side panel - rear left side: Side panel - Scratch(es) - Smart repair

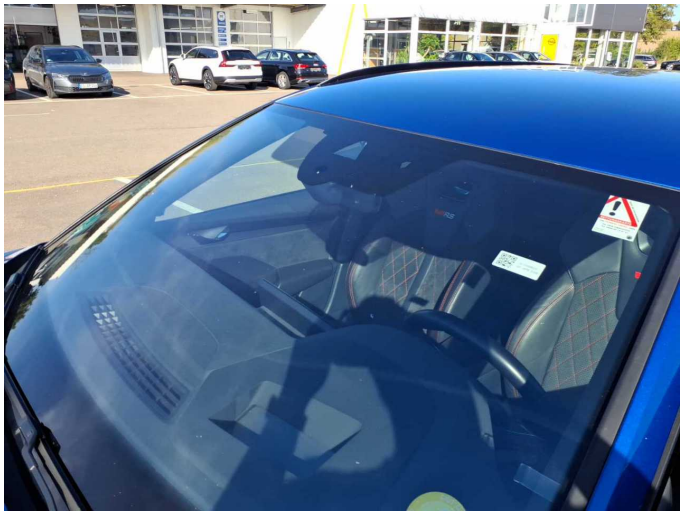
Damage 9: Vehicle glazing: Windscreen - Stone chips - Replace
