Expertise

Protocol number: 48577118
Order No. / Reference: 27245948
Inspection date: 9 Nov 2026

Manufacturer: Seat	Model: Tarraco 2.0 TDI SCR DSG FR
VIN: VSSZZZKN7PW006278

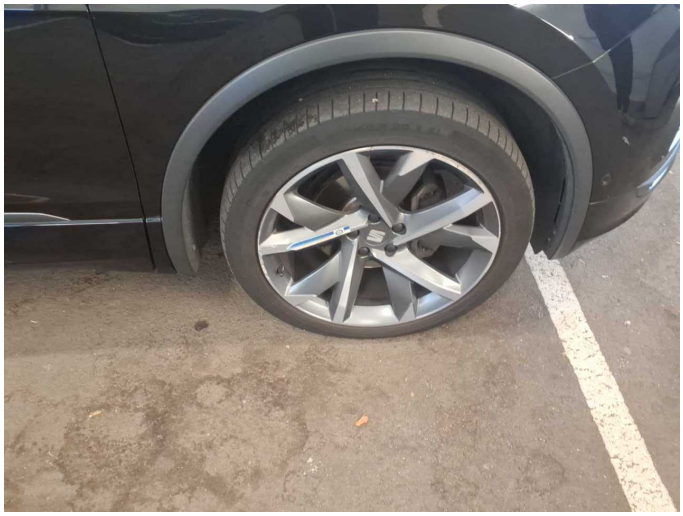
No.	Component group	Description
1	Door - front left side	Door - dent(s) - Smooth repair work
2	Wheel / tyres	Alloy rim - front left side - Scratched - Loss in value
3	Wheel / tyres	Tyre - front right side - Broken / torn - Replace
4	Wheel / tyres	Alloy rim - front right side - Scratched - Loss in value
5	Instrument panel	Centre console - front - Damaged - Replace
6	Door - front right side	Door - Scratch(es) - Paint

Damage 1: Door - front left side: Door - dent(s) - Smooth repair work

Damage 2: Wheel / tyres: Alloy rim - front left side - Scratched - Loss in value
