Expertise

Protocol number: 48605297
Order No. / Reference: 27251671
Inspection date: 4 Nov 2026

Manufacturer: Ford	Model: Transit Custom 300 L2H1 LKW VA Trend
VIN: WF0YXXTTGYKM34930

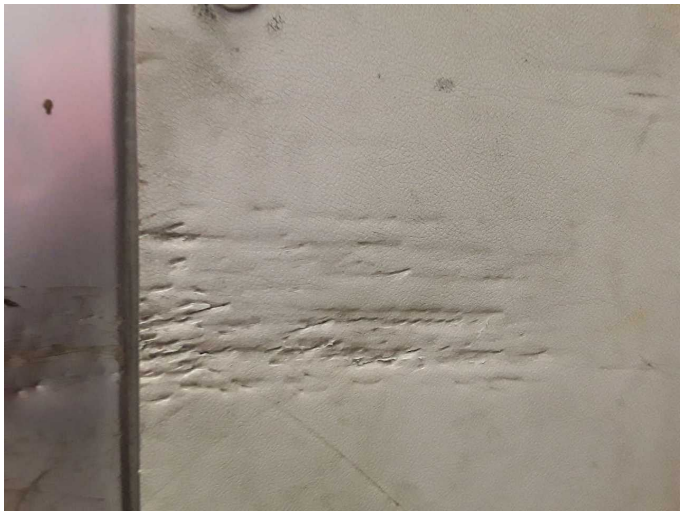
Damage 5: Boot lid / rear door: Trim rear door - hard fibre - centre - Deformed - Replace

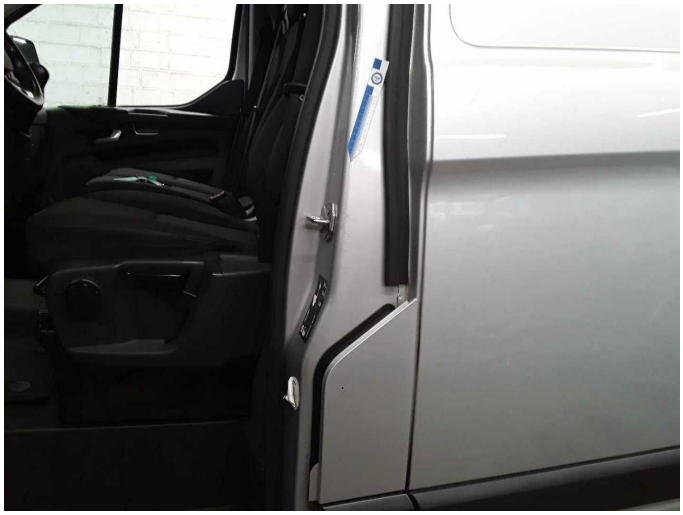
Damage 6: Side panel - rear left side: Sill - Scratch(es) - Smart repair

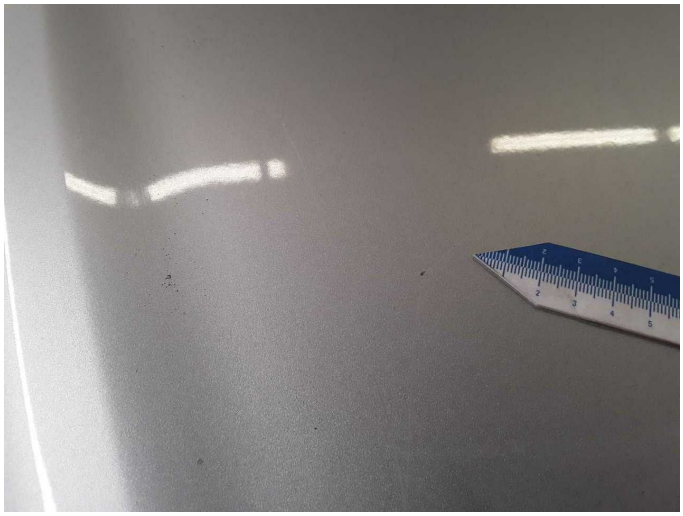
Damage 10: Bonnet: Bonnet - Scratch(es) - Paint

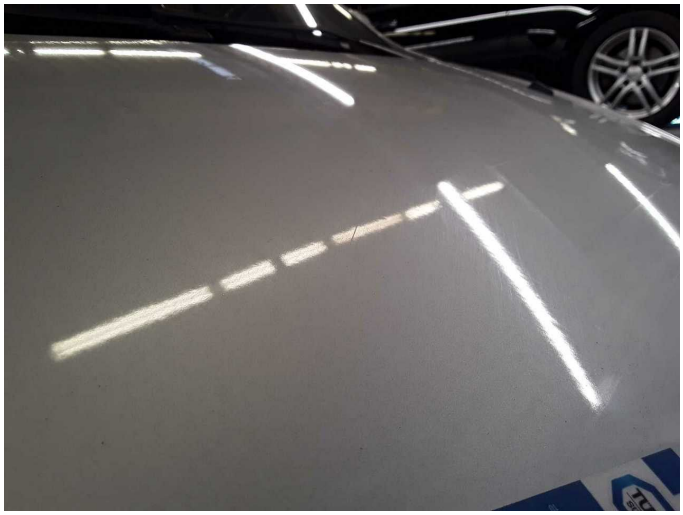
Damage 10: Bonnet: Bonnet - Scratch(es) - Paint

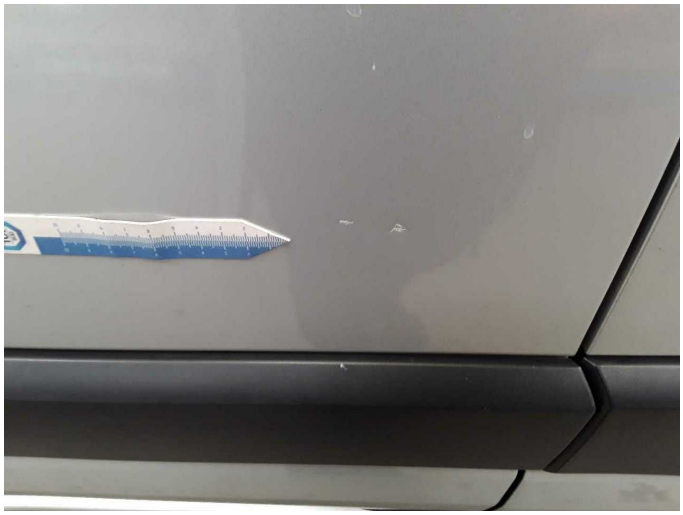
Damage 13: Door - front left side: Door - Dent / paintcoat damage - Repair and paint

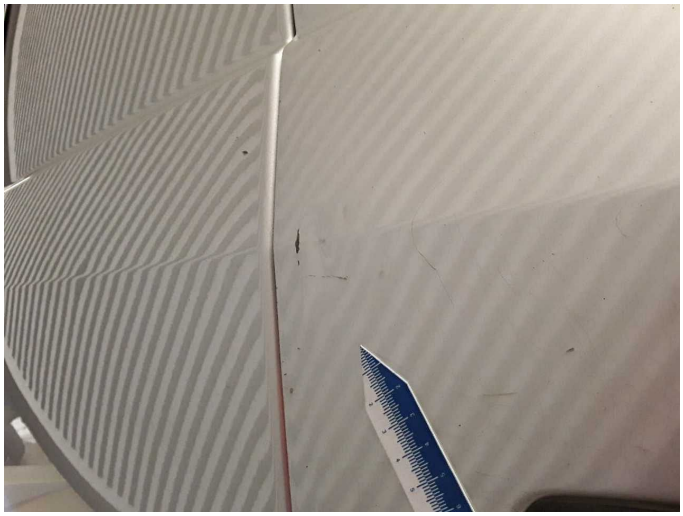
Damage 14: Boot lid / rear door: Rear door - right side - Dent / paintcoat damage - Repair and paint

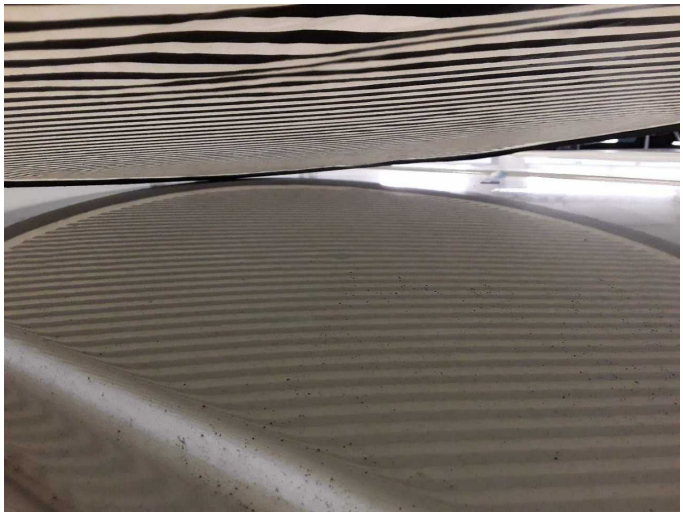
Wear and tear 2: Boot lid / rear door: Rear door - right side (Innen) - Dent / paintcoat damage - No deduction

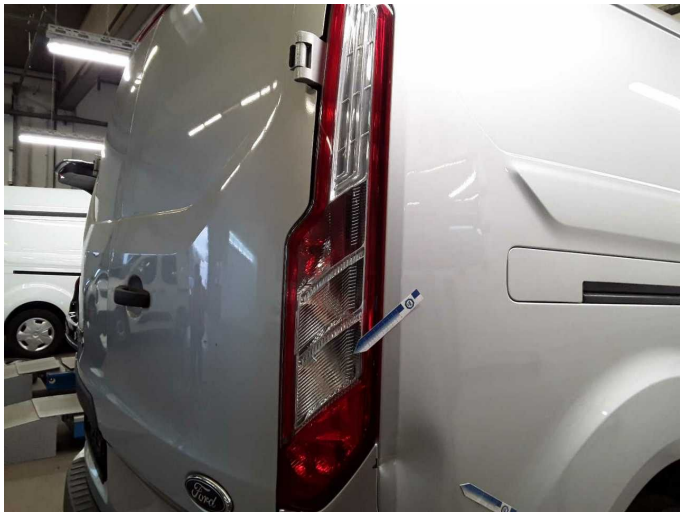
Accident 1: Rear, Side right

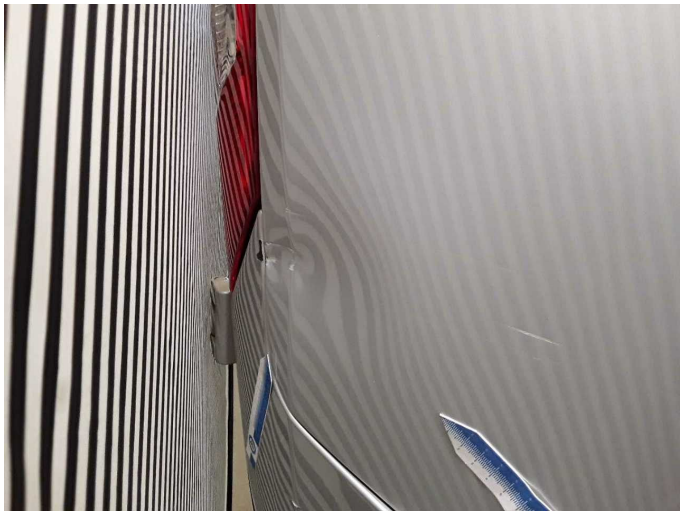
Accident 1: Rear, Side right
