Expertise

Protocol number: 48030888
Order No. / Reference: 27069513
Inspection date: 8 Oct 2026

Manufacturer: Opel	Model: Astra 1.5 D Start/Stop Sports Tourer Business Edition
VIN: W0VBD8EU9N8032760

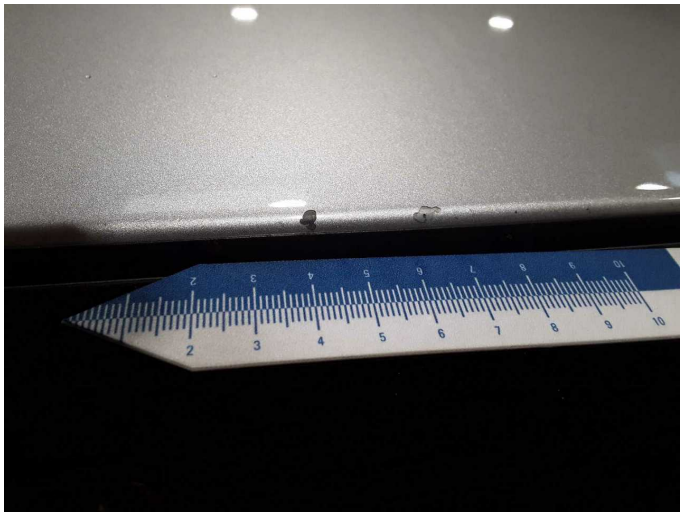
No.	Component group	Description
1	Trim / covers	Door trim - rear right side - Scratch(es) - Loss in value
2	Trim / covers	Door trim - rear left side - Scratched - Replace
3	Rear bumper	Rear bumper - Scratch(es) - Paint
4	Roof	Roof - Stone chips - Paint

Damage 3: Rear bumper: Rear bumper - Scratch(es) - Paint
