# Expertise

Protocol number: 48451909
Order No. / Reference: 27210216
Inspection date: 2 Nov 2026

| Manufacturer: Opel | Model: Astra Sports Tourer 1.5 D Automatik Ultimate |

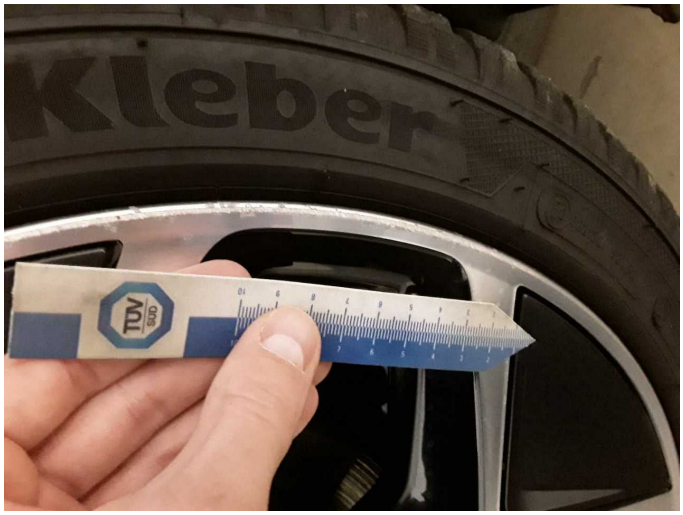
| No. | Component group | Description |
|---|---|---|
| 6 | Wheel / tyres | Alloy rim - rear right side - Scratched - Replace |

**Damage 6:** Wheel / tyres: Alloy rim - rear right side - Scratched - Replace

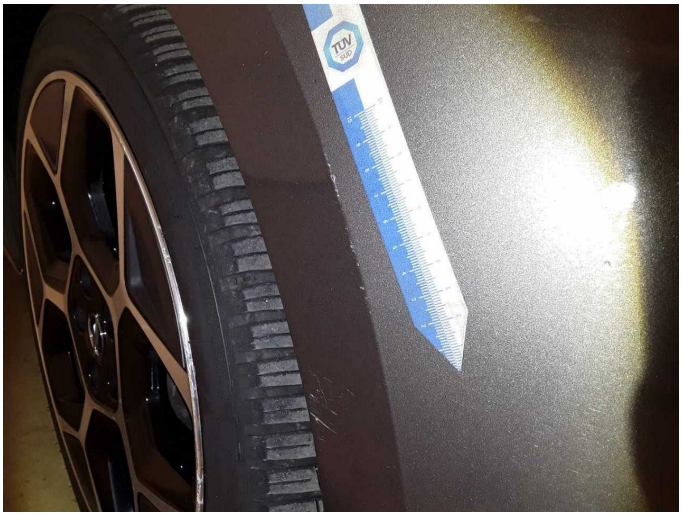
| No. | Component group | Description |
|---|---|---|
| 9 | Front bumper | Front bumper - Scratched - Paint |

**Damage 9:** Front bumper: Front bumper - Scratched - Paint

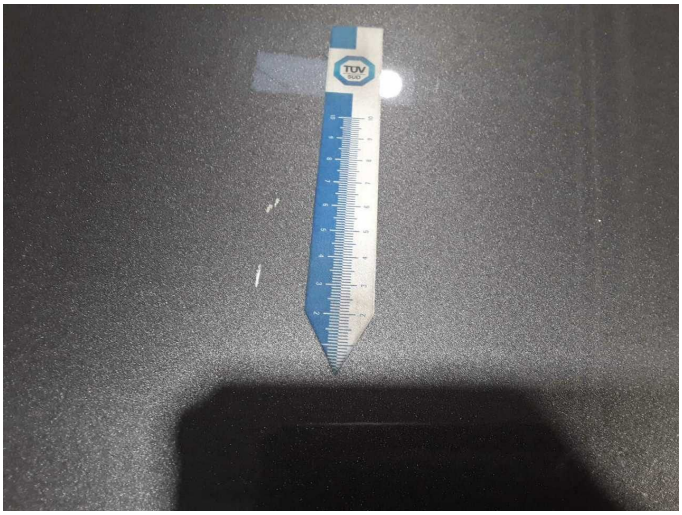
**Damage 9:** Front bumper: Front bumper - Scratched - Paint
