Expertise

Protocol number: 48073657
Order No. / Reference: 26983551
Inspection date: 12 Oct 2026

Manufacturer: Skoda	Model: Octavia Combi 2.0 TDI DSG 4x4 Clever
VIN: TMBLJ8NXXNY097005

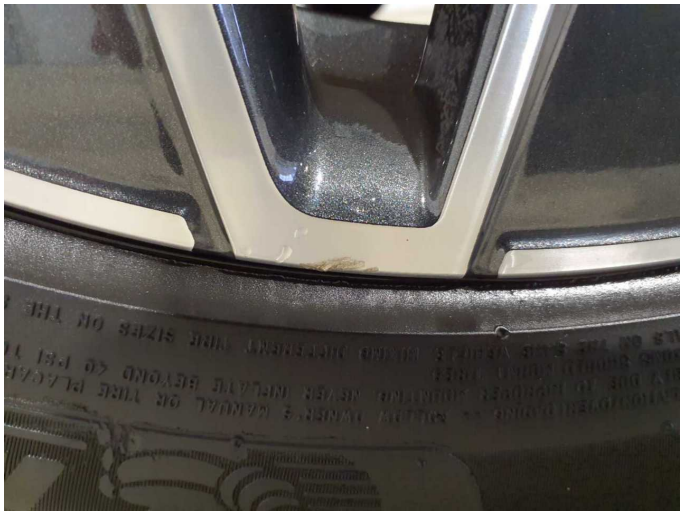
Damage 4: Wheel / tyres: Alloy rim - front left side - Scratch(es) - Loss in value

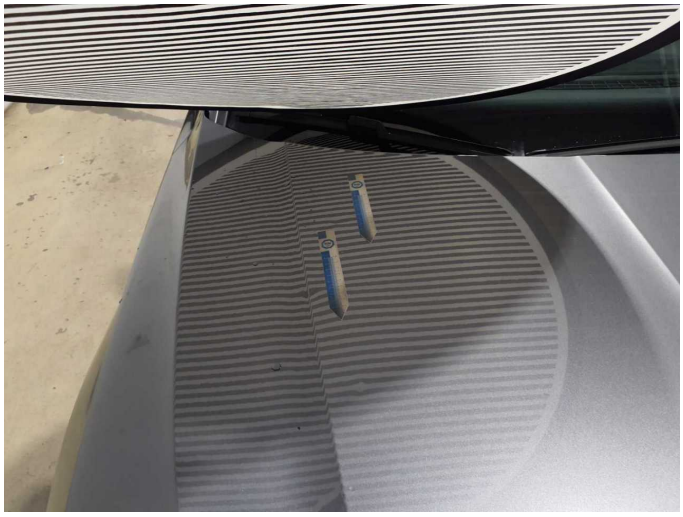
Damage 5: Bonnet: Bonnet - dent(s) - Smooth repair work

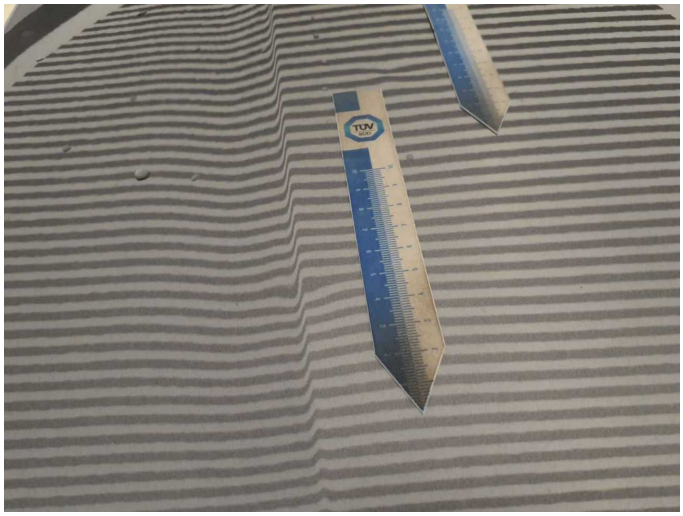
Damage 5: Bonnet: Bonnet - dent(s) - Smooth repair work

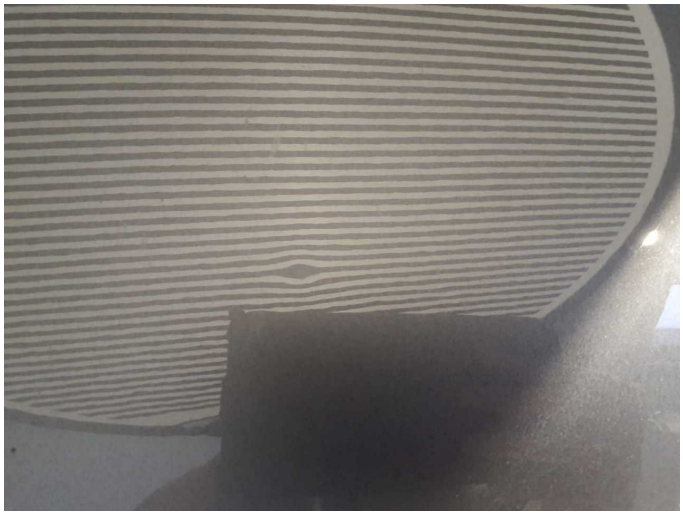
Damage 5: Bonnet: Bonnet - dent(s) - Smooth repair work

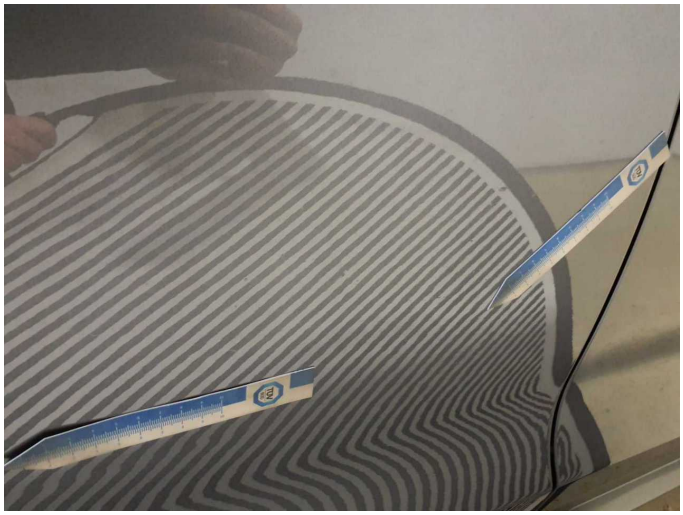
Mudguard - right side	243 µm	Bonnet	236 µm
Side panel - rear left side	215 µm	Side panel - rear right side	294 µm
Door - rear right side	442 µm	Door - front right side	231 µm

Damage 6: Door - rear right side: Door (Wellig) - Unprofessionally repaired - Lacquer

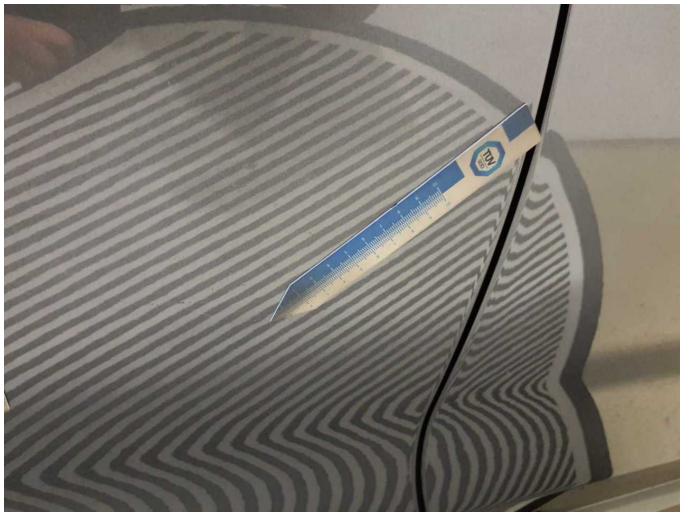
Damage 6: Door - rear right side: Door (Wellig) - Unprofessionally repaired - Lacquer

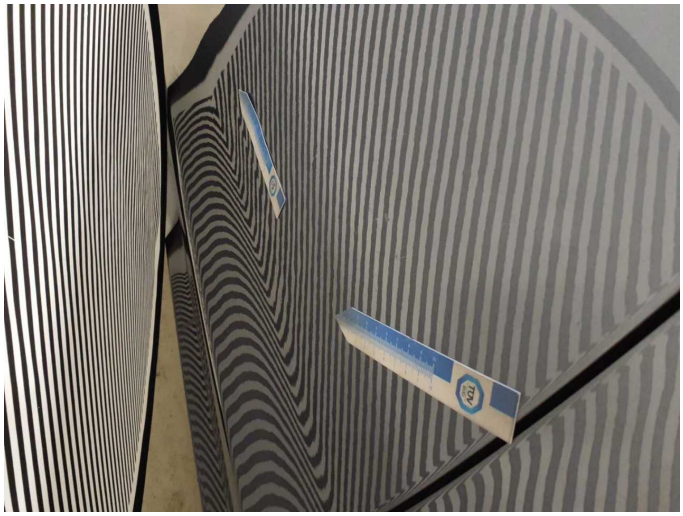
Damage 6: Door - rear right side: Door (Wellig) - Unprofessionally repaired - Lacquer

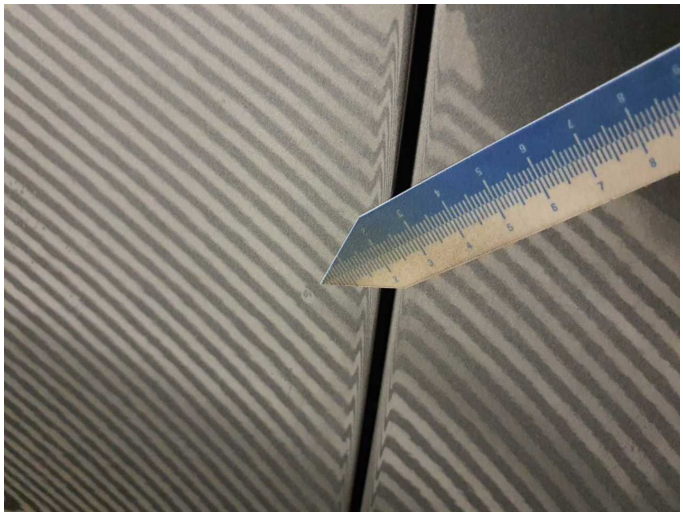
Damage 6: Door - rear right side: Door (Wellig) - Unprofessionally repaired - Lacquer

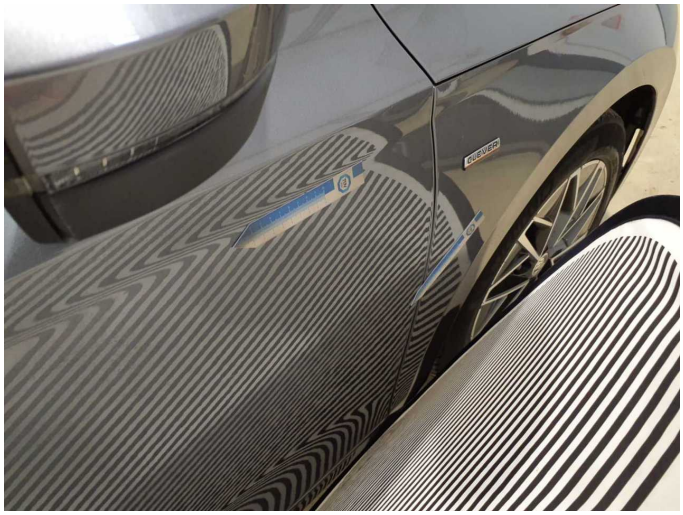
Damage 7: Door - front right side: Door (Wellig und Einschlüsse) - Unprofessionally repaired - Lacquer

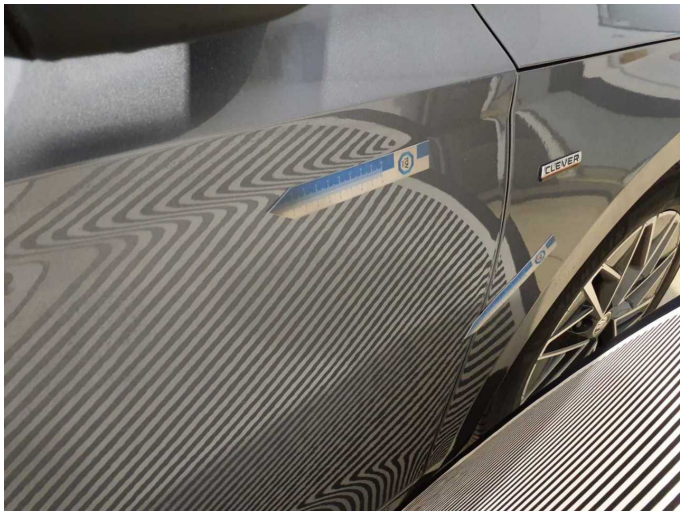
Damage 7: Door - front right side: Door (Wellig und Einschlüsse) - Unprofessionally repaired - Lacquer

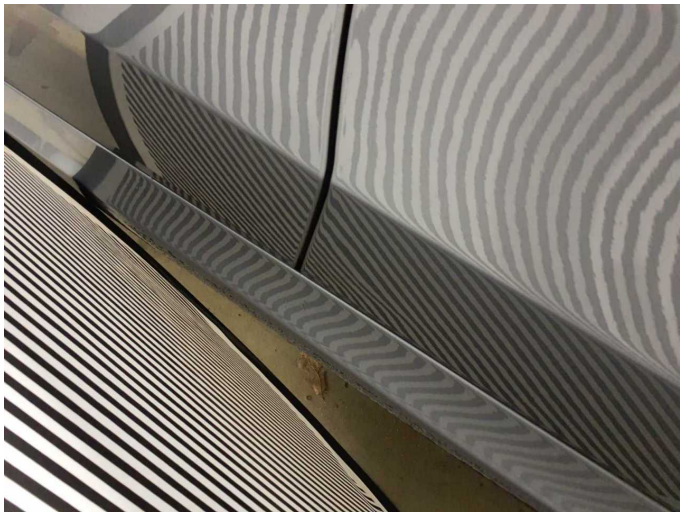
Damage 7: Door - front right side: Door (Wellig und Einschlüsse) - Unprofessionally repaired - Lacquer

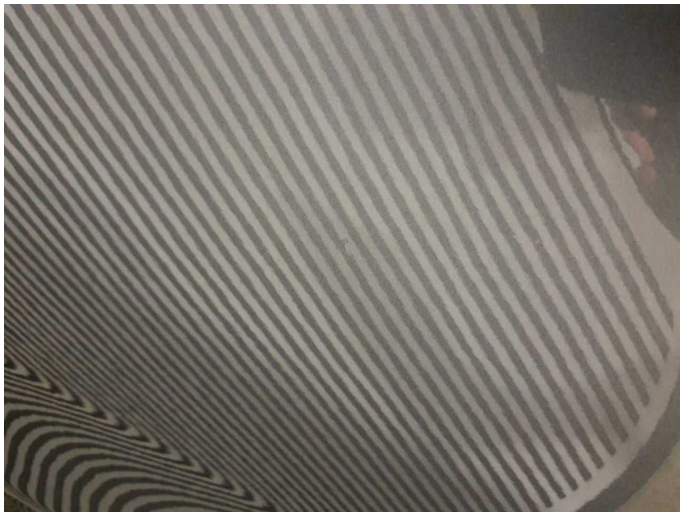
Damage 7: Door - front right side: Door (Wellig und Einschlüsse) - Unprofessionally repaired - Lacquer
