TÜV SÜD Auto Partner GmbH
Wiesenring 2
04159 Leipzig

Expertise

Protocol number: 48253874
Order No. / Reference: 27156390
Inspection date: 19 Oct 2026

Manufacturer: Volkswagen	Model: Passat Variant 2.0 TDI SCR DSG Business
VIN: WVWZZZ3CZPE036740

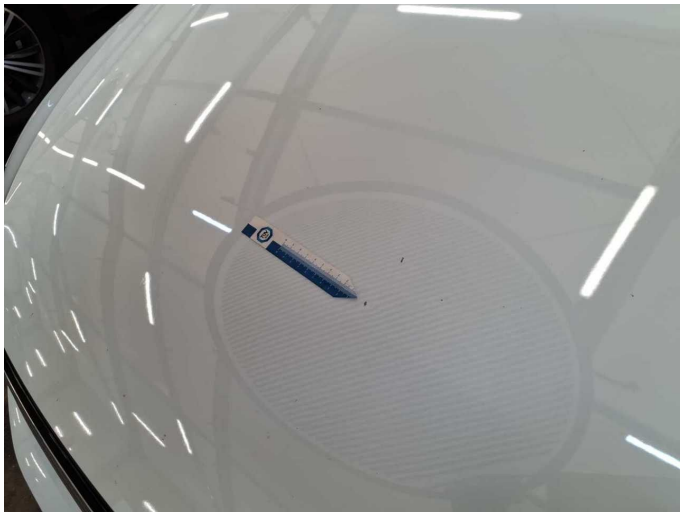
Damage 7: Bonnet: Bonnet - Dent / paintcoat damage - Repair and paint

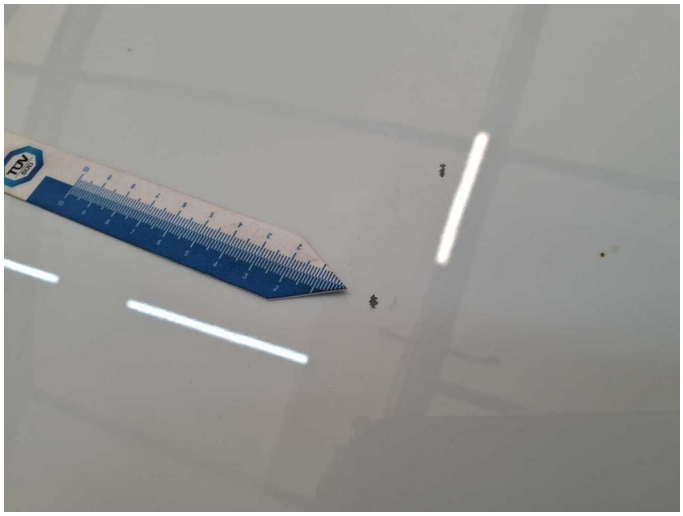
Damage 7: Bonnet: Bonnet - Dent / paintcoat damage - Repair and paint
