TÜV SÜD Auto Partner GmbH
Wiesenring 2
04159 Leipzig

Expertise

Protocol number: 48321321
Order No. / Reference: 27113900
Inspection date: 26 Oct 2026

Manufacturer: Mercedes-Benz	Model: C 220 d T 9G-TRONIC Avantgarde Advanced
VIN: W1KAH0EBXSF176759

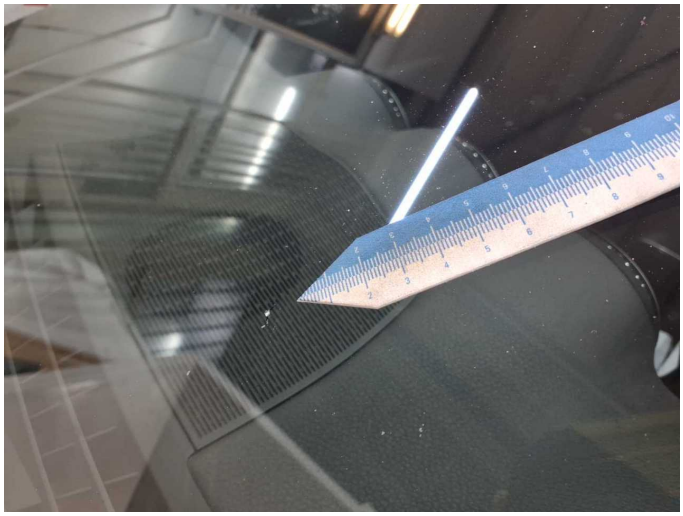
Damage 2: Vehicle glazing: Windscreen - Stone chips - Replace

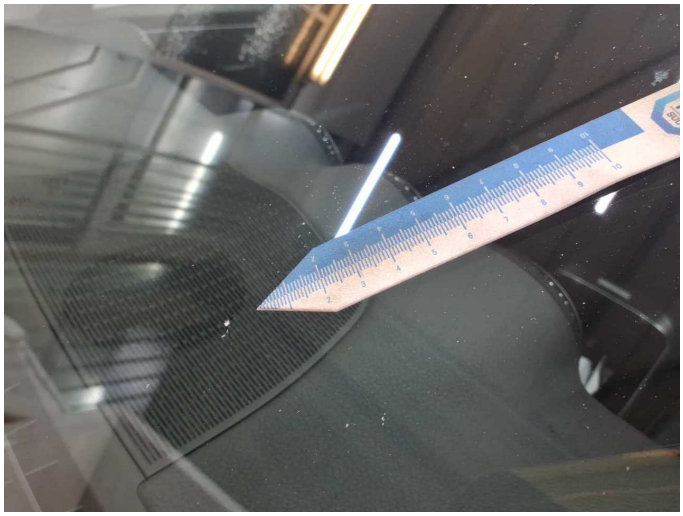
Damage 2: Vehicle glazing: Windscreen - Stone chips - Replace
