TÜV SÜD Auto Partner GmbH
Wiesenring 2
04159 Leipzig

Expertise

Protocol number: 48402499
Order No. / Reference: 27208480
Inspection date: 30 Oct 2026

Manufacturer: Ford	Model: S-Max 2.0 EcoBlue Aut. TITANIUM
VIN: WF0JXXWPCJNM13302

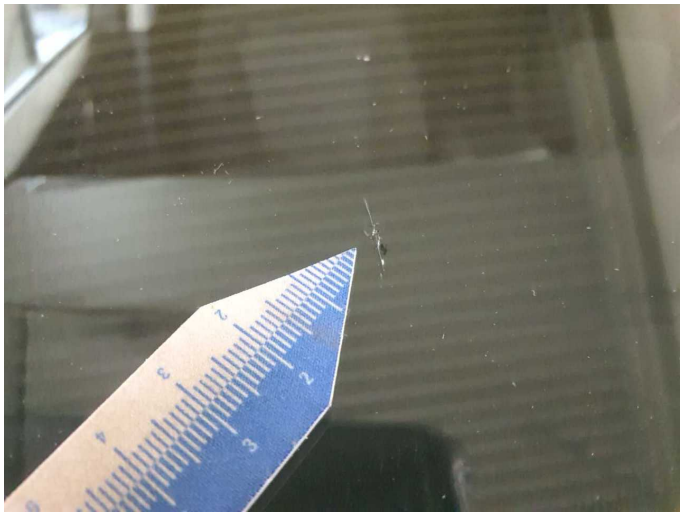
No.	Component group	Description
1	Misc.	Inspection / maintenance - No evidence - No deduction
2	Equipment	Tirefit filler - Expired - Replace
3	Vehicle glazing	Windscreen with lane departure assistant - Broken / torn - Smart repair
4	Mudguard - left side	Mudguard - left side - Paint defect - Paint

Damage 3: Vehicle glazing: Windscreen with lane departure assistant - Broken / torn - Smart repair
