Expertise

Protocol number: 48519576
Order No. / Reference: 27213577
Inspection date: 3 Nov 2026

Manufacturer: Mercedes-Benz	Model: 315 CDI Sprinter Standard HA 9G-TRONIC Kasten
VIN: W1V9076331P500416

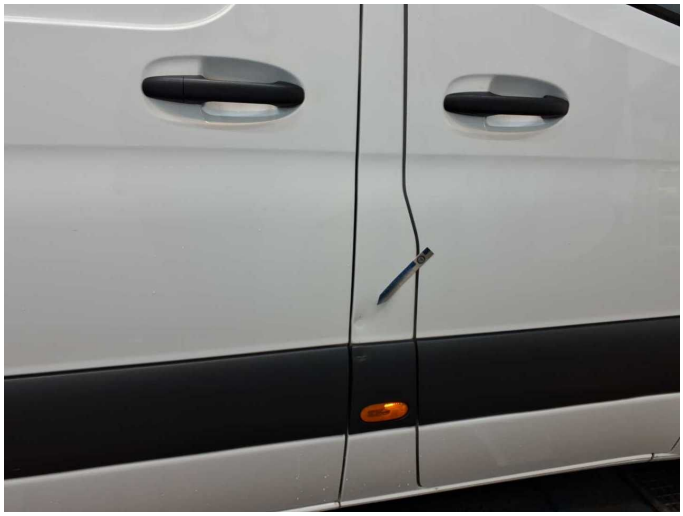
No.	Component group	Description
1	Bonnet	Insulation lining - Damage caused by marten / rodent - Replace
2	Side panel - rear right side	Wheel arch (Delle) - dent(s) - Repair and paint
3	Cab	Insulation lining - Damage caused by marten / rodent - Replace
4	Body	B-pillar - right side (inkl. Verkleidung) - dent(s) - Repair and paint
5	Mudguard - right side	Mudguard - right side - Dent / paintcoat damage - Repair and paint

- Marder Spuren sind im Motorraum, weitere Schäden sind möglich.

Damage 3: Cab: Insulation lining - Damage caused by marten / rodent - Replace
