TÜV SÜD Auto Partner GmbH
Wiesenring 2
04159 Leipzig

Expertise

Protocol number: 48059122
Order No. / Reference: 27152885
Inspection date: 12 Oct 2026

Manufacturer: Ford	Model: Kuga 2.5 Duratec PHEV TITANIUM
VIN: WF0FXXWPMHPE87952

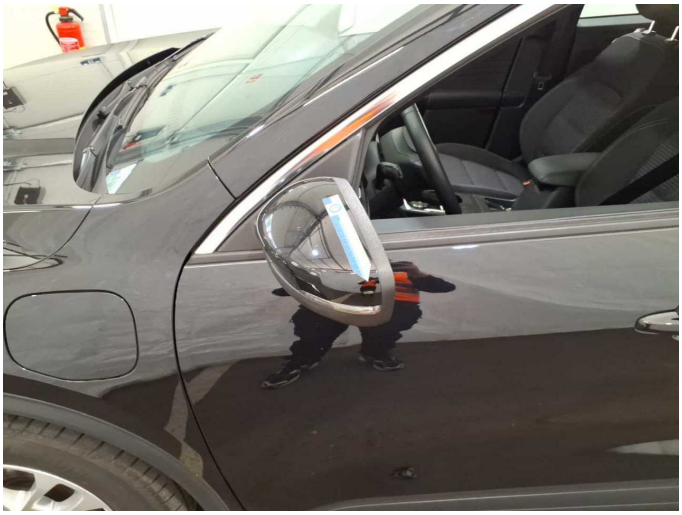
Damage 2: Wing mirror - left side: Cap - Scratch(es) - Smart repair

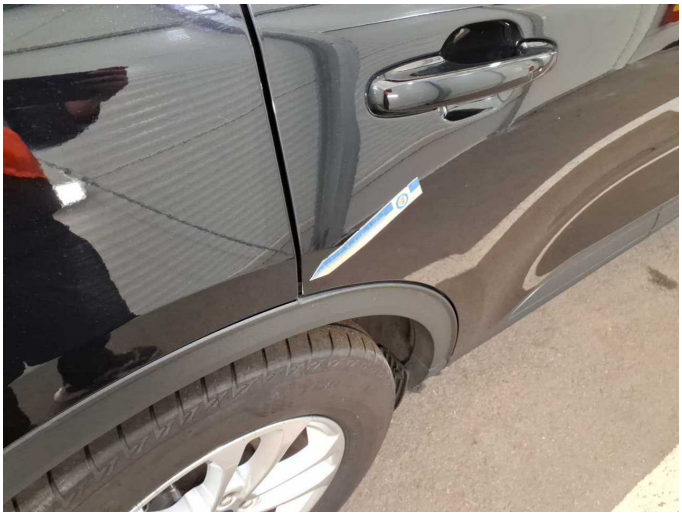
Damage 3: Door - rear right side: Door edge - Scratch(es) - Smart repair

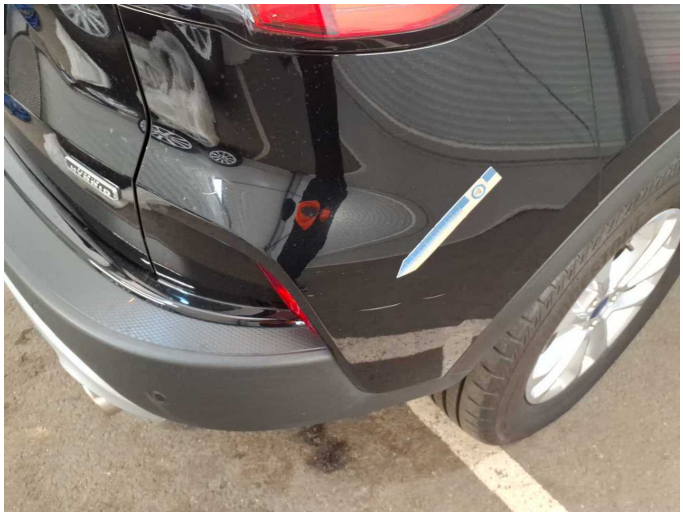
Damage 6: Rear bumper: Rear bumper - Scratch(es) - Smart repair

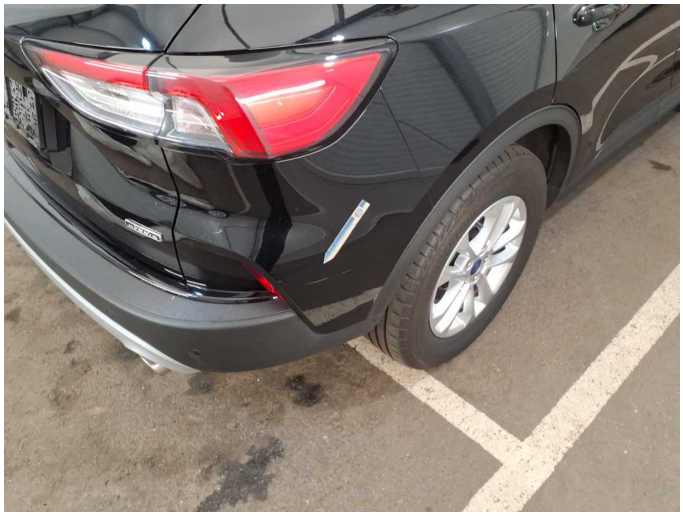
Damage 6: Rear bumper: Rear bumper - Scratch(es) - Smart repair

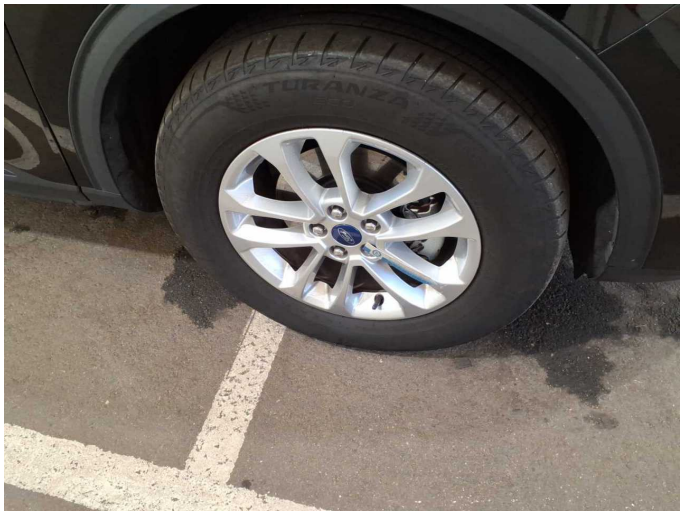
Damage 7: Wheel / tyres: Alloy rim - front right side - Scratch(es) - Loss in value

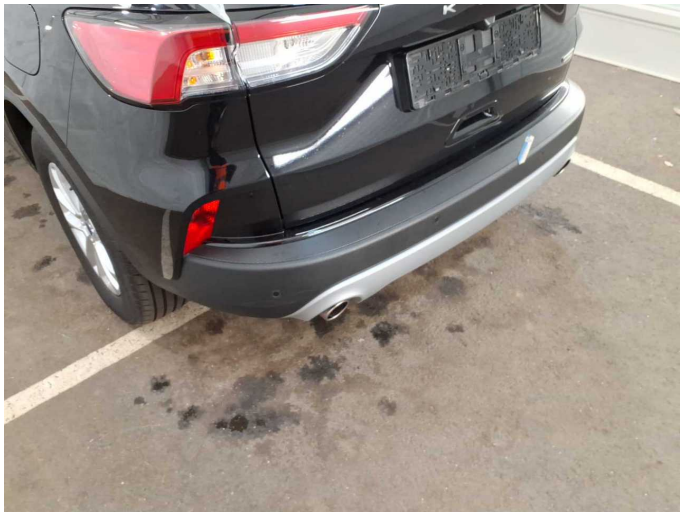
Damage 10: Rear bumper: Rear bumper (unpainted) - Scratch(es) - Loss in value
