Expertise

Protocol number: 48134838
Order No. / Reference: 27081547
Inspection date: 9 Oct 2026

Manufacturer: Skoda	Model: Kodiaq 2.0 TDI 4x4 DSG L&K
VIN: TMBLN7NS1M8064556

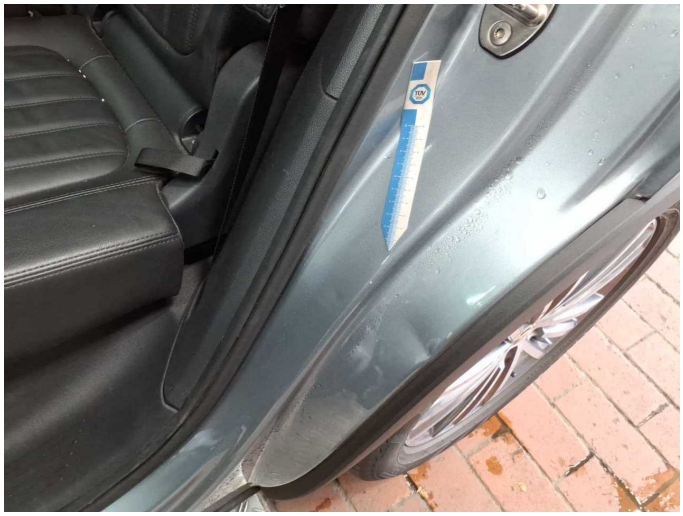
Damage 1: Side panel - rear left side: Sill - Dent / paintcoat damage - Repair and paint

Damage 2: Door - rear right side: Door - dent(s) - Repair and paint

Damage 3: Vehicle glazing: Windscreen - Broken / torn - Replace

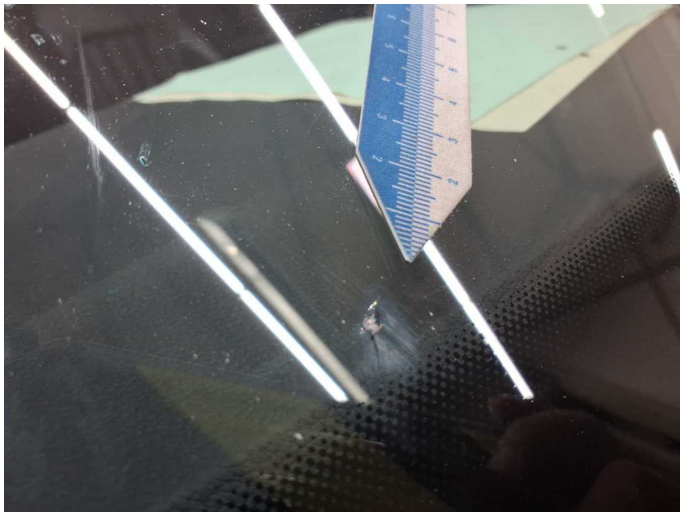
Damage 3: Vehicle glazing: Windscreen - Broken / torn - Replace
