Expertise

Protocol number: 48297500
Order No. / Reference: 27191442
Inspection date: 22 Oct 2026

Manufacturer: Skoda	Model: Kodiaq 1.5 TSI iV DSG Selection
VIN: TMBJW7PS2ST083175

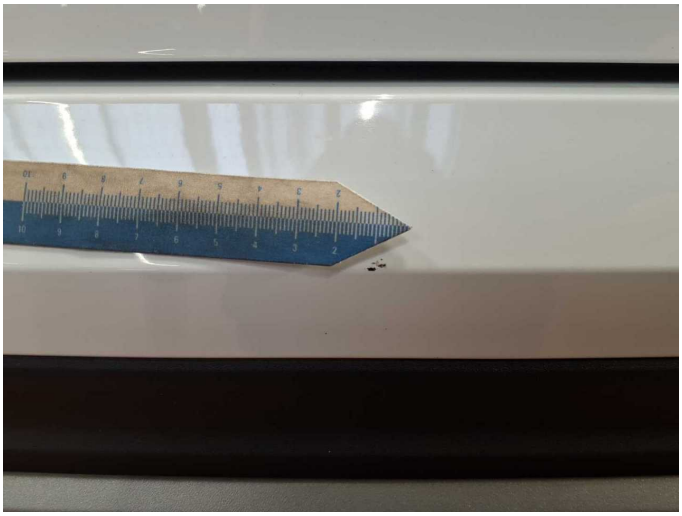
No.	Component group	Description
1	Rear bumper	Rear bumper - Scratch(es) - Smart repair

Damage 1: Rear bumper: Rear bumper - Scratch(es) - Smart repair

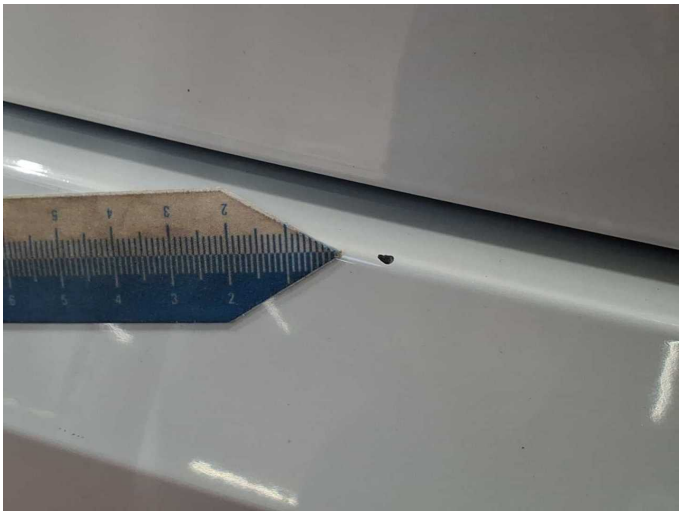
Damage 1: Rear bumper: Rear bumper - Scratch(es) - Smart repair
