Expertise

Protocol number: 48350063
Order No. / Reference: 27170310
Inspection date: 23 Oct 2026

Manufacturer: Skoda	Model: Kodiaq 2.0 TDI DSG Ambition
VIN: TMBJJ7NS2R8501619

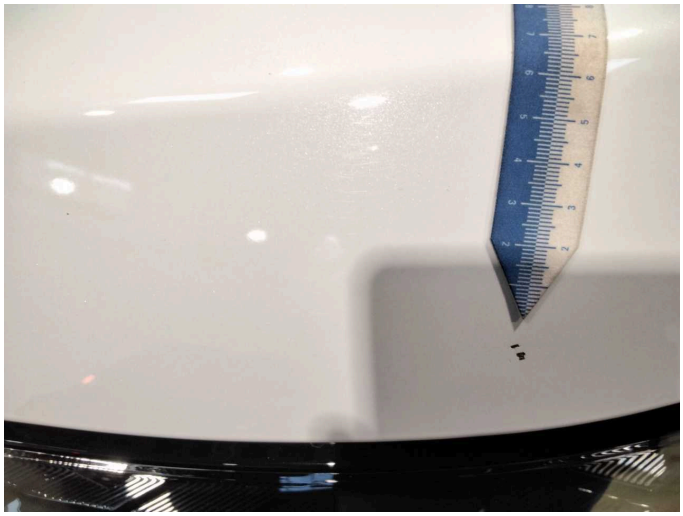
No.	Component group	Description
1	Misc.	Main inspection - No evidence - No deduction
2	Bonnet	Bonnet - Scratch(es) - Smart repair
3	Vehicle glazing	Windscreen - Stone chips - repair according to calculation

Damage 2: Bonnet: Bonnet - Scratch(es) - Smart repair

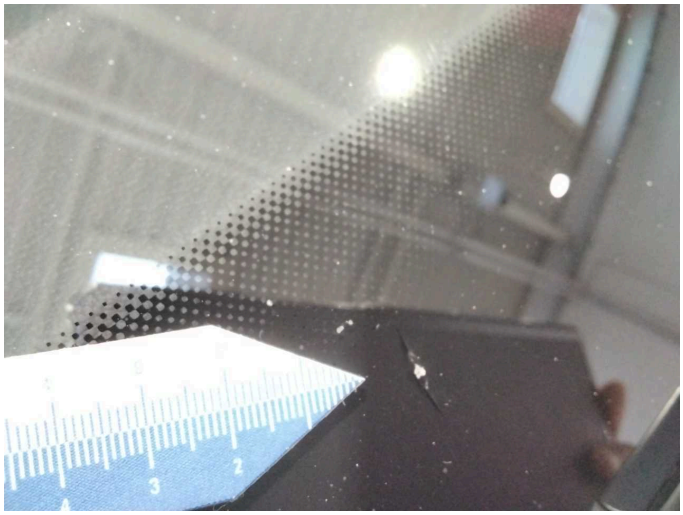
Damage 3: Vehicle glazing: Windscreen - Stone chips - repair according to calculation
