Expertise

Protocol number: 48476875
Order No. / Reference: 27191629
Inspection date: 3 Nov 2026

Manufacturer: Skoda	Model: Octavia Combi 2.0 TDI DSG Style
VIN: TMBJG8NX9RY100424

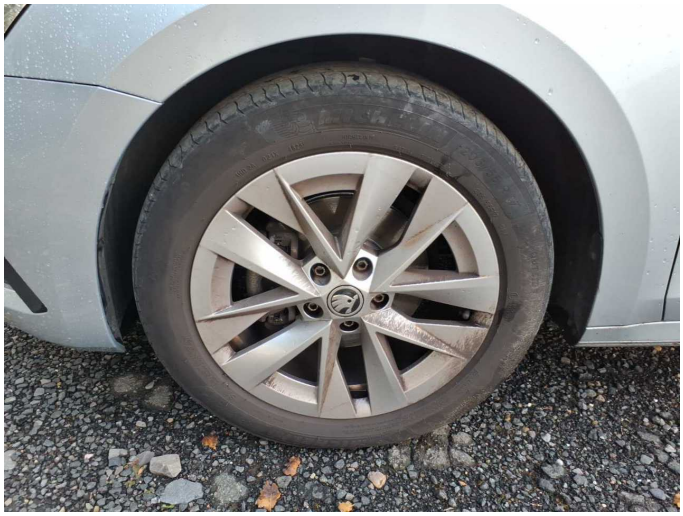
Figure 16: Mounted tyres

#	Tyre size	Type of tyre	Manufacturer	Tread depth
1)	205/55 R17 91V	Summer tyres on Light alloy	Michelin	2mm / 2mm
2)	205/55 R17 91V	Summer tyres on Light alloy	unterschiedliche Hersteller	5mm / 5mm

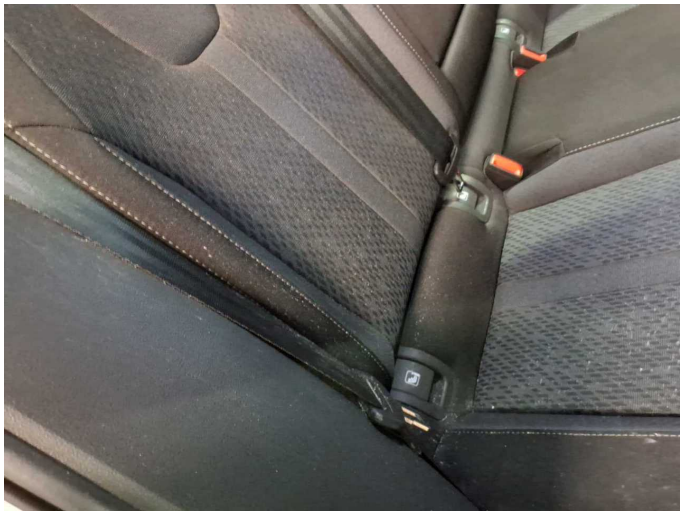
No.	Component group	Description
1	Equipment	Vehicle key (Batterie) - Empty - Replace
2	Seat - rear	Upholstery (Fussmatte rechts und Teppich) - Soiled - Clean
3	Boot lid / rear door	Boot lid - Glued / labelled - De-glue / neutralise
4	Bonnet	Bonnet (Matte Stellen vom Finish) - Paint defect - Smart repair
5	Side panel - rear left side	Side panel - Scratch(es) - Paint
6	Rear bumper	Rear bumper - Scratch(es) - Paint
7	Front bumper	Front bumper (Viele) - Stone chips - Paint

Damage 2: Seat - rear: Upholstery (Fussmatte rechts und Teppich) - Soiled - Clean

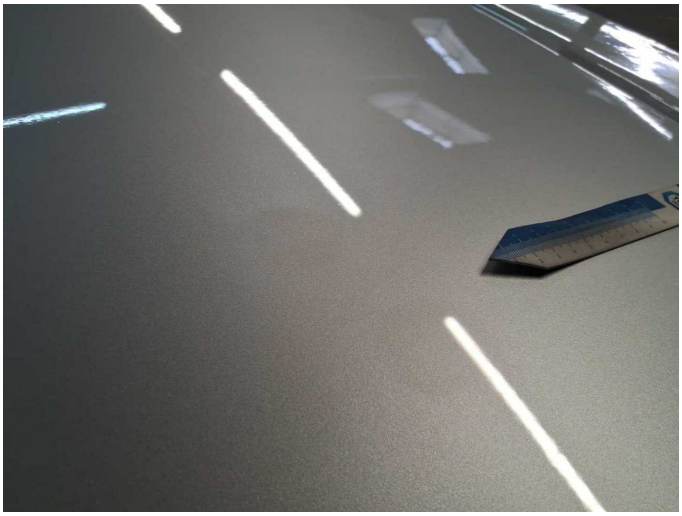
No.	Repainting
1	Roof rail - right side, Professionally carried out, Invoice of repair done Non-existent
2	Bonnet, Unprofessionally carried out, Invoice of repair done Non-existent

Damage 4: Bonnet: Bonnet (Matte Stellen vom Finish) - Paint defect - Smart repair

Bonnet: 215 µm

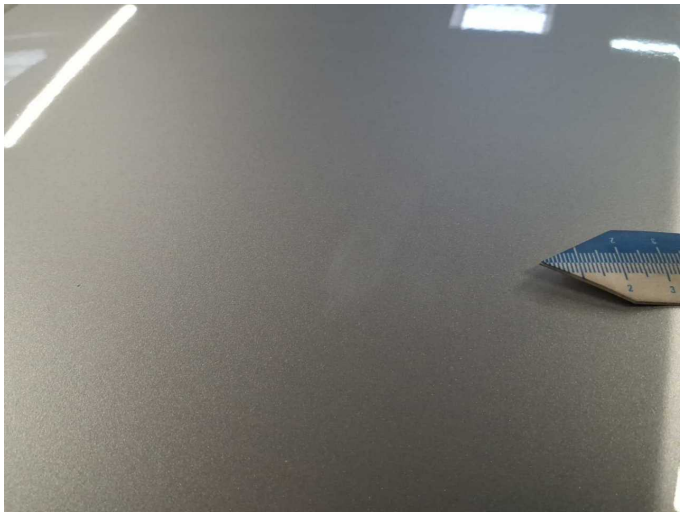
Damage 4: Bonnet: Bonnet (Matte Stellen vom Finish) - Paint defect - Smart repair
