TÜV SÜD Auto Partner GmbH
Wiesenring 2
04159 Leipzig

Expertise

Protocol number: 47159868
Order No. / Reference: 26863617
Inspection date: 20 Aug 2026

Manufacturer: Volkswagen	Model: Passat Variant 2.0 TDI SCR Business
VIN: WVWZZZ3CZPE016332

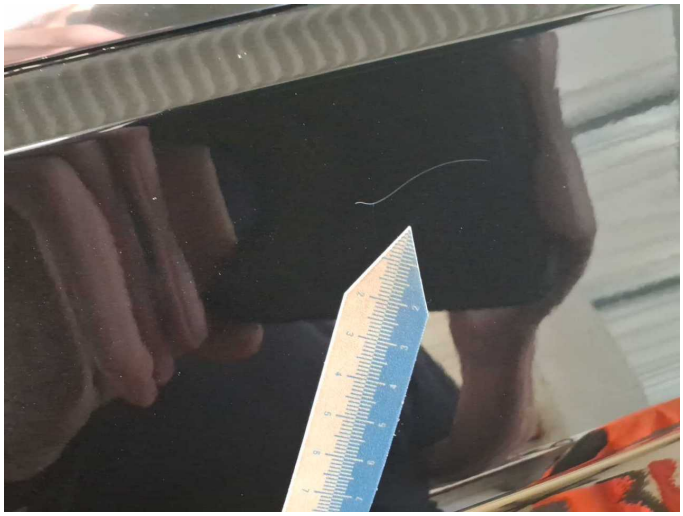
Damage 5: Door - rear left side: Door - Scratch(es) - Paint

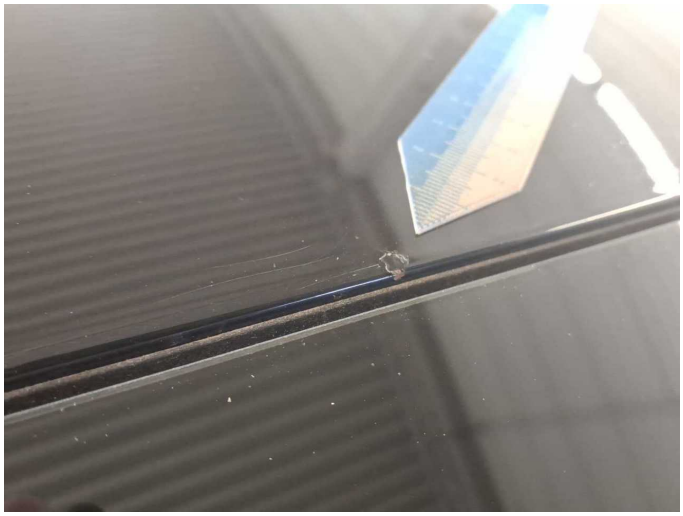
Damage 6: Side panel - rear left side: Side panel - Scratch(es) - Paint
