AUDI Q3 SPORTBACK

Vehicle information

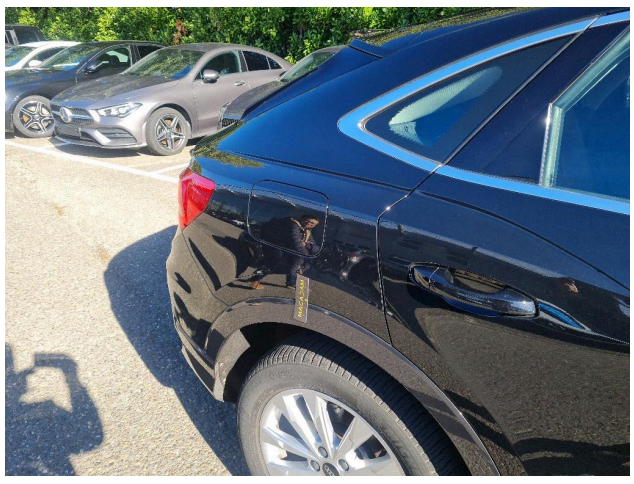
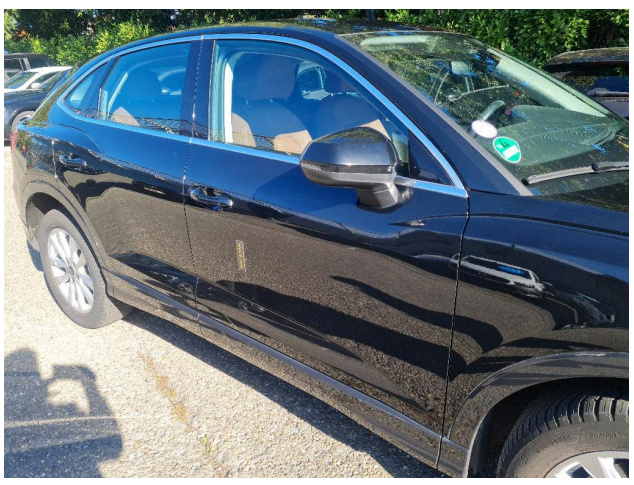
Door FR
Scratch(es)
Paint
Right

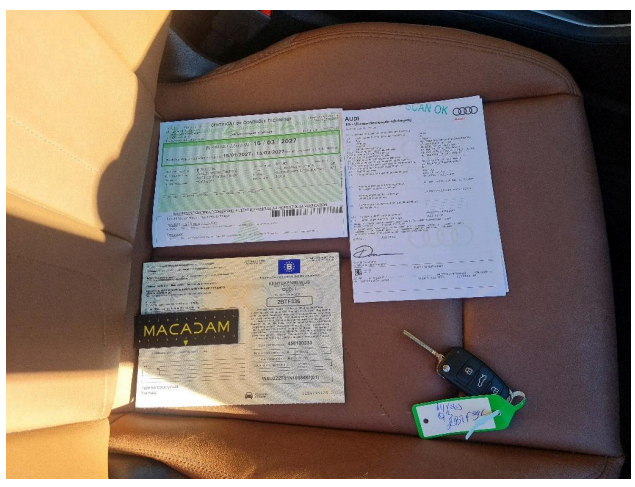
Ignition key
Missing
Replace
Interior

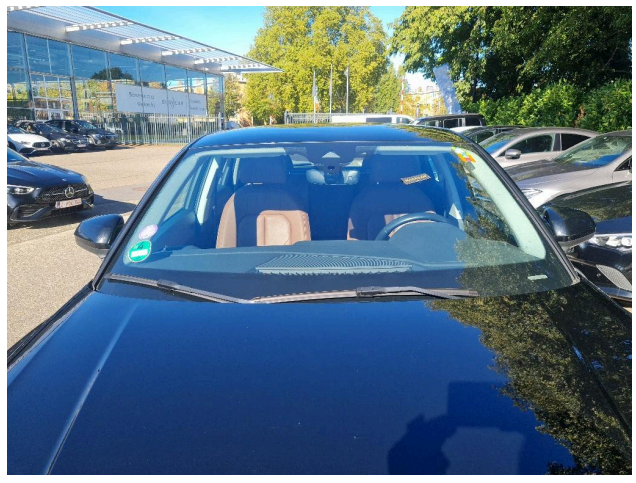
Windscreen
Stone chip(s)
Replace
Front
