Expertise

Protocol number: 48458074
Order No. / Reference: 27228584
Inspection date: 2 Nov 2026

Manufacturer: Ford	Model: Transit 350 L3H2 Lkw HA Trend
VIN: WF0EXXTTREPD20226

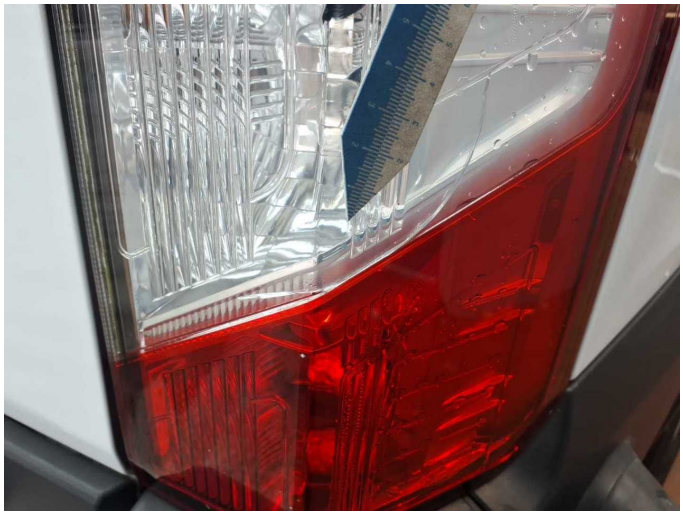
Damage 2: Tail light: Tail lamp - right side - Broken / torn - Replace

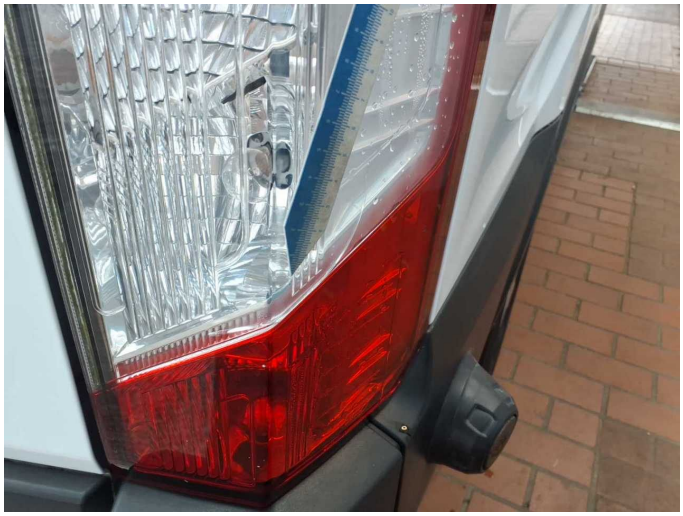
Damage 2: Tail light: Tail lamp - right side - Broken / torn - Replace

Damage 3: Side panel - rear left side: Side panel (Lackabplatzer) - Paint defect - Repair and paint

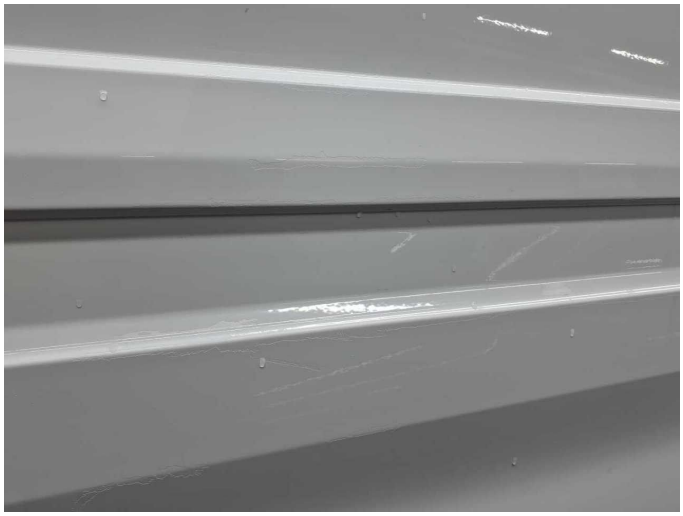
Damage 3: Side panel - rear left side: Side panel (Lackabplatzer) - Paint defect - Repair and paint

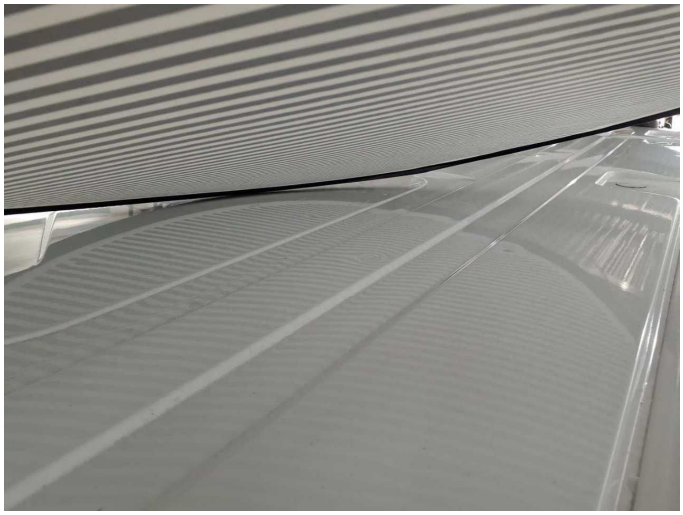
Damage 4: Roof: Roof - Damage by hail - Repair

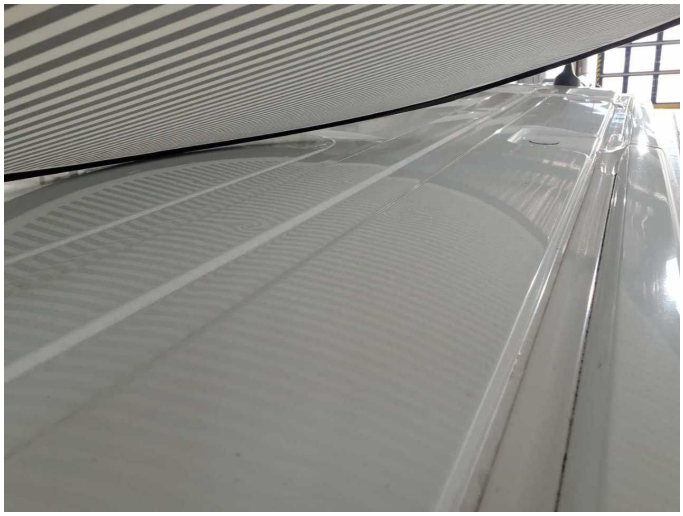
Damage 4: Roof: Roof - Damage by hail - Repair
