Expertise

Protocol number: 48457816
Order No. / Reference: 27109002
Inspection date: 3 Nov 2026

Manufacturer: Skoda	Model: Kodiaq 2.0 TDI DSG Ambition
VIN: TMBJJ7NS2R8014713

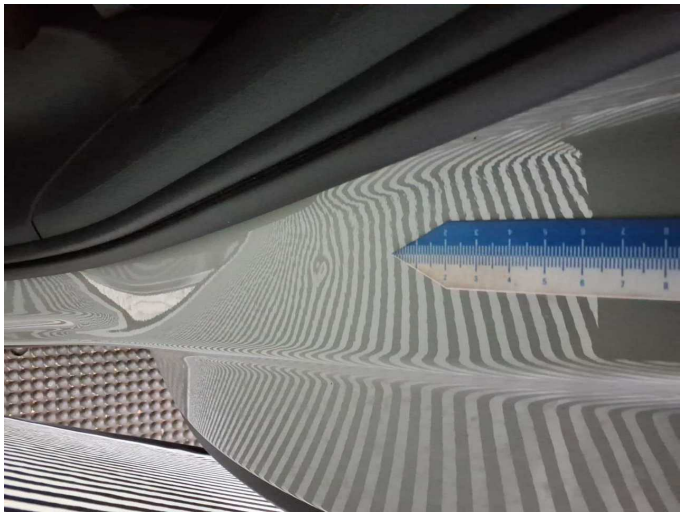
Damage 2: Side panel - rear left side: Side panel - dent(s) - Smooth repair work

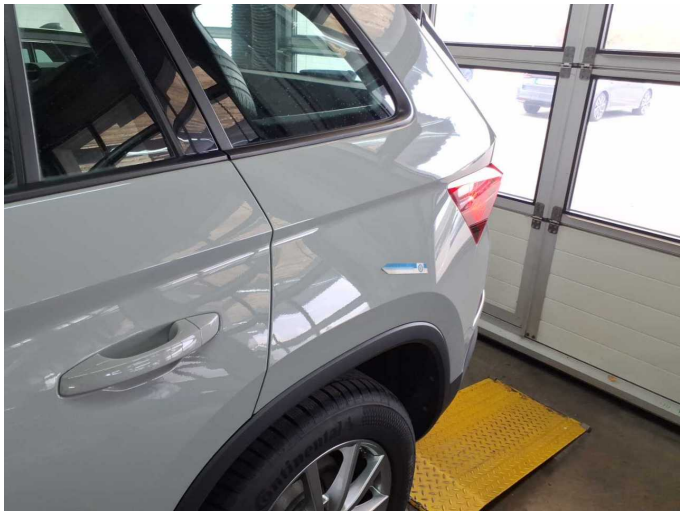
No.	Component group	Description
1	Side panel - rear left side	Sill - dent(s) - Smooth repair work
2	Side panel - rear left side	Side panel - dent(s) - Smooth repair work
3	Misc.	Main inspection - Due - Perform
4	Misc.	Inspection / maintenance - Due - Replace

Damage 1: Side panel - rear left side: Sill - dent(s) - Smooth repair work
