Expertise

Protocol number: 48419384
Order No. / Reference: 27224500
Inspection date: 29 Oct 2026

Manufacturer: Opel	Model: Astra Sports Tourer 1.5 D Business Edition
VIN: VXKFCYHZLP1053292

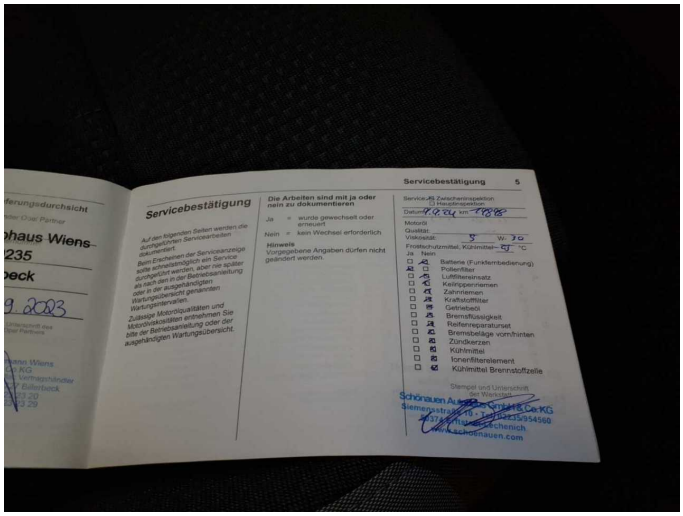
Figure 13: Documents

Documents submitted	At the time of the inspection, the vehicle registration certificate Part 2 (title) was available, but the vehicle registration certificate Part 1 (document) was not. (Copy)
VIN comparison	The vehicle identification number (VIN) was read from the vehicle and its conformity with the submitted documents was confirmed by the undersigned during the inspection.
Inspection	The inspection conditions were sufficient for the assessment of the vehicle. Lifting equipment and/or a pit were available for examining the vehicle.
Test drive	No test drive/shunting maneuver was carried out during the inspection of the vehicle.
Engine function test	An engine test run was performed.
