Expertise

Protocol number: 48072116
Order No. / Reference: 27097586
Inspection date: 12 Oct 2026

Manufacturer: Skoda	Model: Kodiaq 2.0 TDI 4x4 DSG Sportline
VIN: TMBLN9NS9M8519150

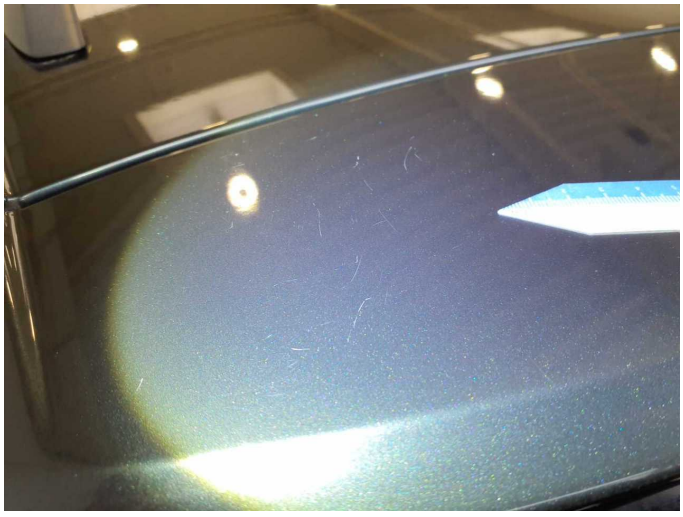
Damage 1: Boot lid / rear door: Rear spoiler - Scratch(es) - Smart repair

Damage 2: Rear bumper: Rear bumper - Scratch(es) - Smart repair

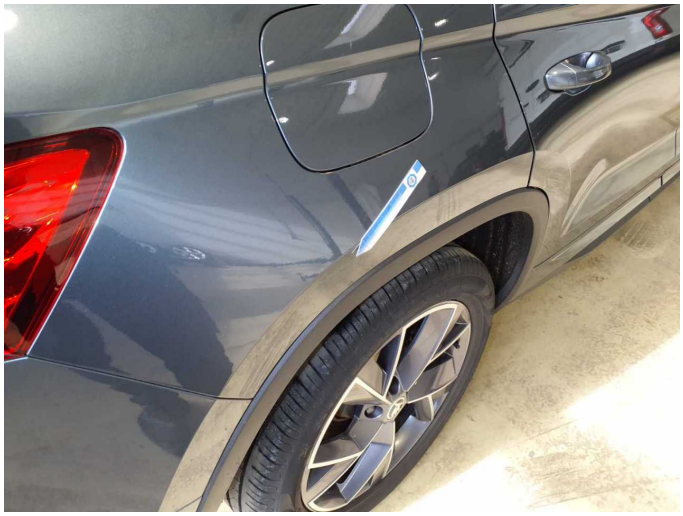
Damage 2: Rear bumper: Rear bumper - Scratch(es) - Smart repair

Damage 3: Side panel - rear right side: Side panel - Scratch(es) - Smart repair

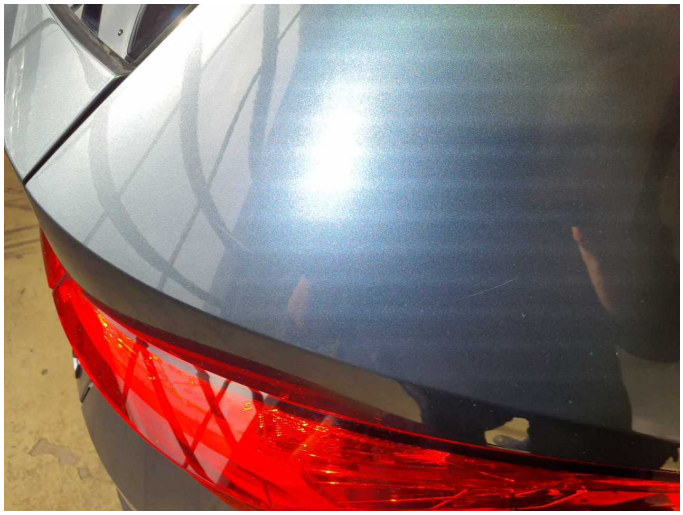
Damage 3: Side panel - rear right side: Side panel - Scratch(es) - Smart repair

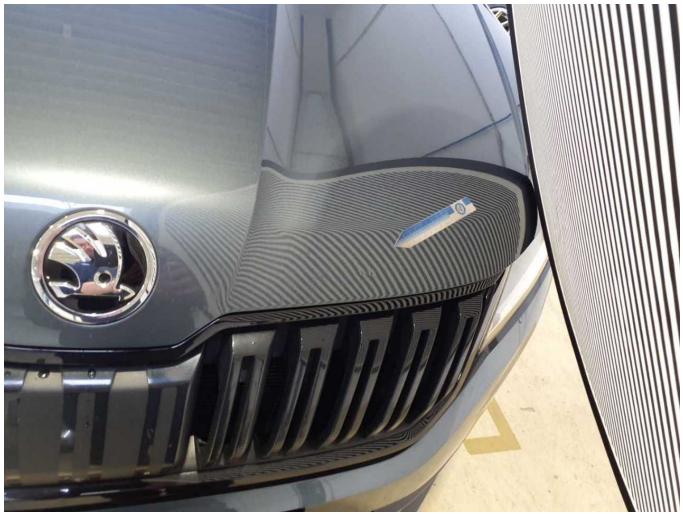
Damage 4: Bonnet: Bonnet - Dent / paintcoat damage - Loss in value

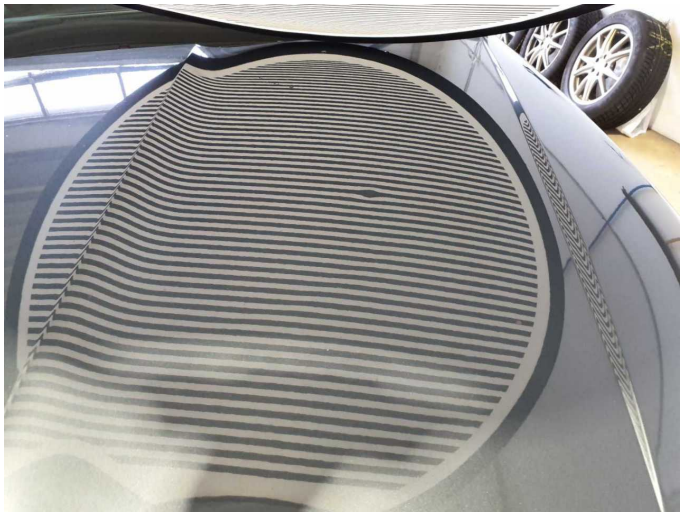
Damage 4: Bonnet: Bonnet - Dent / paintcoat damage - Loss in value

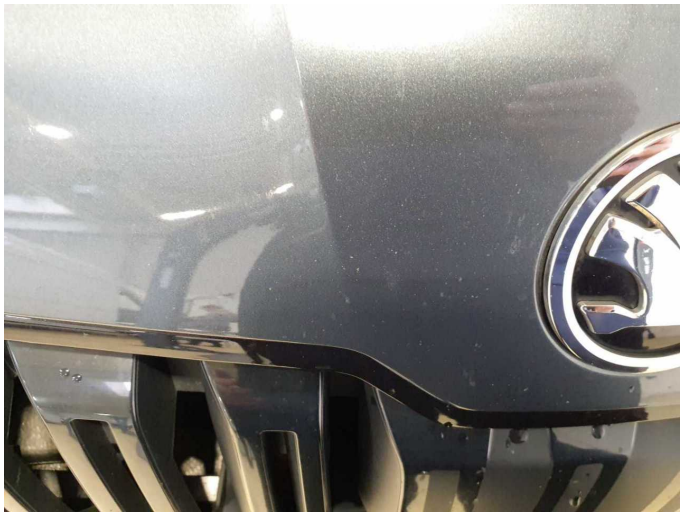
Damage 4: Bonnet: Bonnet - Dent / paintcoat damage - Loss in value

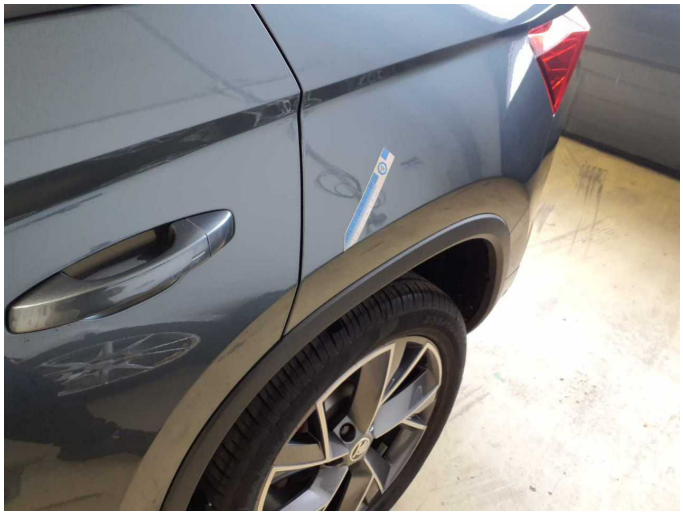
Damage 5: Side panel - rear left side: Side panel (Einschluss und wellig) - Unprofessionally repaired - Smart repair

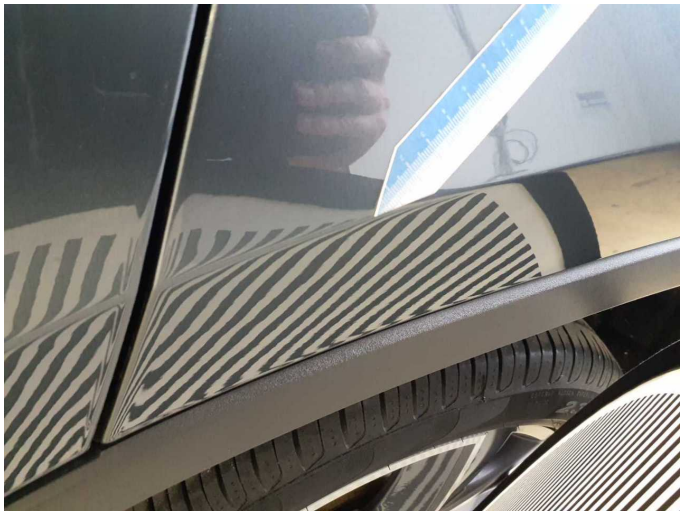
Damage 5: Side panel - rear left side: Side panel (Einschluss und wellig) - Unprofessionally repaired - Smart repair

Damage 6: Door - rear left side: Door (Wellig-Mehrkosten möglich) - Unprofessionally repaired - Smart repair

Damage 7: Wheel / tyres: Tyre - right - Porous / cracked - Replace

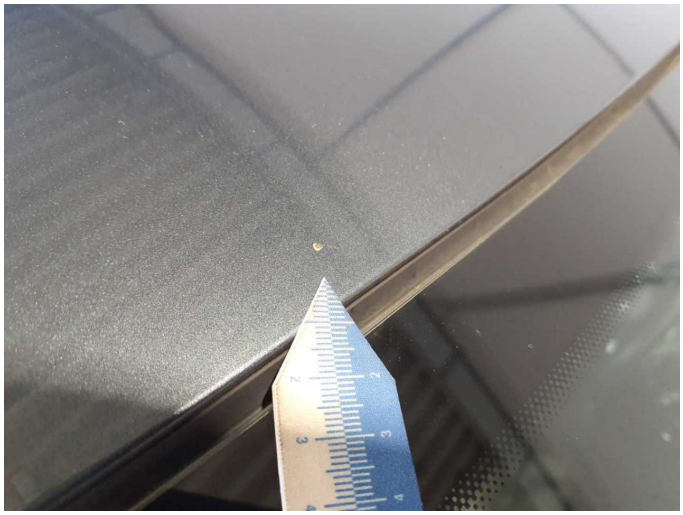
Damage 8: Roof: Roof - Corrosion - Repair and paint

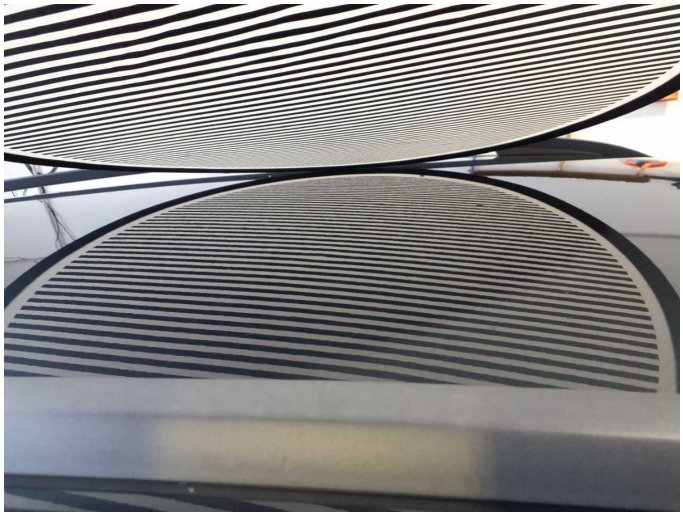
Damage 8: Roof: Roof - Corrosion - Repair and paint

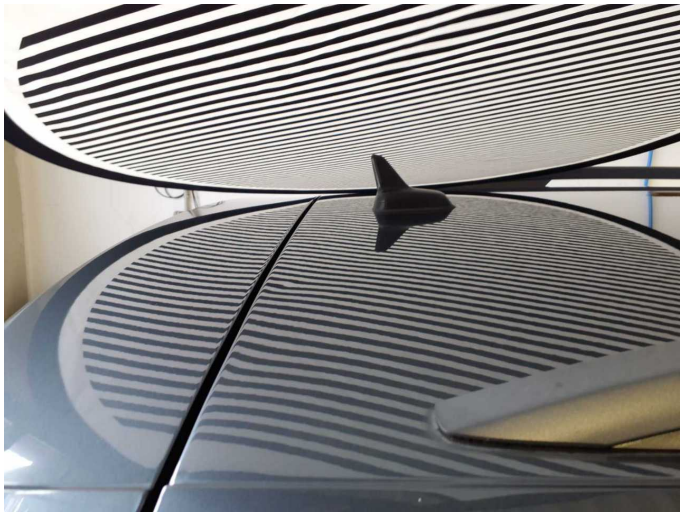
Damage 8: Roof: Roof - Corrosion - Repair and paint

Missing part 1: Equipment: Umbrella - Missing - Replace

Repainting 1: Door - front left side

Repainting 2: Side panel - rear left side

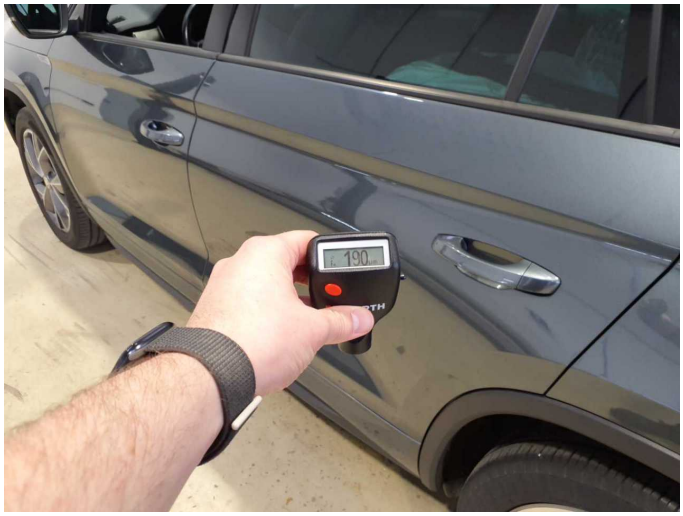
Repainting 2: Side panel - rear left side

Repainting 3: Door - rear left side
