AUDI A3 BERLINE

Make:	**AUDI**	License:	**2CMY075**
Gearbox:		Body color:	
Model:	**A3 BERLINE**	VIN:	**WAUZZZGY1PA023429**
Fuel type:		Power:	**110 kW**
Version:	**1.5 TFSI 35 110KW S LINE**	First registration	**21/09/2022**
Mileage:	**25543 km**	N° of doors:

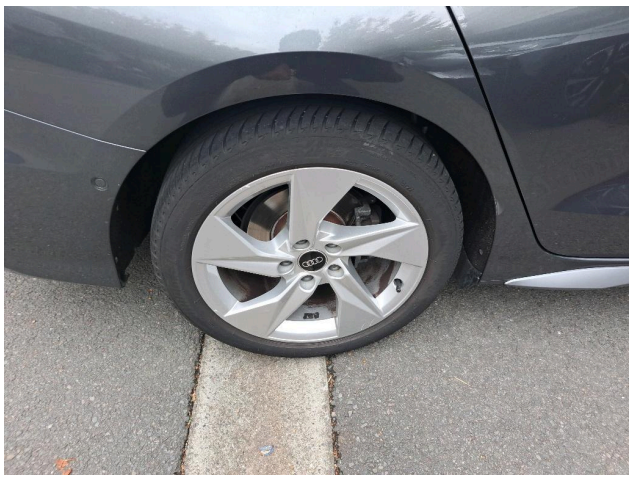
Alloy rim FR

Scratch(es)

Repair and paint (complete)

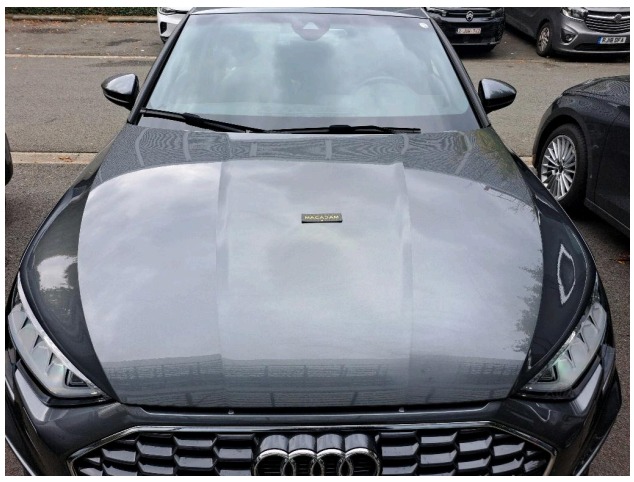
Bodywork
Damaged
Acceptable
Roof & others
