Expertise

Protocol number: 48599998
Order No. / Reference: 27204599
Inspection date: 2 Nov 2026

Manufacturer: Ford	Model: Transit 350 L4H3 Lkw HA Trend
VIN: WF0EXXTTRENT79173

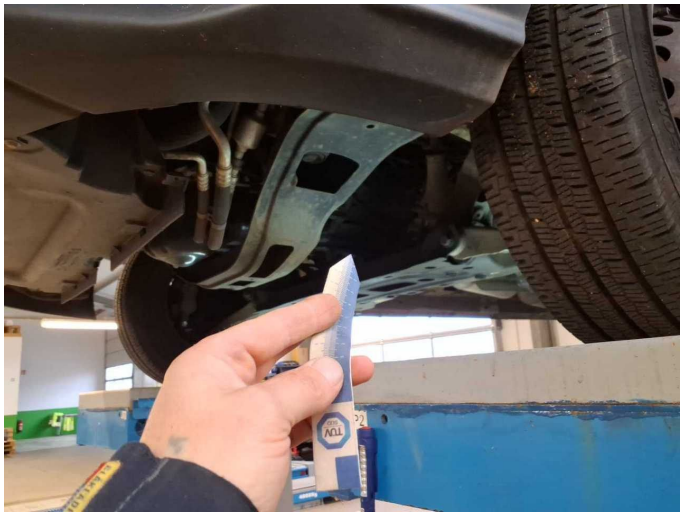
Damage 1: Additional lamp: Cargo area lamp -rear (Komplett) - Non-operational - Perform diagnosis

Damage 2: Gearbox: Gearbox (Achse voller Öl) - Leaking - Perform diagnosis

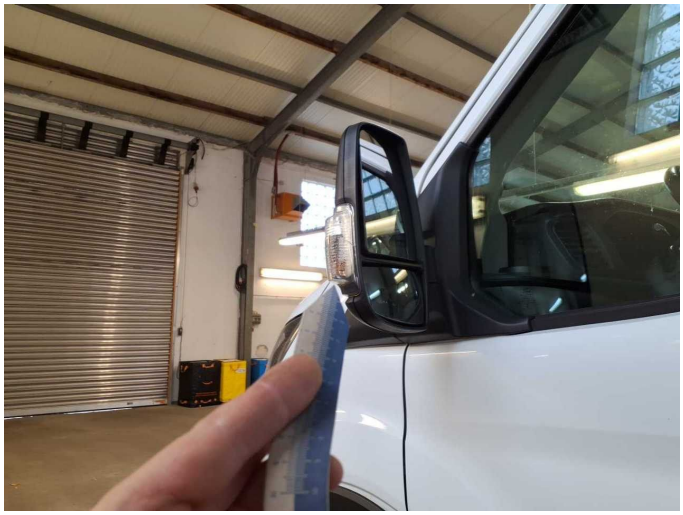
Damage 2: Gearbox: Gearbox (Achse voller Öl) - Leaking - Perform diagnosis

Damage 3: Indicator - front: Mirror - left side - Broken / torn - Replace

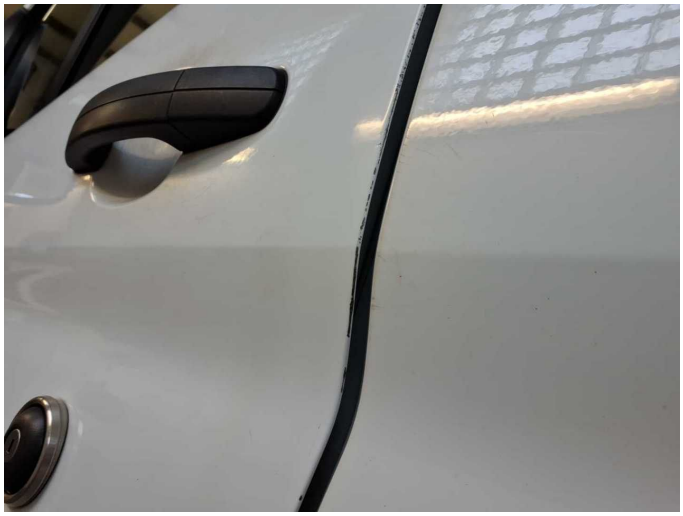
Damage 4: Door - front left side: Door - Dent / paintcoat damage - Smart repair

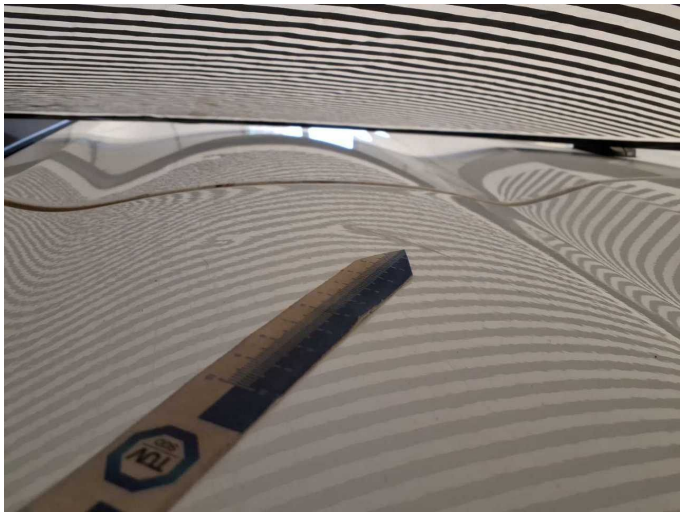
Damage 8: Door - front right side: Door - Dent / paintcoat damage - Repair and paint

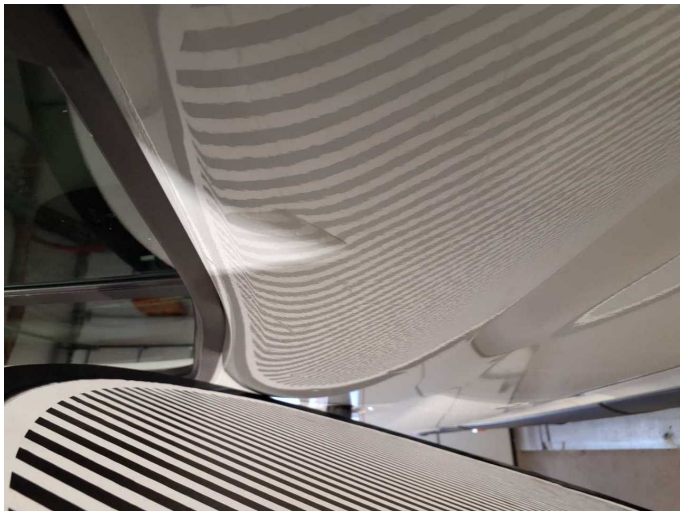
Damage 8: Door - front right side: Door - Dent / paintcoat damage - Repair and paint

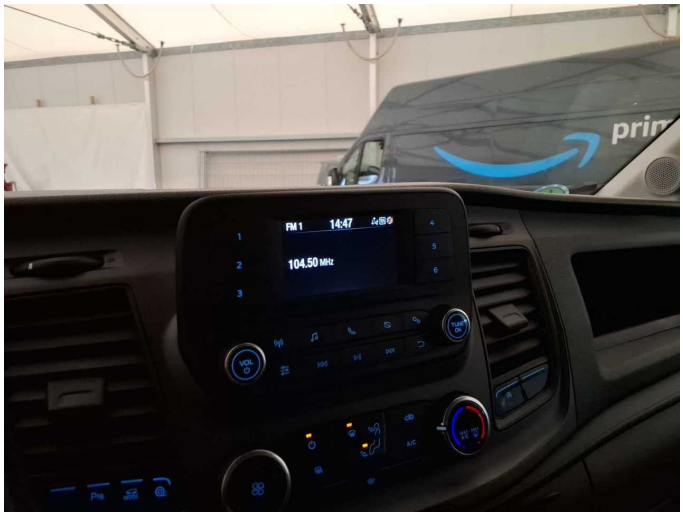
Damage 9: Multimedia system: Radio (Display Pixelfehler) - Functional / admissibility - Replace

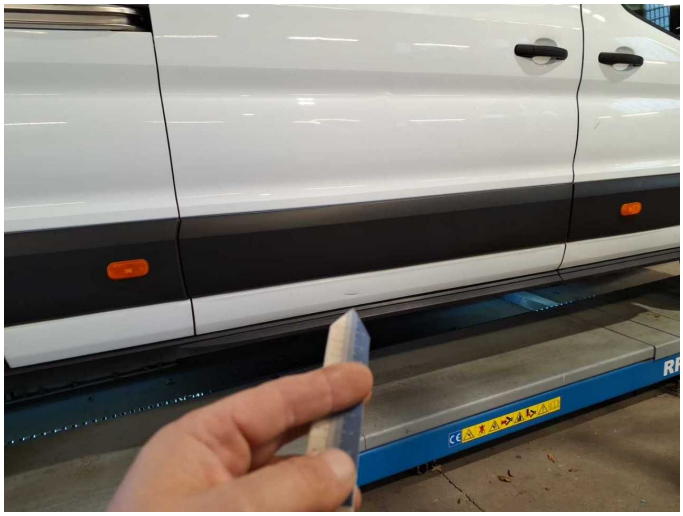
Damage 9: Multimedia system: Radio (Display Pixelfehler) - Functional / admissibility - Replace

Damage 10: Sliding door, right: Sliding door - Deformed - Repair and paint

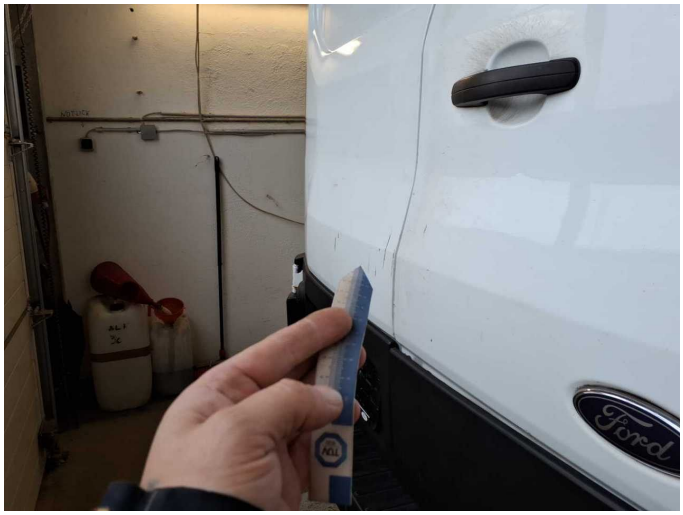
Damage 10: Sliding door, right: Sliding door - Deformed - Repair and paint

Damage 11: Boot lid / rear door: Rear door - left side - Dent / paintcoat damage - Repair and paint

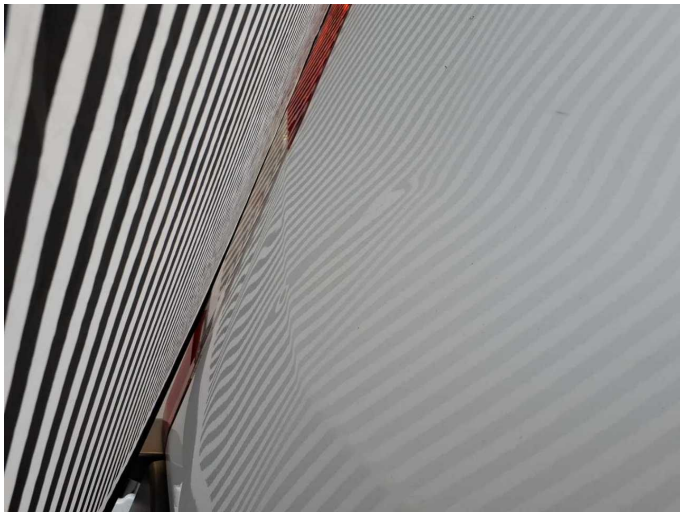
Damage 11: Boot lid / rear door: Rear door - left side - Dent / paintcoat damage - Repair and paint

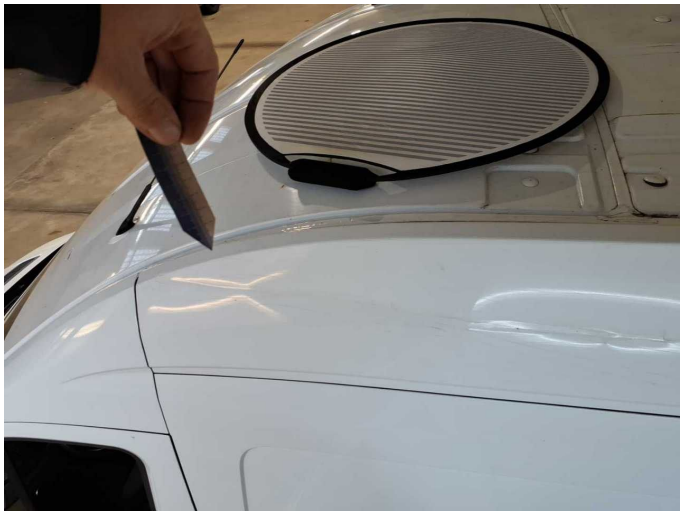
Damage 12: Roof: Roof rail - left side (Mittelteil) - Deformed - Repair and paint

Damage 13: Misc.: Misc. (KLAPPREGAL RECHTS) - Missing - Replace

Damage 14: Roof: Roof (Korrosion, Blende fehlt) - Dent / paintcoat damage - Repair and paint

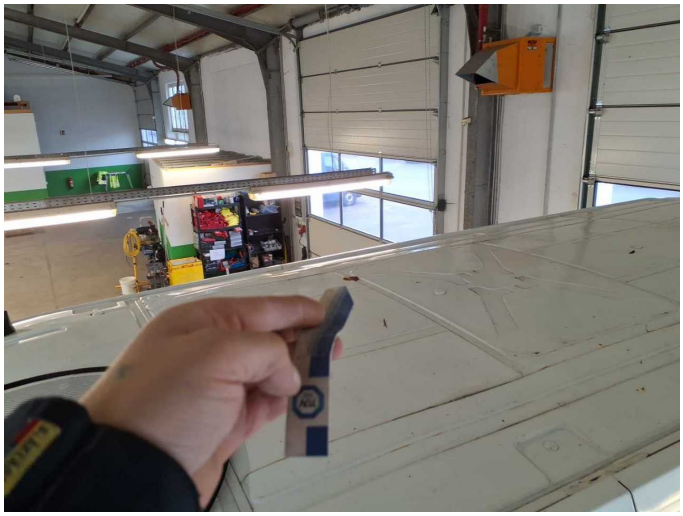
Damage 14: Roof: Roof (Korrosion, Blende fehlt) - Dent / paintcoat damage - Repair and paint

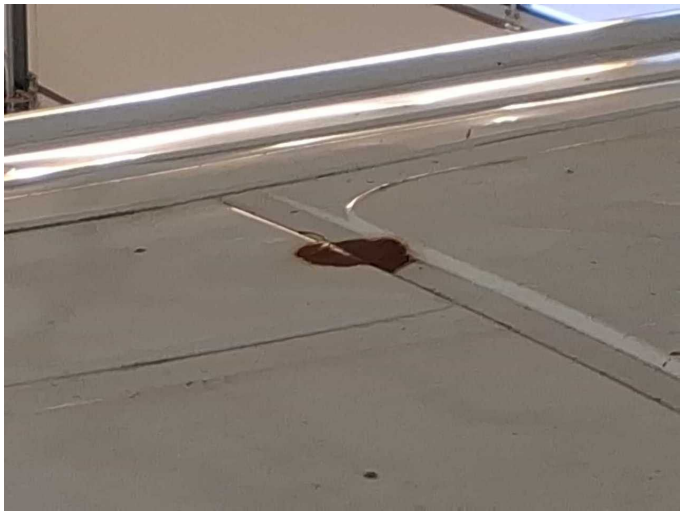
Damage 14: Roof: Roof (Korrosion, Blende fehlt) - Dent / paintcoat damage - Repair and paint

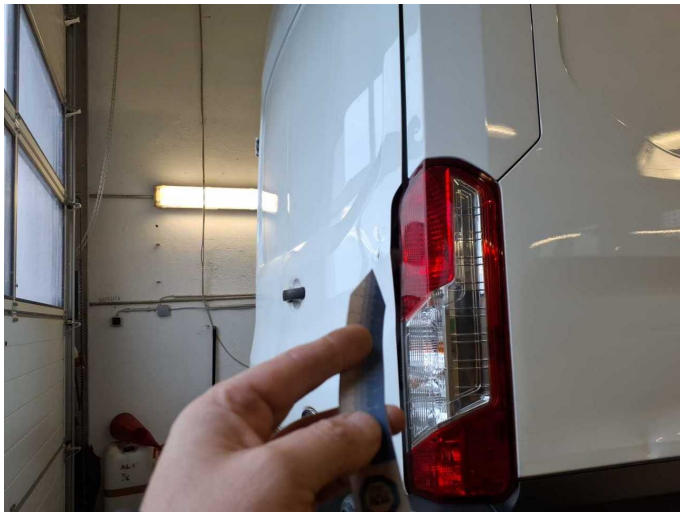
Damage 14: Roof: Roof (Korrosion, Blende fehlt) - Dent / paintcoat damage - Repair and paint

Damage 15: Boot lid / rear door: Rear door - right side - Broken / torn - Replace

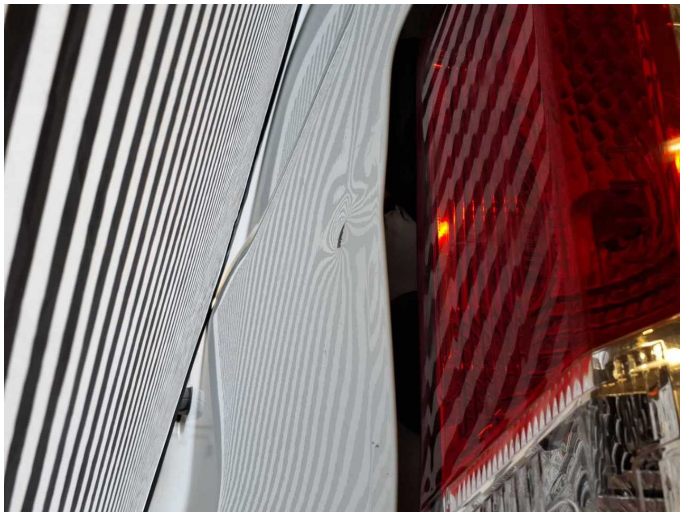
Damage 15: Boot lid / rear door: Rear door - right side - Broken / torn - Replace

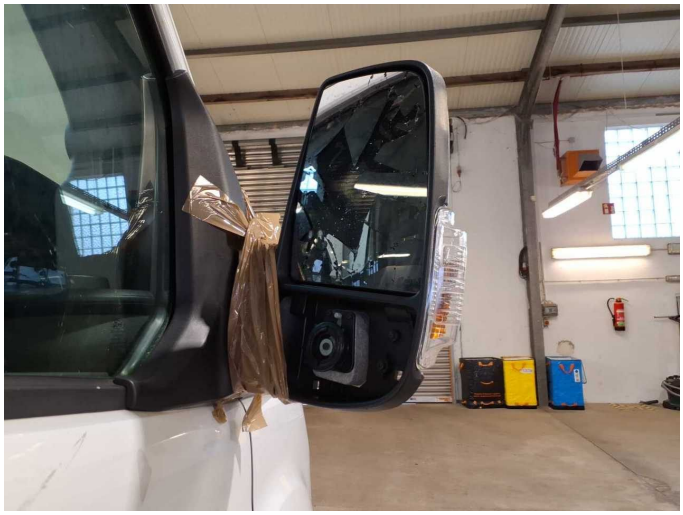
Accident 2: Front, Side right

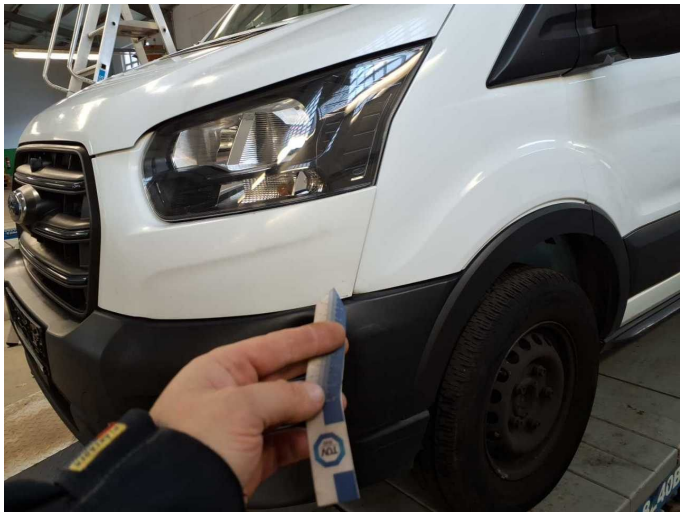
Accident 3: Front, Side - left

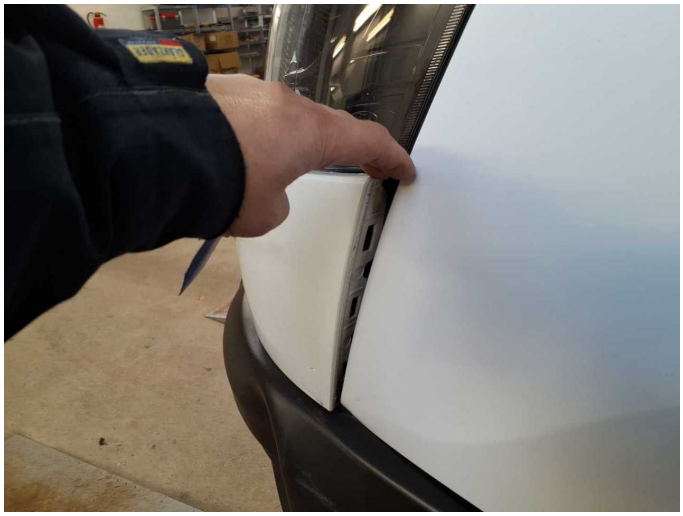
Accident 3: Front, Side - left

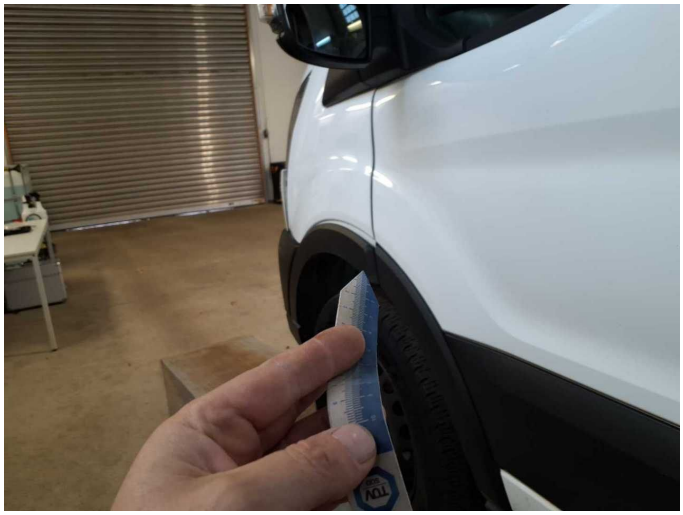
Accident 3: Front, Side - left

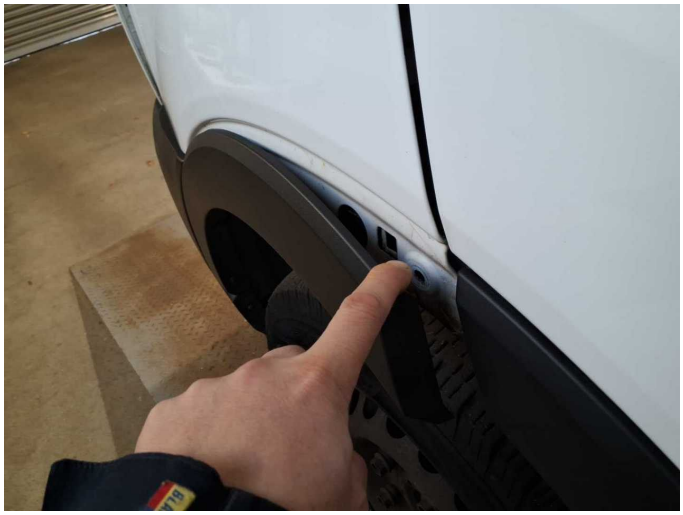
Accident 3: Front, Side - left

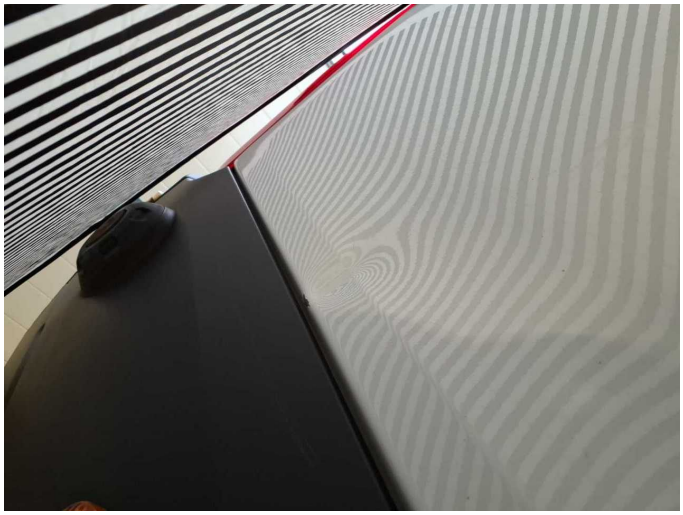
Accident 4: Side right

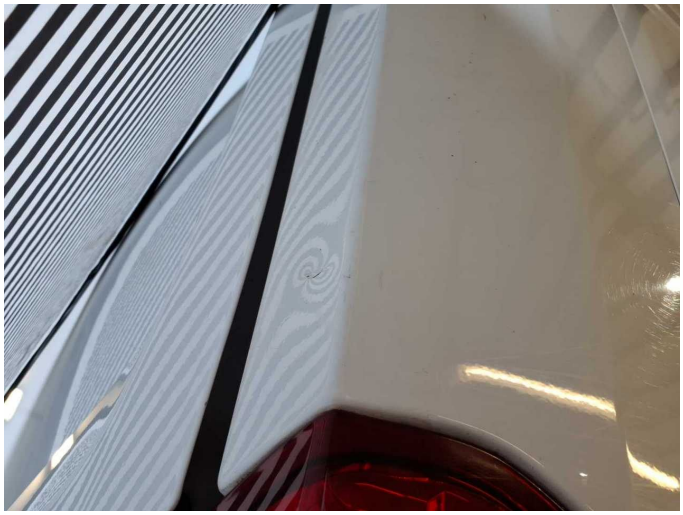
Accident 4: Side right
