Expertise

Protocol number: 48411730
Order No. / Reference: 27019524
Inspection date: 27 Oct 2026

Manufacturer: Ford	Model: Transit Custom 280 L1H1 LKW VA Trend
VIN: WF0YXXTTGYMM47737

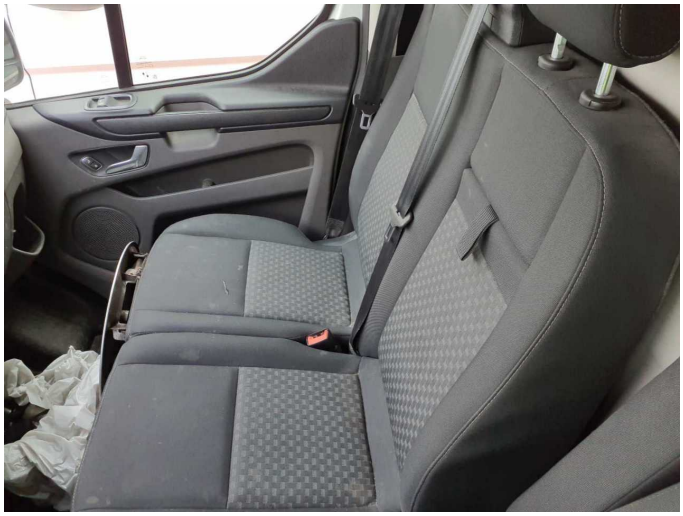
Damage 1: Seat - front: Seat cover - left side (Sitze) - Soiled - Clean

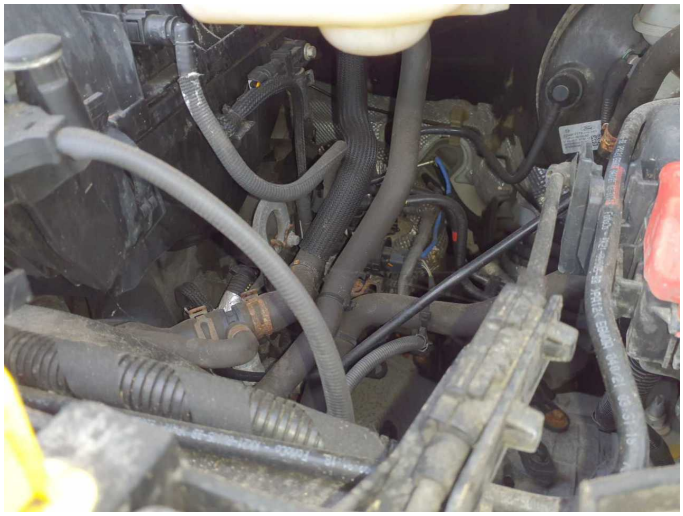
- Motorschaden vorhanden.

- Motorraum teilweise zerlegt. Kein Motorstart möglich.

Damage 4: Engine: Engine - Defective - Replace
