Expertise

Protocol number: 47967397
Order No. / Reference: 27036820
Inspection date: 6 Oct 2026

Manufacturer: Ford	Model: Focus Turnier 1.5 EcoBlue Start-Stopp-System TITANIUM X
VIN: WF0PXXGCHPNB88619

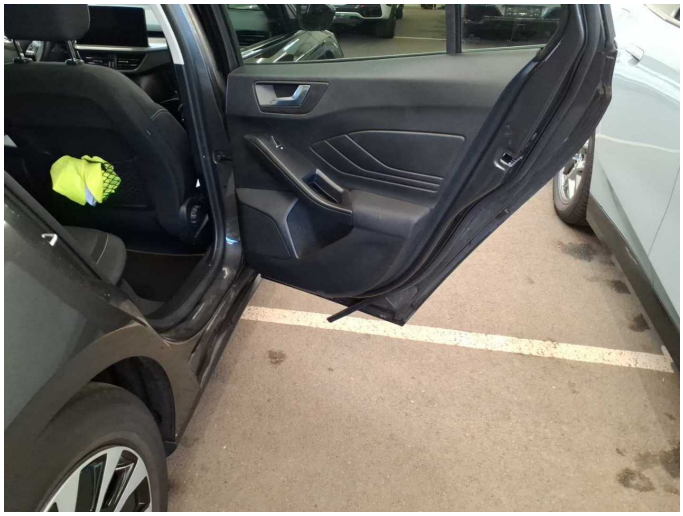
Damage 1: Side panel - rear right side: Side panel - Scratch(es) - Smart repair
