Expertise

Protocol number: 48511704
Order No. / Reference: 27199472
Inspection date: 26 Oct 2026

Manufacturer: Skoda	Model: Octavia Combi 2.0 TDI DSG 4x4 Scout
VIN: TMBLK8NX8PY162983

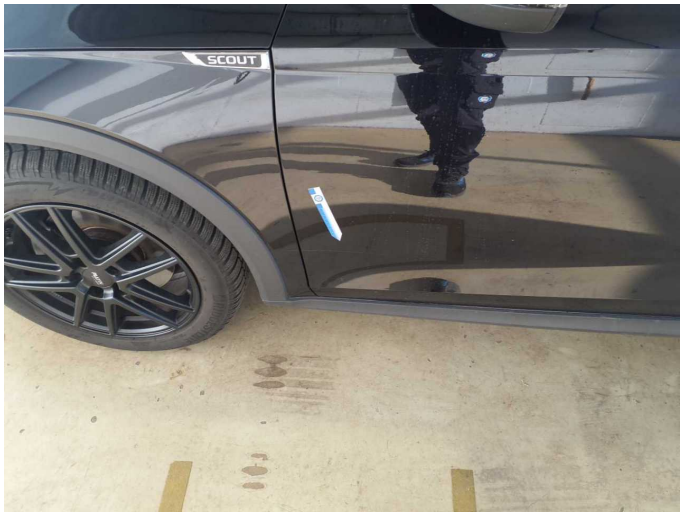
No.	Component group	Description
1	Trim / covers	C-pillar - trim - interior, left sde - Scratched - Loss in value
2	Mudguard - right side	Mudguard - right side - Scratch(es) - Smart repair
3	Door - front left side	Door - Scratch(es) - Smart repair
4	Rear bumper	Spoiler - Scratch(es) - Replace
5	Front bumper	Front bumper - Dent / paintcoat damage - Smart repair
6	2nd wheel set	2 tyres - Worn - Replace
7	Door - front right side	Door - Dent / paintcoat damage - Repair and paint
8	Rear bumper	Rear bumper - Dent / paintcoat damage - Repair and paint
9	Side panel - rear right side	Side panel - Scratch(es) - Paint
10	Front bumper	Spoiler - Scratched - Replace
11	Side panel - rear left side	Side panel - Dent / paintcoat damage - Repair and paint
12	Door - rear right side	Door - Dent / paintcoat damage - Paint
13	Door - rear left side	Door - Dent / paintcoat damage - Repair and paint
14	Bonnet	Bonnet - Dent / paintcoat damage - Repair and paint

Damage 2: Mudguard - right side: Mudguard - right side - Scratch(es) - Smart repair

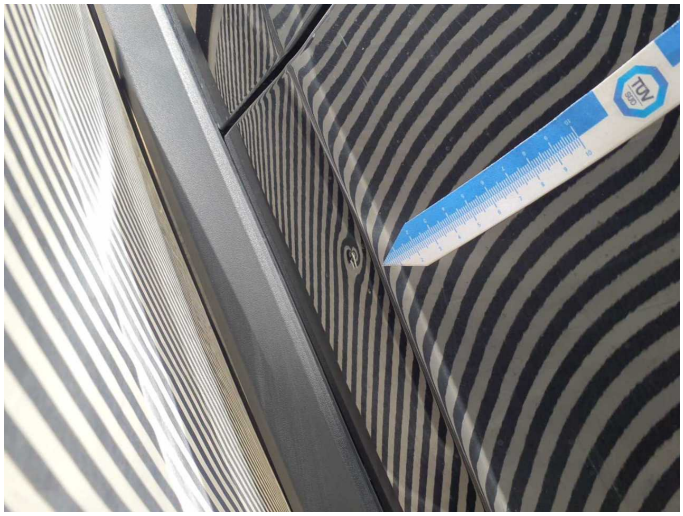
Damage 7: Door - front right side: Door - Dent / paintcoat damage - Repair and paint

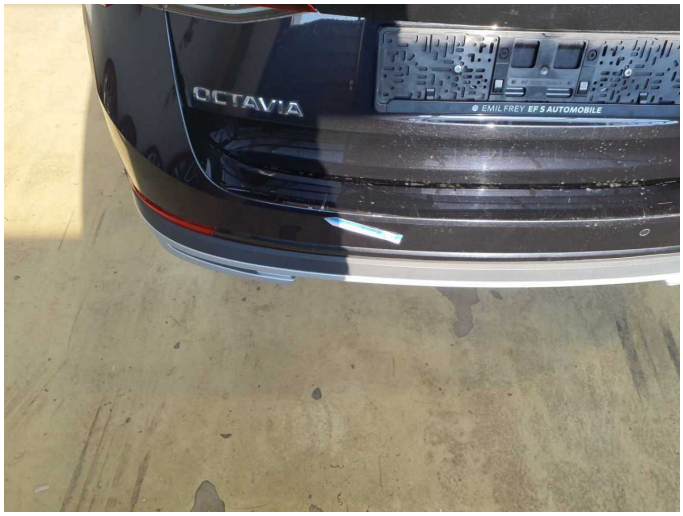
Damage 8: Rear bumper: Rear bumper - Dent / paintcoat damage - Repair and paint

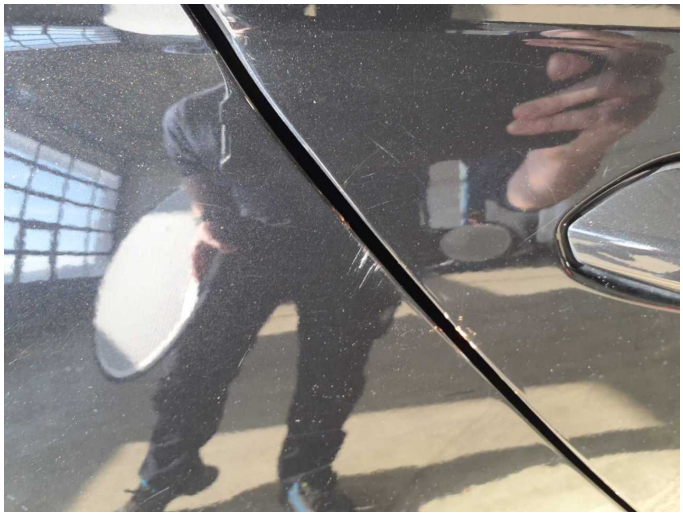
Damage 9: Side panel - rear right side: Side panel - Scratch(es) - Paint

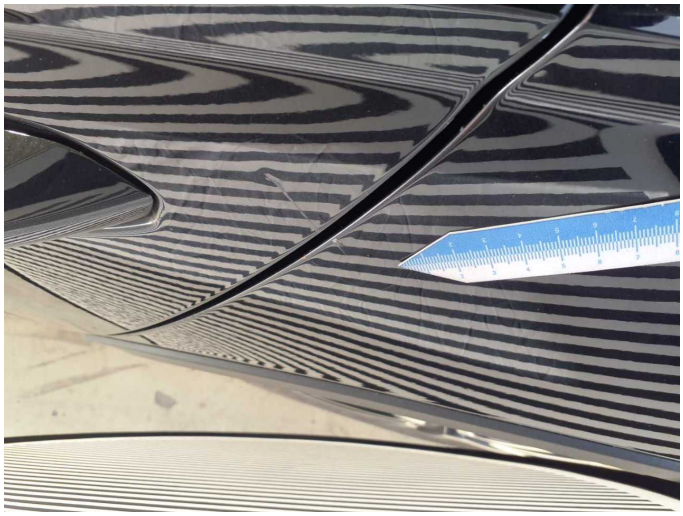
Damage 11: Side panel - rear left side: Side panel - Dent / paintcoat damage - Repair and paint

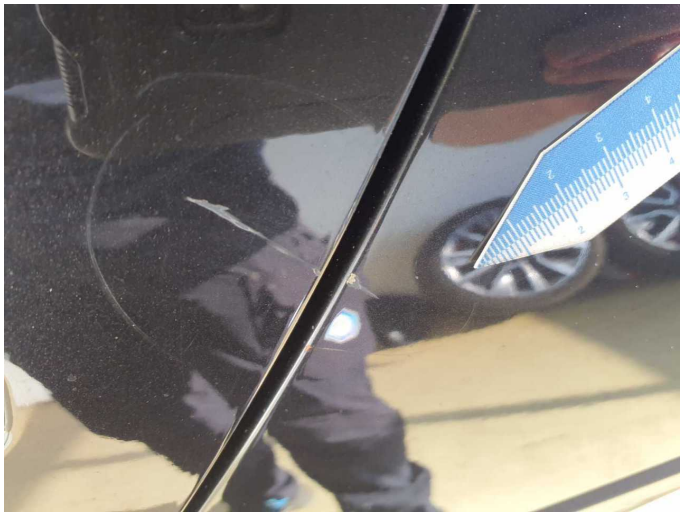
Damage 11: Side panel - rear left side: Side panel - Dent / paintcoat damage - Repair and paint

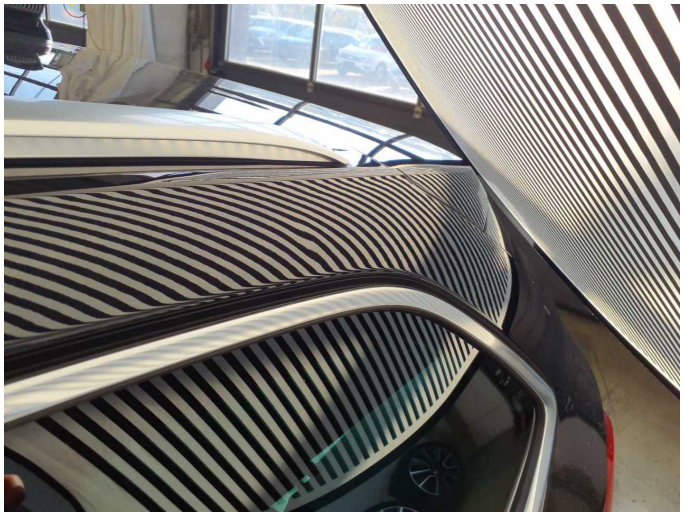
Damage 11: Side panel - rear left side: Side panel - Dent / paintcoat damage - Repair and paint

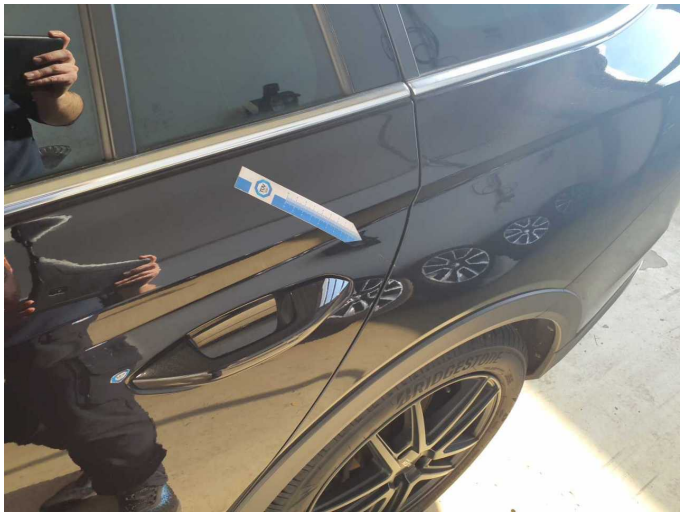
Damage 12: Door - rear right side: Door - Dent / paintcoat damage - Paint

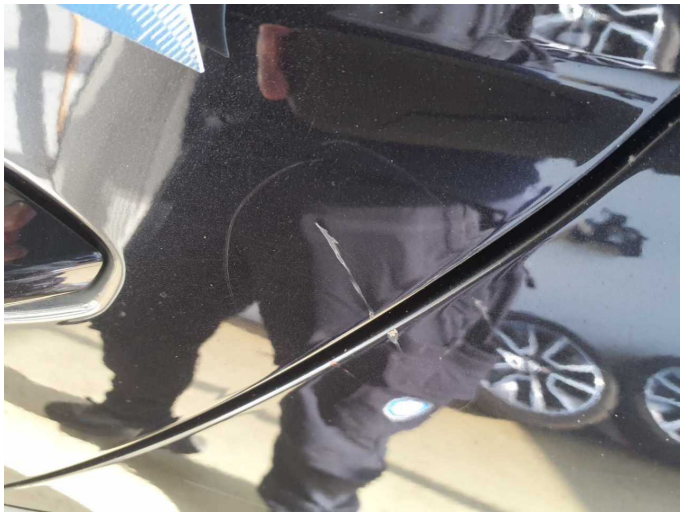
Damage 13: Door - rear left side: Door - Dent / paintcoat damage - Repair and paint

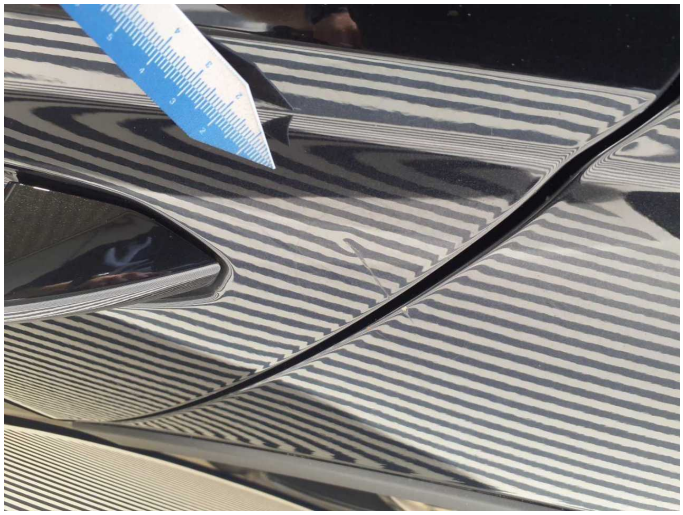
Damage 13: Door - rear left side: Door - Dent / paintcoat damage - Repair and paint

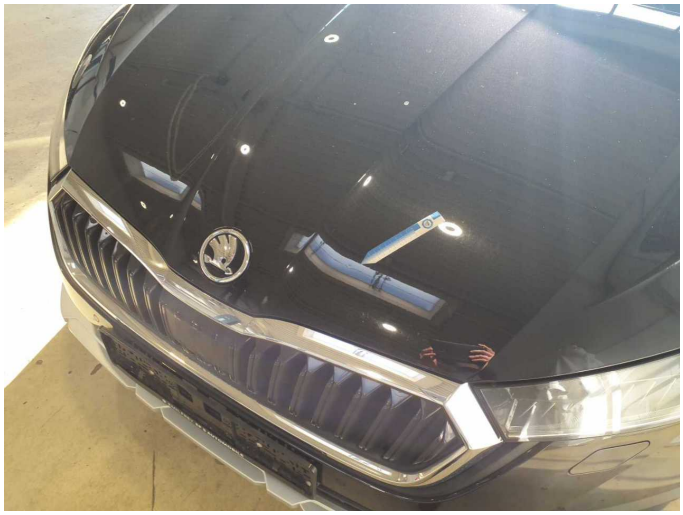
Damage 14: Bonnet: Bonnet - Dent / paintcoat damage - Repair and paint

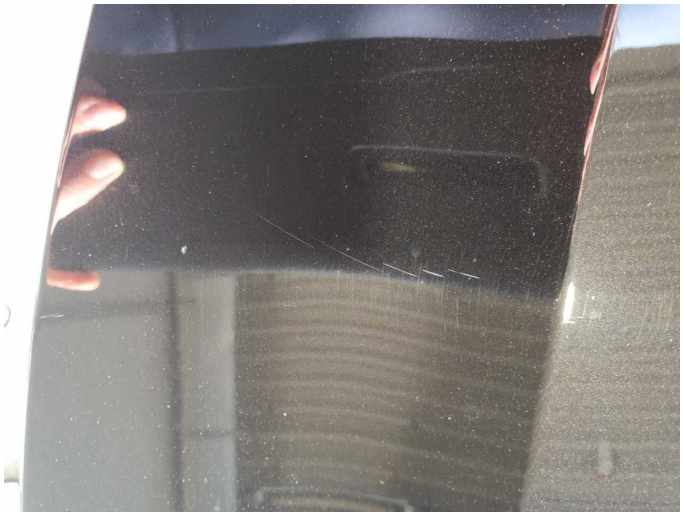
Damage 14: Bonnet: Bonnet - Dent / paintcoat damage - Repair and paint

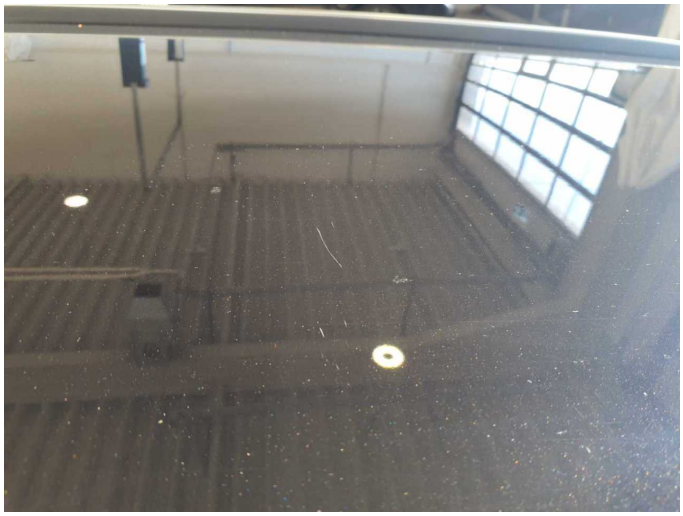
Damage 15: Roof: Roof - Scratch(es) - Paint

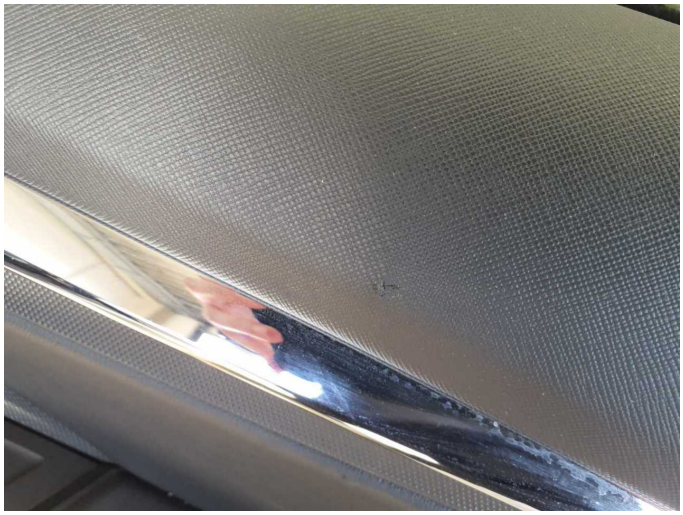
Wear and tear 2: Trim / covers: Door trim - front right side - Scratch(es) - No deduction

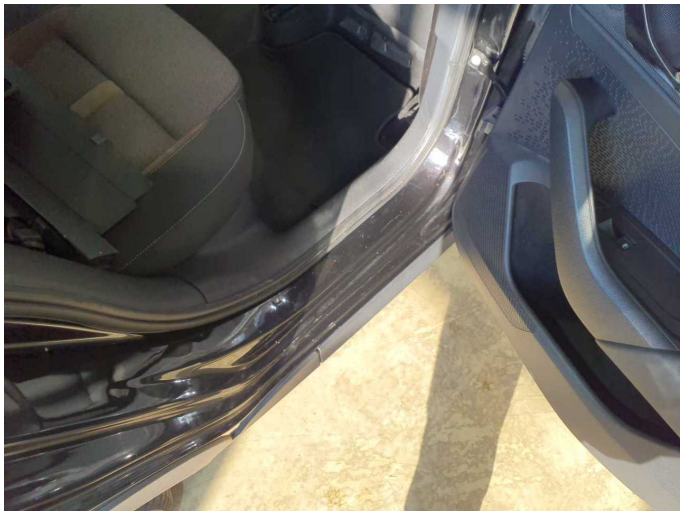
Wear and tear 2: Trim / covers: Door trim - front right side - Scratch(es) - No deduction
