Expertise

Protocol number: 46520930  
Order No. / Reference: 26546968  
Inspection date: 7 Jul 2026

Manufacturer: Ford

Model: Galaxy 2.5 Duratec FHEV VIGNALE

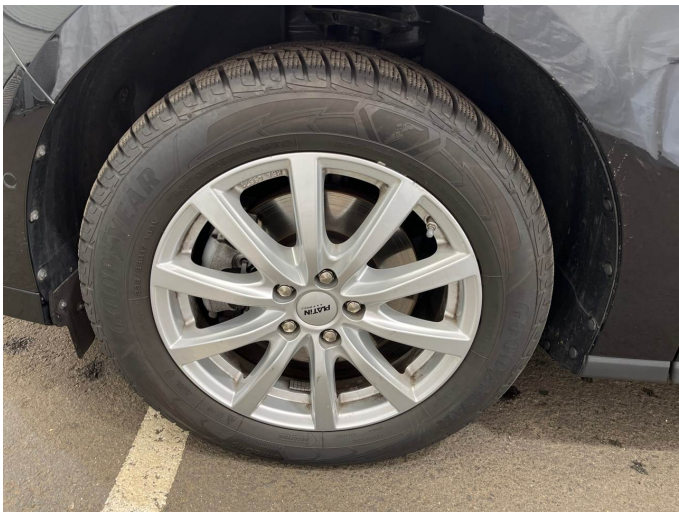
Figure 12: Mounted tyres

- Die Unterbodenbesichtigung war nur ebenerdig & eingeschränkt möglich. Mehrkosten möglich.
- Für den montierten Radsatz wurde kein Nachweis erbracht.
- Winterradsatz ist kein Bestandteil des Auslieferungsumfangs.
