## Expertise

Protocol number: 46021827  
Order No. / Reference: 26417537  
Inspection date: 18 Jun 2026

Manufacturer: Ford

Model: Transit Connect 200 L1 S&S Trend

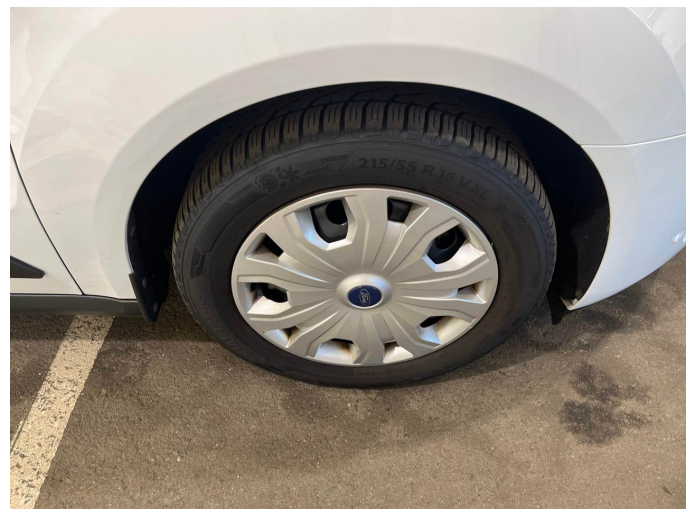
Figure 12: Mounted tyres

#	Tyre size	Type of tyre	Manufacturer	Tread depth
1)	215/55 R16 97V	All-season tyres on Steel rim with wheel cover	Barum	5mm / 5mm
2)	215/55 R16 97V	All-season tyres on Steel rim with wheel cover	Barum	7mm / 7mm
