Expertise

Protocol number: 46346969
Order No. / Reference: 26670855
Inspection date: 3 Jul 2026

Manufacturer: Peugeot

Model: 508 SW Plug-In Hybrid 225 e-EAT8 GT

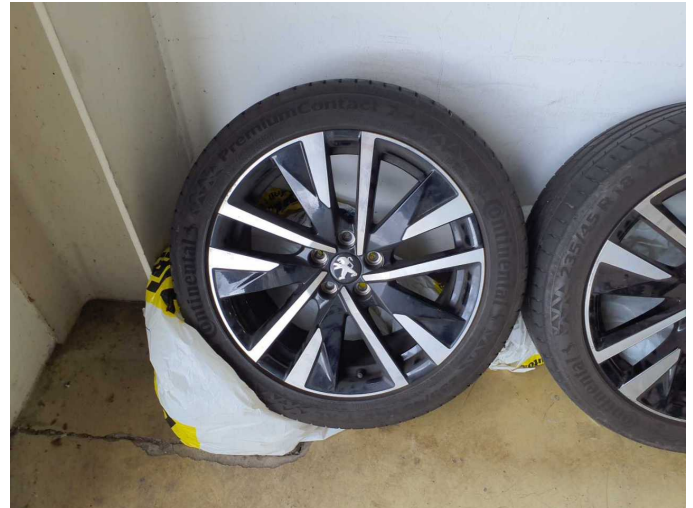
No.	Component group	Description
1	Misc.	Inspection / maintenance (1.,3.,4. und 5. Wartung überzogen)
2	Misc.	Main inspection - No evidence - No deduction
3	2nd wheel set	1 alloy rim - Scratch(es) - Loss in value
4	Door - front right side	Door edge - Scratch(es) - Smart repair
5	Door - front left side	Door edge - Scratch(es) - Smart repair
6	Door - front right side	Door - Scratch(es) - Smart repair
7	2nd wheel set	1 tyre - Porous / cracked - Replace
8	2nd wheel set	1 tyre - Porous / cracked - Replace
9	Instrument panel	Indicator light (Systemfehler Elektroantrieb) - on - Perform diagnosis
10	Misc.	Inspection / maintenance - Due - Perform
11	2nd wheel set	1 alloy rim - Scratch(es) - Replace
12	2nd wheel set	1 alloy rim - Scratch(es) - Replace
13	Rear bumper	Rear bumper - Scratch(es) - Paint
14	Door - rear right side	Door - Dent / paintcoat damage - Repair and paint
15	Bonnet	Bonnet (Anätzung) - Paint defect - Repair and paint

Damage 3: 2nd wheel set: 1 alloy rim - Scratch(es) - Loss in value
