Expertise

Protocol number: 45923190
Order No. / Reference: 26451667
Inspection date: 11 Jun 2026

Model: Vivaro 2.0 D Cargo L EHZ Autm. Elegance

VIN: VXEVFEHZ7N7042612

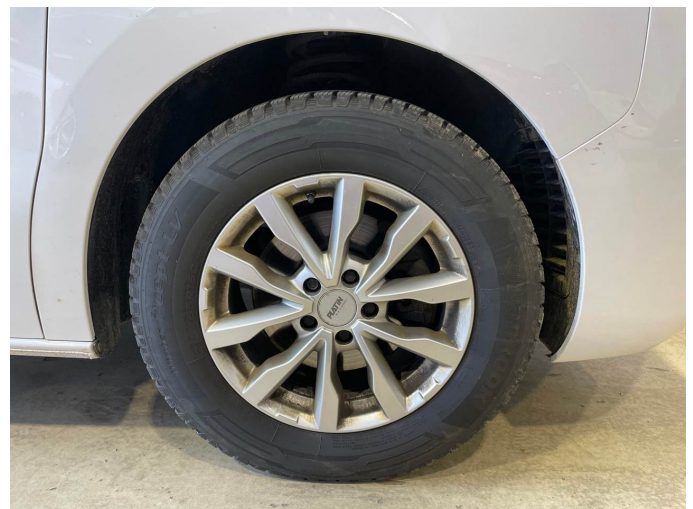
Figure 12: Mounted tyres

#	Tyre size	Type of tyre	Manufacturer	Tread depth
1)	215/65 R16 109T	Winter tyres on Light alloy	Hankook	5mm / 5mm
2)	215/65 R16 106T	Winter tyres on Light alloy	Continental	6mm / 6mm
