Expertise

Protocol number: 46678129  
Order No. / Reference: 26620928  
Inspection date: 20 Jul 2026

Manufacturer: Opel

Model: Astra 1.5 D Start/Stop Sports Tourer Business Edition

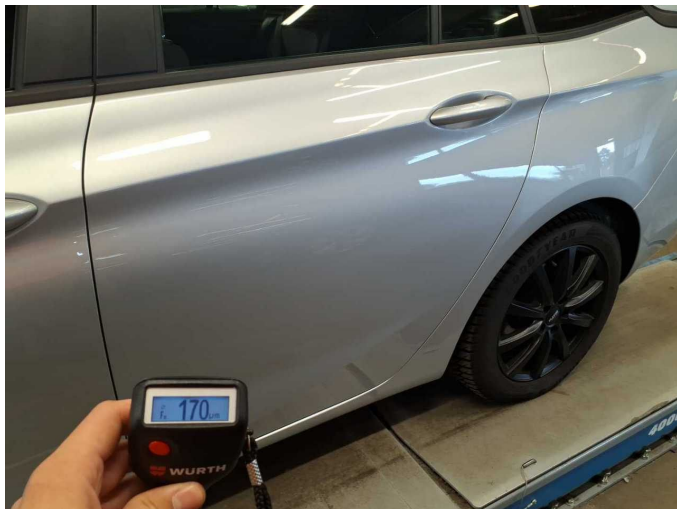
| No. | Repainting |
|---|---|
| 3 | Door - rear left side, Professionally carried out, Invoice of repair done Non-existent |

**Repainting 3:** Door - rear left side
